MINISTRY OF TRANSPORTS AND INFRASTRUCTURE  
ROMANIAN RAILWAY AUTHORITY - AFER

## INVESTIGATING REPORT

On the fire occurred on the 2<sup>nd</sup> of November 2010 at the locomotive DA 60-0965-8, hauling the passenger train no. 1555-2, in the Branch of the Railway County Iasi, between the railway stations Bucecea – Veresti, at the km 13+500

Final edition  
The 20<sup>th</sup> of January 2011

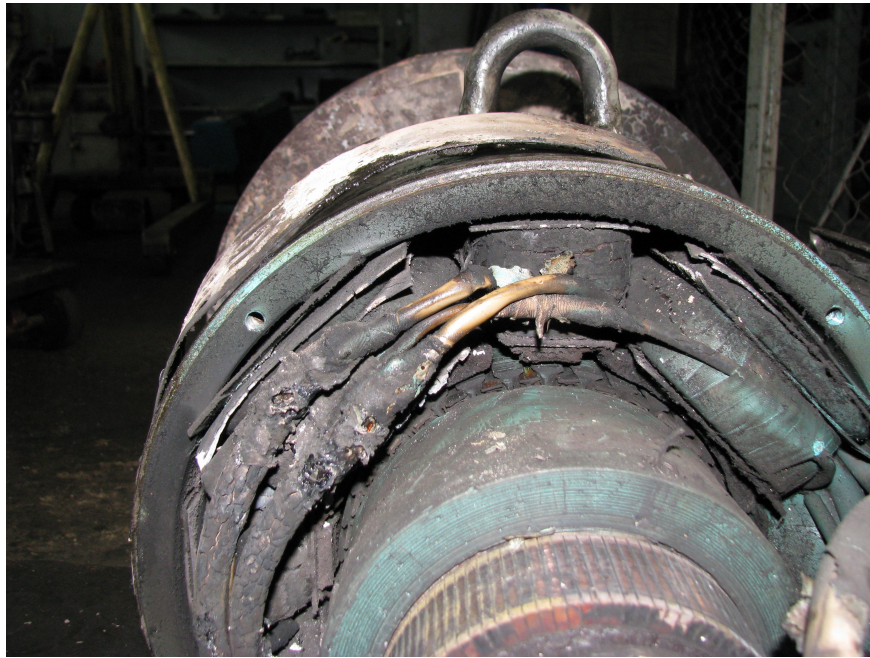
- the connections from the brush ring carbonized;
  - the collector with heating traces;
  - traces of molten tin at the ends of the bars;
  - rotor shortcircuit observed through the hole in the rotor winding with expulsion of turns.

**The connections from the stator coil carbonized**

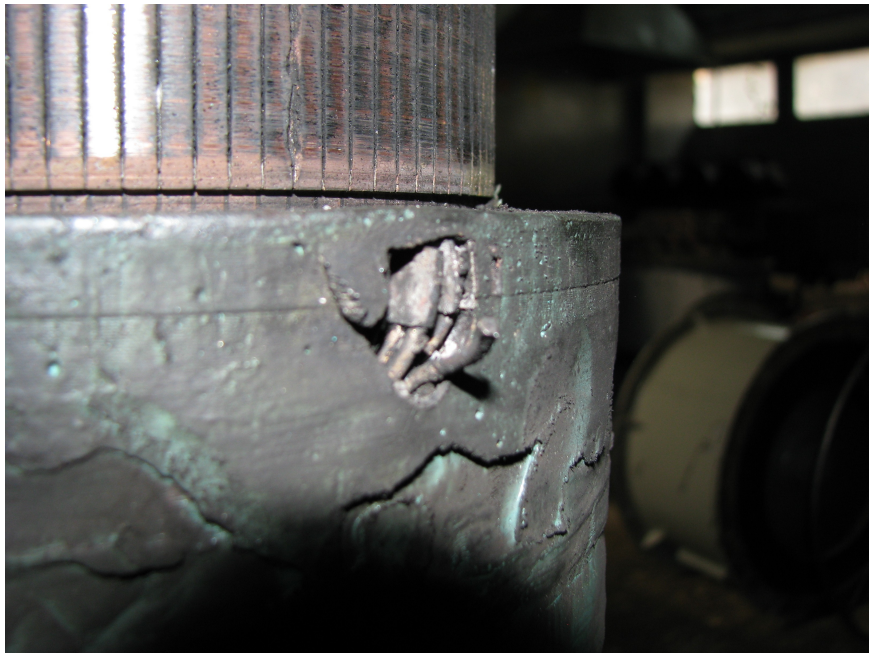
**Rotor shortcircuit observed through the hole in the rotor winding with expulsion of turns.**

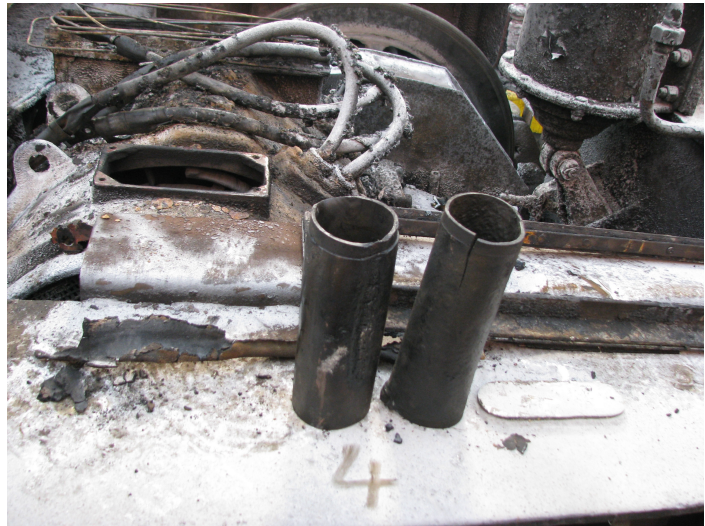
- At the engine no. 4

the cover applied on the fire insulation of the power cables carbonized and in some places melted; the bellows from the ventilation chanel carbonized; the fastening frame of the cables in the box and the insulation sleeves of the fastening connections had superficial thermic affecting; there were no sign of unsuitable work.

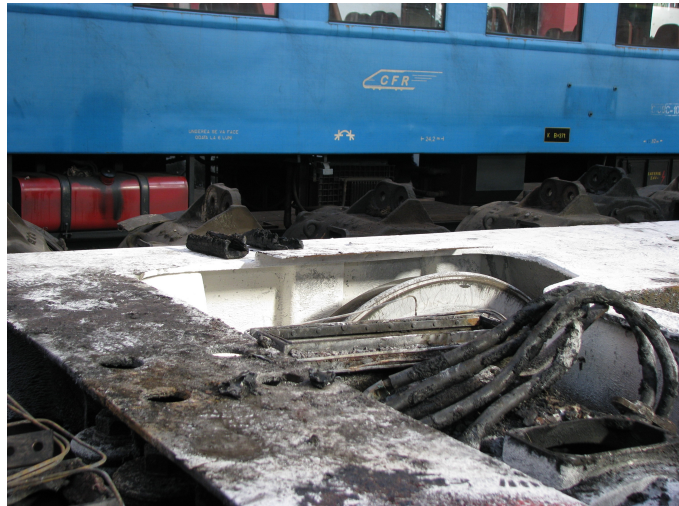
- At the engine no. 5

the cover applied on the fire insulation of the power cables carbonized and in some places melted; the bellows from the ventilation chanel carbonized; the fastening frame of the cables in the box and the insulation sleeves of the fastening connections carbonized; there were no sign of unsuitable work

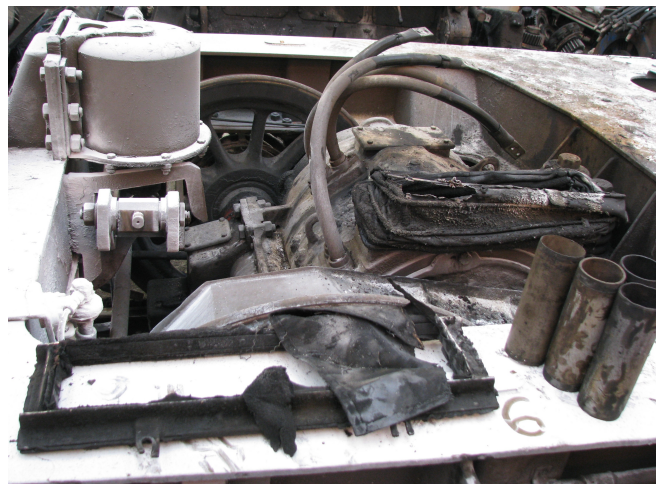
- At the engine no. 6

the cover applied on the fire insulation of the power cables in good condition; the bellows from the ventilation chanel in suitable condition; the fastening frame of the cables in the

box and the insulation sleeves of the fastening connections carbonized;

there were no sign of unsuitable work

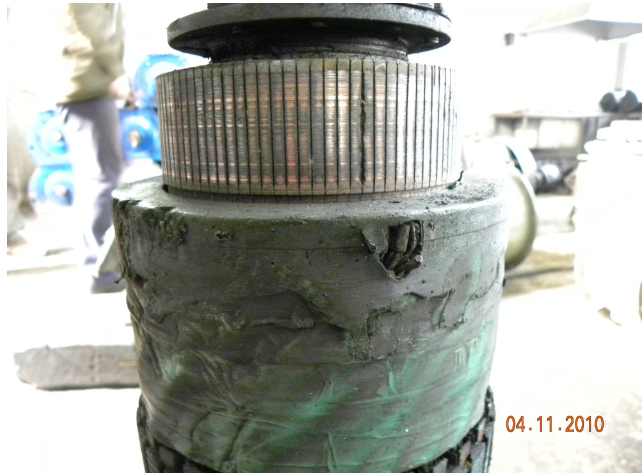
**Photo 1 – shortcircuit in the winding**

The shortcircuit occurred because of the diminuation of the dielectric resistance of the electric insulating material between the rotor turn winding.

- the overheating of the area and the expulsion of the ends of the rotor windings;
- the high heating of the tin from the rotor winding soldering of the winding ends connected to the collector;
- appearance of sparks and flame at the collector of the forced ventilation electromotor;
- evacuation out of the cover of the forced ventilation electromotor of molten material from the rotor winding (molten copper), tin drops and sparks.

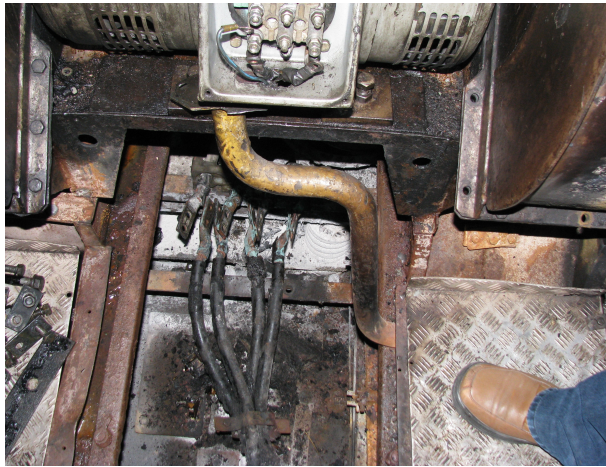
The molten material from the rotor winding (molten copper), tin drops and sparks generated by the shortcircuit from the forced ventilation electromotor winding of the traction electro-motors from the bogie no. 2 of the locomotive, were sent out of the box of the forced ventilation electromotor, through the ventilation holes existing in the inspection covers of the collector (photo 2) and led to the ignition of the nearby oil, that were the initial centre of the fire.

**Photo 2 – the ventilation holes of the inspection covers of the ventilation engine**

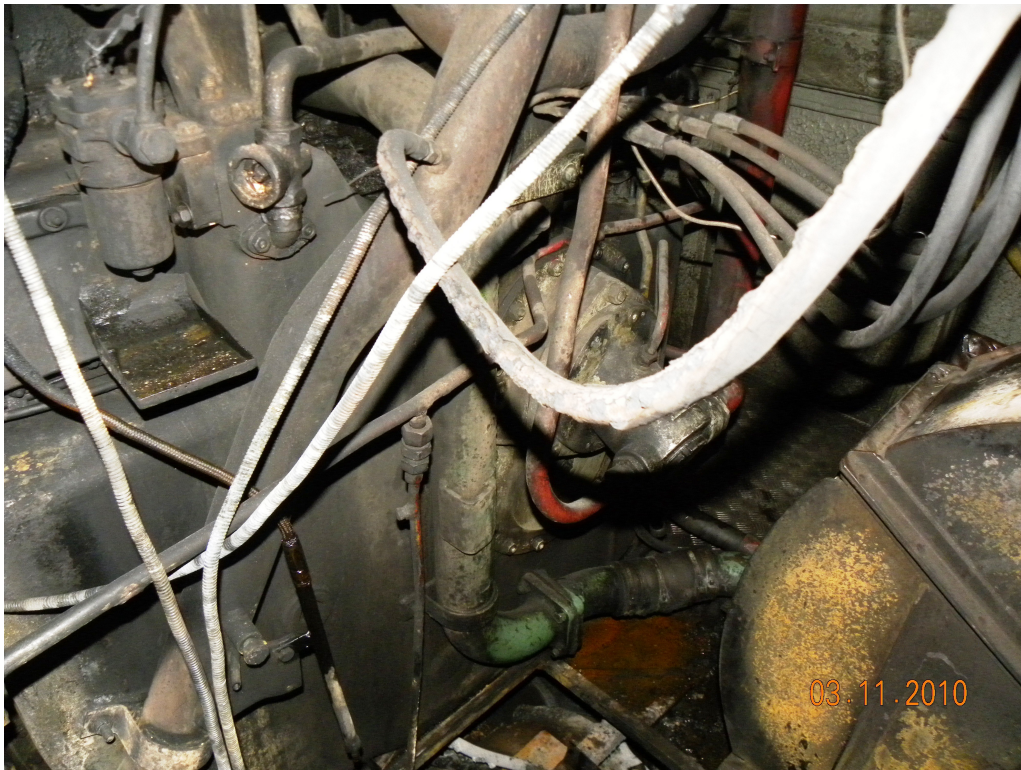
- around the forced ventilation electromotor of the traction electro-motors from the locomotive bogie no. 2, between the diesel engine and the locomotive box, left side (photos 3,4,5);
- the connections from the ventilation channel of the traction electro-motors 4 (photo 6) and 5 (photo 7);
- The covering applied on the fire insulation of the power cables of the traction electro-motors 4 and 5 of the locomotive (photos 6,7).

**Photo 3 – the distance between the shield of the diesel engine and the fastening support of the forced ventilation electromotor**

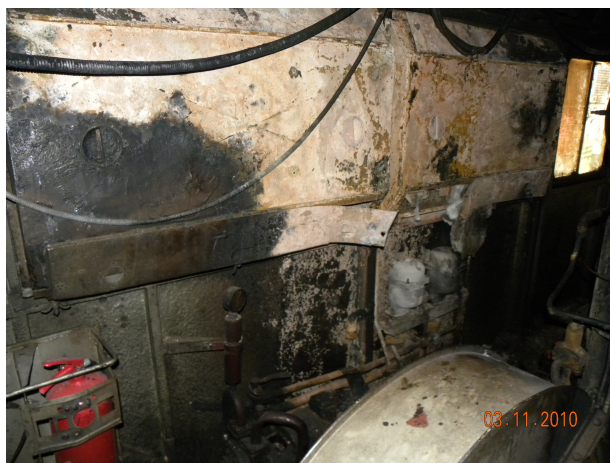
**Photo 4 – the distance between the ventilator of the forced ventilation engine and the wall of the locomotive box (left side)**

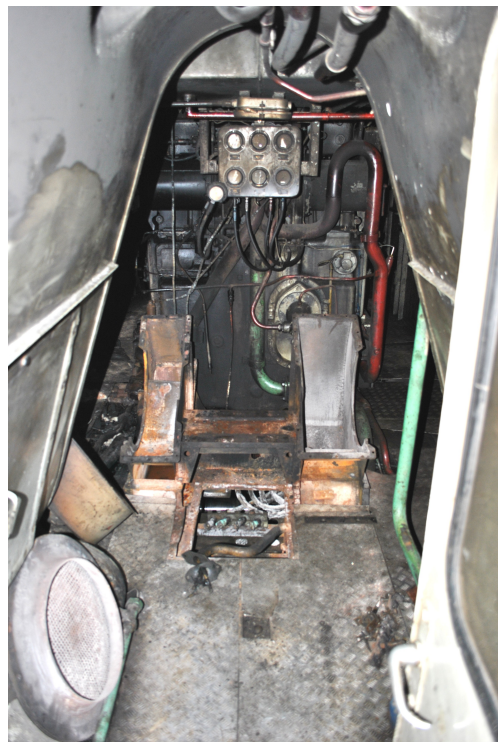
**Photo 5 – the distance between the forced ventilation electromotor and the driving cab II of the locomotive**

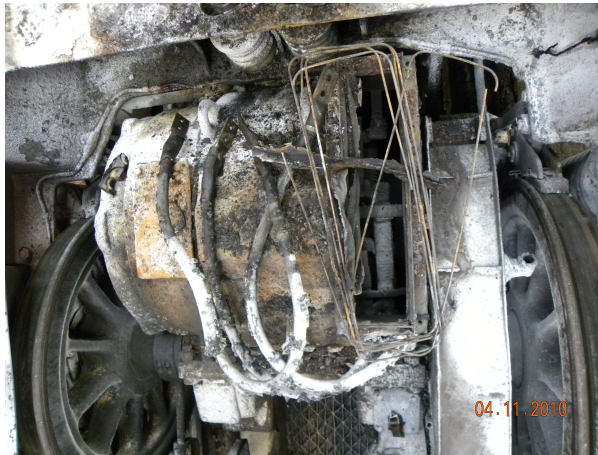
**Photo 6 – the condition of the bellows and the power cables of the traction electromotor no. 4**

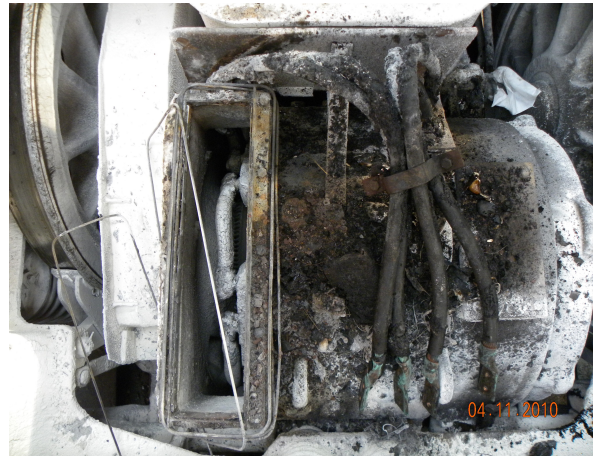
**Photo 7 the condition of the bellows and the power cables of the traction electromotor no. 4**

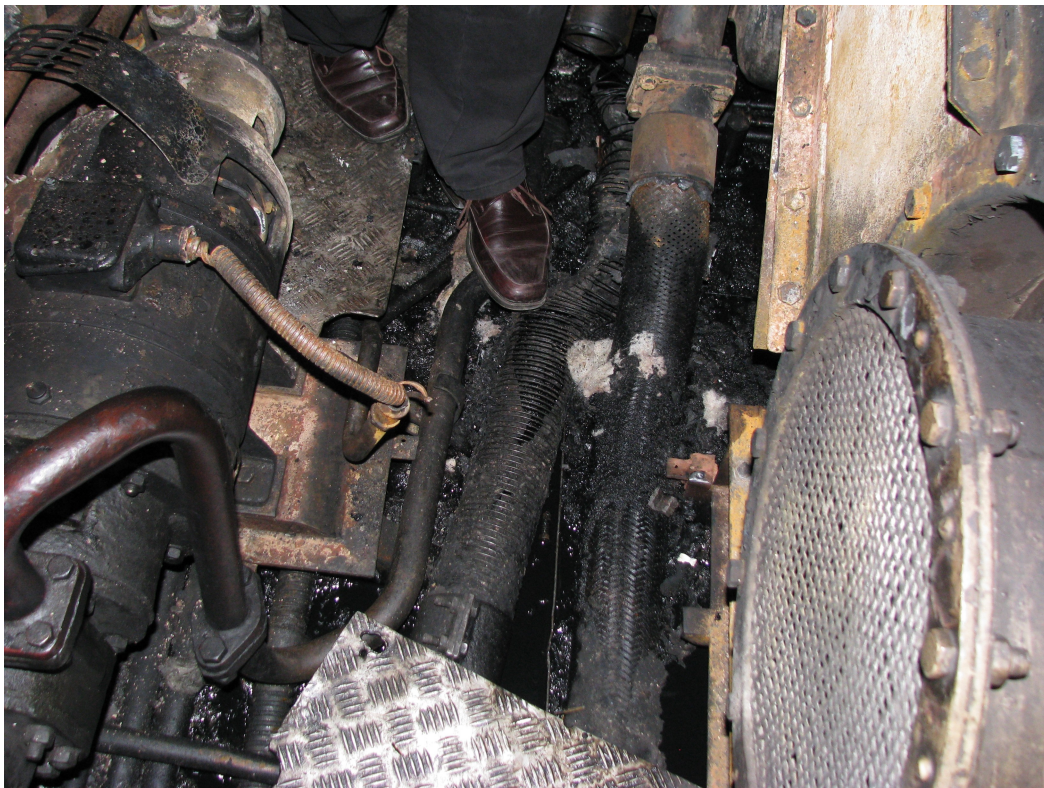
In the engines box the fire was kept by the rubber of Argus tubes Ø80x1035 and by the oil drained through Argus tubes, from the lubrication equipment of diesel engine (photo 8).

**Photo 8 Argus tubes, from the lubrication equipment of diesel engine after fire**
