**MINISTRY OF TRANSPORT AND INFRASTRUCTURE - MTI
ROMANIAN RAILWAY AUTHORITY - AFER
ROMANIAN RAILWAY INVESTIGATING BODY - OIFR**

INVESTIGATING REPORT

of the railway accident happened on the 18th of March 2010, on the running line between the railway stations Crivadia and Merisor

Final edition
The 23rd of November 2010

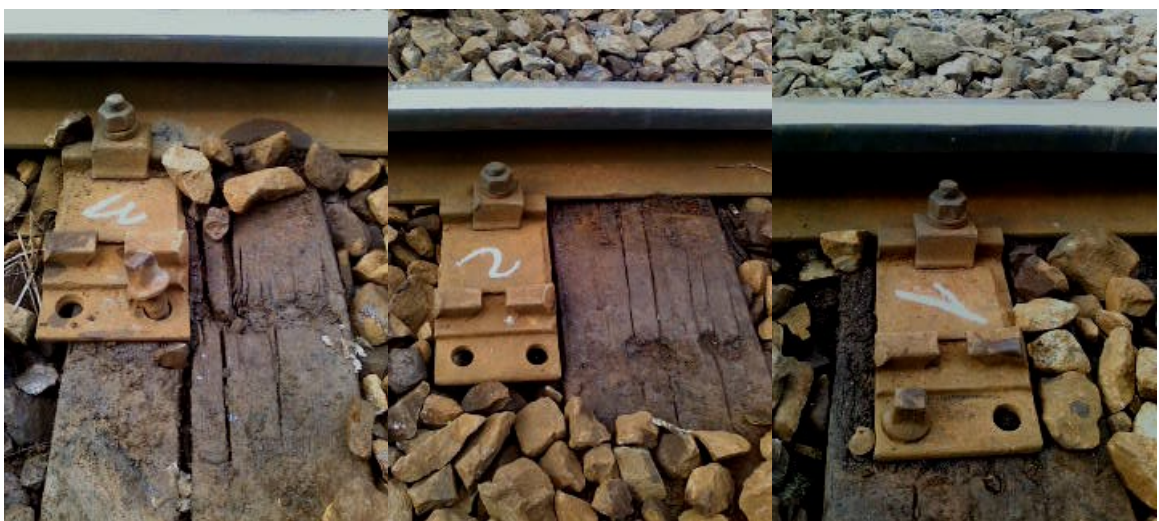
the fastening of the inside track rail of the curve on sleepers

- one the sleeper at this trace the metallic plate was not fasten
- those two sleepers, between that was that sleeper, had the metallic plates fastened in two coach screws each of them, instead 4;
- under the metallic plates from this sleepers one did not onserve the polyethylene plates. However, on the sleepers there were no traces specific to the lateral displacement under the forces induced by the running rolling stock;

fastening of the outside track rail of the curve on the sleepers

- the afferent metallic plates of those 3 sleepers were fastening according to the instruction

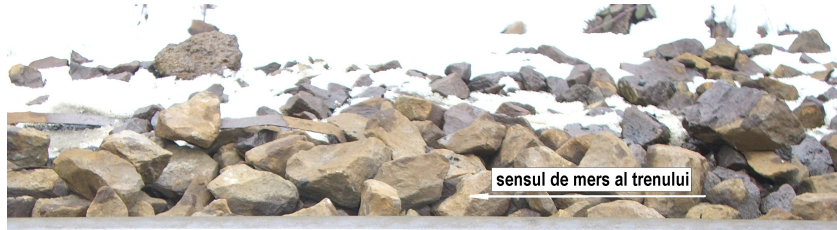
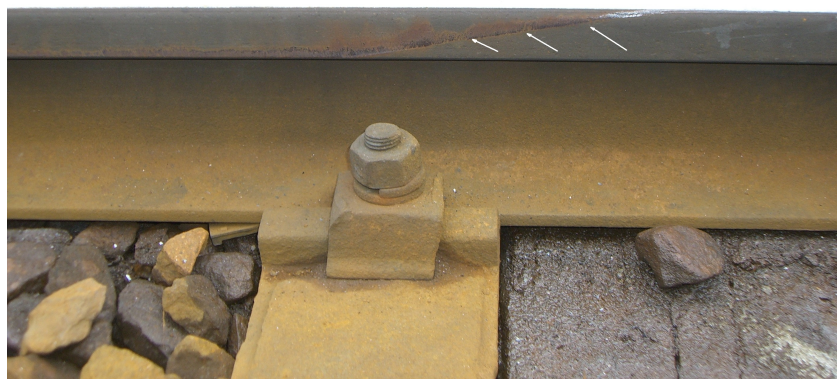
the curve inside track rail

- on the active lateral surface of the rail head one found out a trace of leaving of the rail running surface by the tyre, without affecting the fastening metallic elements for the rail fastening on the metallic plates or those for the fastening of the metallic plates on the sleepers;

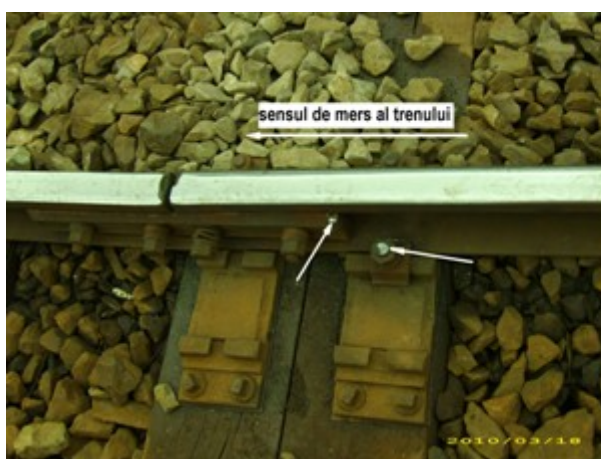
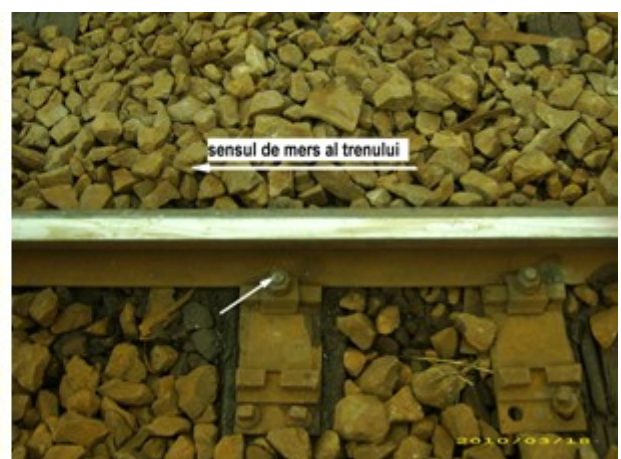
- from this trace, starting with the second sleepers, in the train running direction, and up to the point where one observed the first fall trace from the running surface of the left rail (rail from curve outside track) left by the tyre (about 156 m), vertical screws, that fasten the rail base on the metallic plates, had polishing and hit traces of the up surface of the rod end. Also, the fish plates from the joints had traces of slight hits;

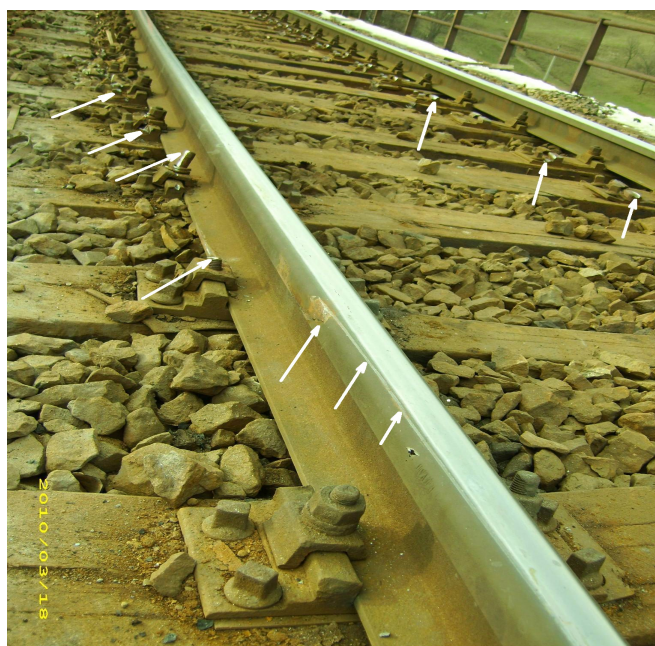
b) *km 58+760 – place of the first trace of leaving of the running surface of the rail head corresponding to the curve outside track*

- at about 156 m (km 58+760) against the previous trace from the active lateral surface of the rail head corresponding to the curve inside track, there was found out on the

outside lateral surface of the rail corresponding to the outside track of the curve, a trace of leaving of the running surface of this rail head, followed by the successive hit of the metallic elements for the fastening of the rail on the sleepers, both on the left side of the rail corresponding to the curve outside track, and to the same metallic elements inside the track, serving for the fastening of the right rail in the running direction of the train, corresponding to the curve inside track.

- starting with this point, the train run about 77 m up to stop, on this distance being identified elements of the track superstructure, damaged because of the running of the rolling stock on them (vertical screws, coach screws, metallic plates, sleepers);

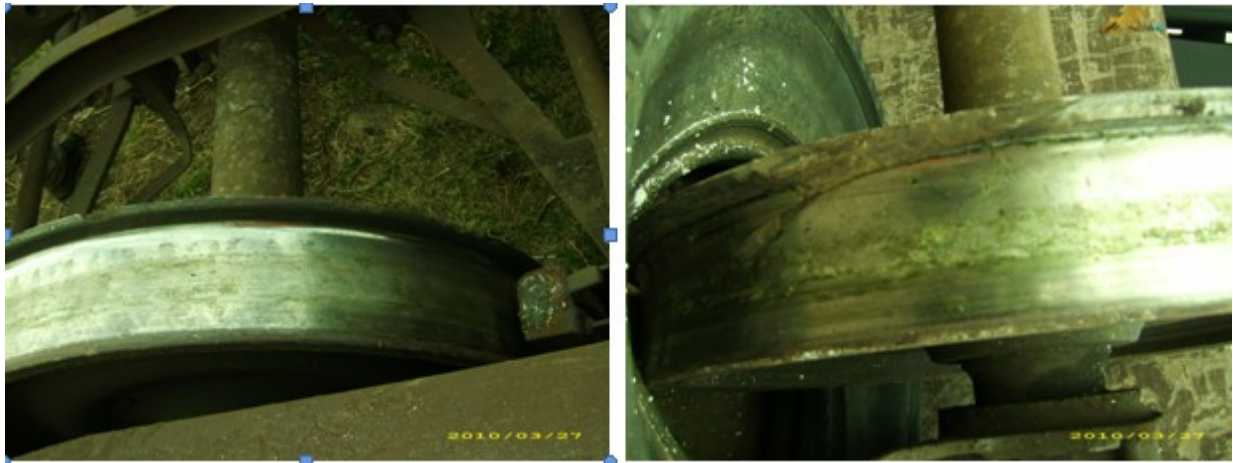
At the wagon no. 88536656494-0 (the 5th of the train), the first derailed bogie of the first wagon in the train running direction, at the wheels 5 and 7, running on the outside track of the curve there were found out:

- quota q_r under the limit 6,5 mm accepted in the tabel 1, point 5 of the Instruction no. 250, version 2005, that is 5 mm at both wheels;
- at the first wheel no. 7:
 - edgeds and wears of 2-4 mm on the active surface on about 70% from the wheel diameter;

- thickness of the wheel flange of 18 mm, under the limit of 22 mm, stipulated in the tabel no. 1, point 8 from the Instruction no. 250, version 2005;
- at the wheel 5, lack of a part from its flange on about 160 mm;

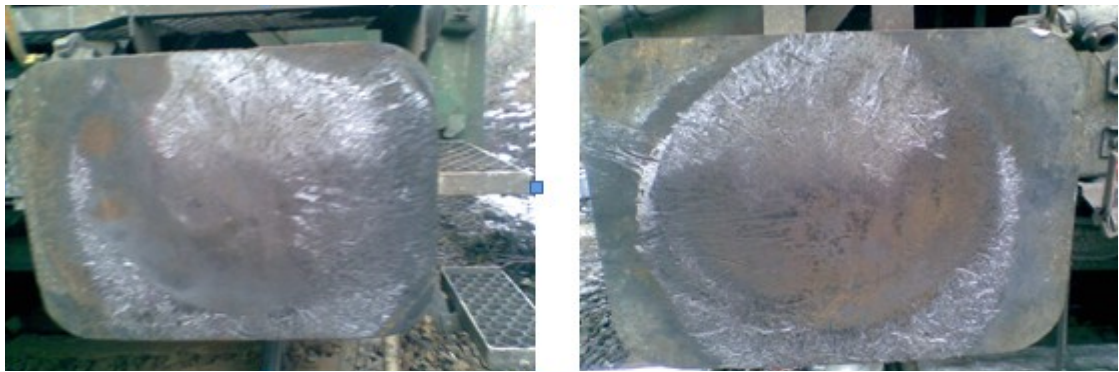
- strong wears at the disks of the buffers from the wagons no 88536657494-0 and no. 88536657723-2, because of it the running in curve led to a very strong friction between them;
- important unloading of the first axle (corresponding to the wheels 7-8) of this wagon, because the stiffness behaviour of the wagons no. 88536656494-0 and no. 88536657723-2 and a spontaneous brake application on a curved track section with gradient 15,3‰.

- the buffer trays had very important wears;

The root cause of this accident is the lack of regulations that stipulate the periodical lubrication of the disks of the wagon buffers, between two periodical repairs.

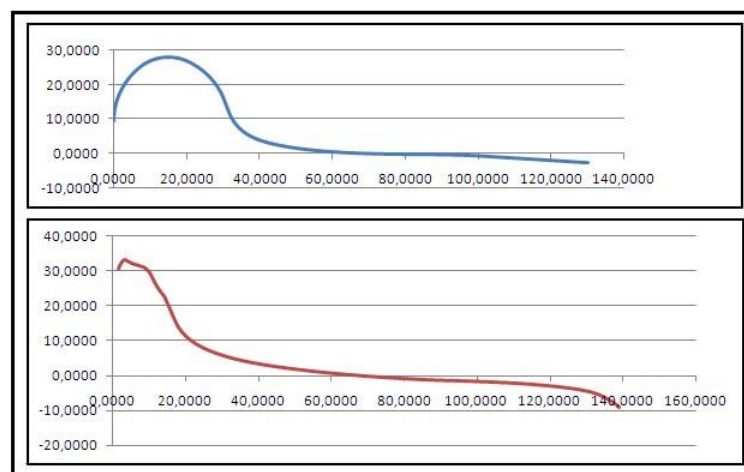
In order to present the real running profile of the wheel no. 7 of this wagon, one used the device Mini Prof Weel, manufactured by Greenwood Engineering. In the bellow drawing is presented the real profile of this wheel flange related to the running profile ORE.

- key: - blue chart is the running profile ORE;
- red chart is the real running profile of the wheel measured with the device Mini Prof Weel.

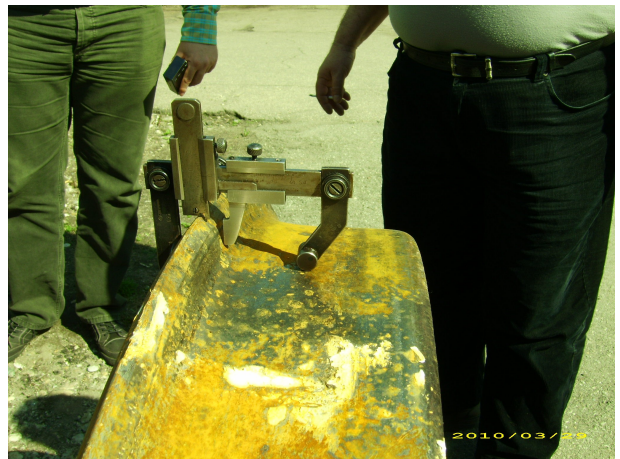
- one could not perform measurements of the flanges of the wheels 5 and 7 belonging to the wagon no. 88536656494-0 and of the wheel no. 7 from the wagon no. 88536656723-2, because the running surface profile of this wheel could not be measured (the thickness of the wheel flange was under the minimum value of 20 mm that can be measured with device for the checking of the wheel flange size of the wagon type DVB 1-40;

- there were performed measurements of the flange profile of the wheels 6 and 8 of the wagon no. 88536656494-0 and of the wheel 8 of the wagon no. 88536656723-2 (complementary wheels with the wheels 5 and 7) and the values of their geometrical parts (flange height, thickness, flange and quota q_r) were between the limits accepted by the Instruction no. 250, version 2005.

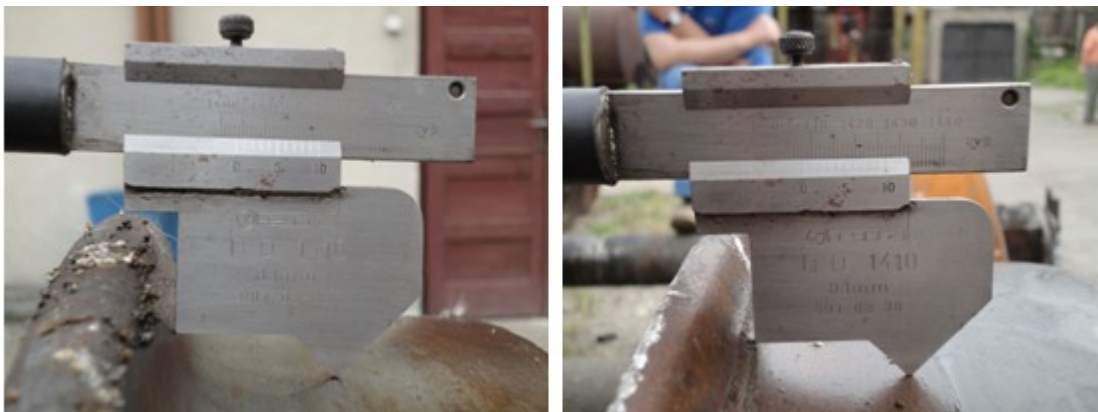
- the distance between the outside surfaces of the flanges of the wheels 7-8, measured in two antipodal points was 1403 and 1408 mm, under the limit value (1410 mm) stipulated in the table 1, point 4, letter a of the Instruction no. 250, version 2005;

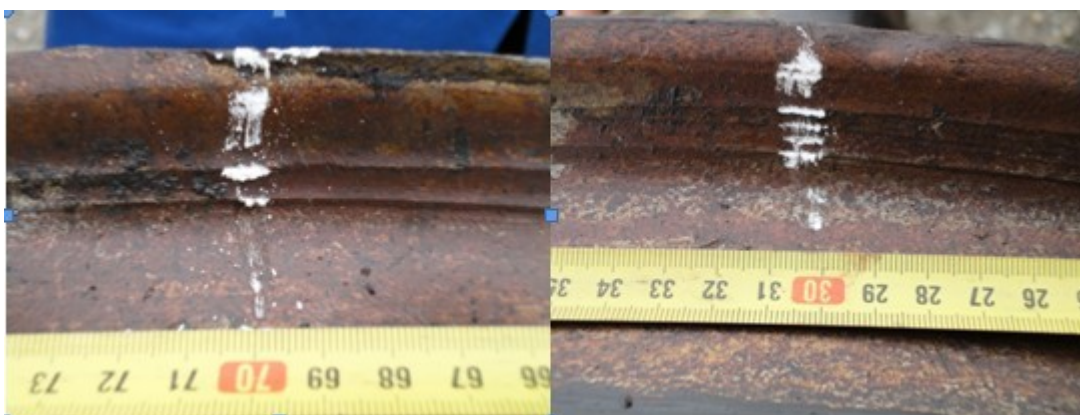
- on whole wheel outer surface, on the active flange of the wheel no. 7 there were observed edges and wears arranged gradually, from which one of them leads to the tip of the wheel flange.

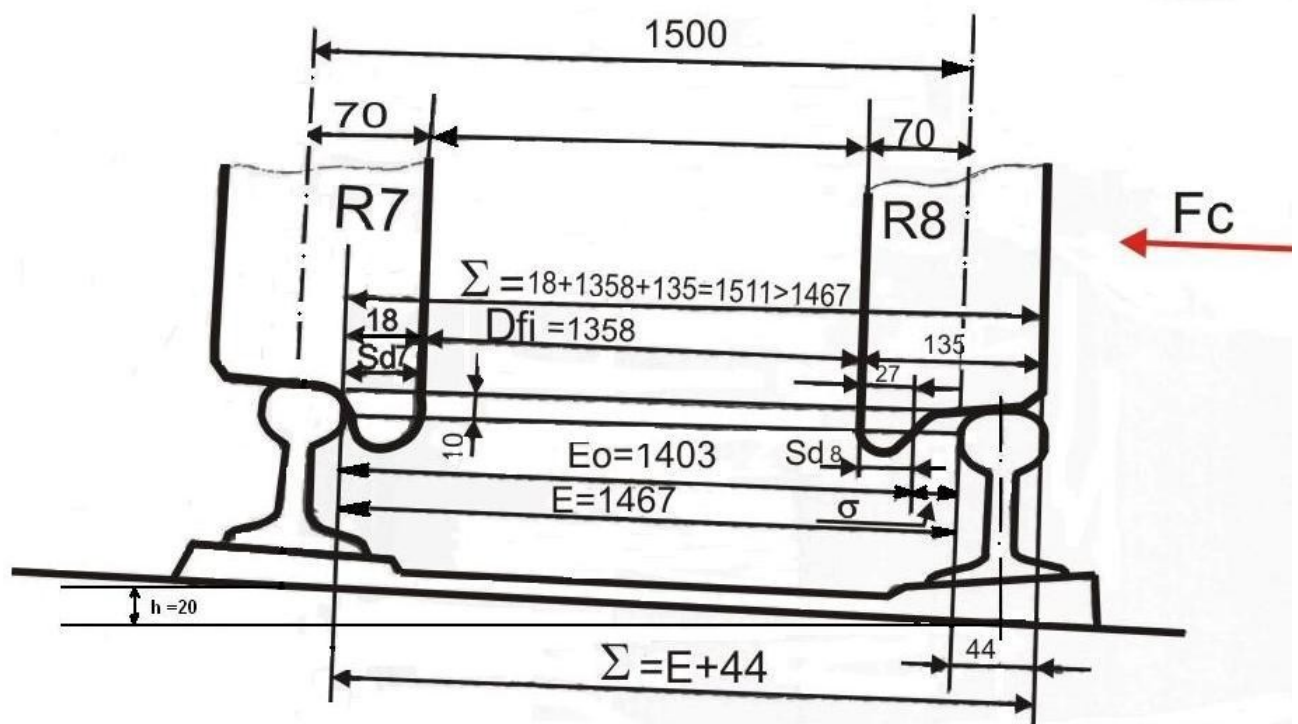
drawing no 1- *axle no. 7-8 before derailment*

- at the moment of the train braking start, gradient 15,3‰ corresponding to the area where the railway accident happened, the first part of the train was very high compressed. In these conditions the axle corresponding to the wheels no 7-8 of the first bogie in the running direction of the wagon no. 88536656494-0 (the 5th of the train) arrived at the km 58+916, where the interaction between the rails and the wheels of the axle 7-8 was as in in the drawing no 1;

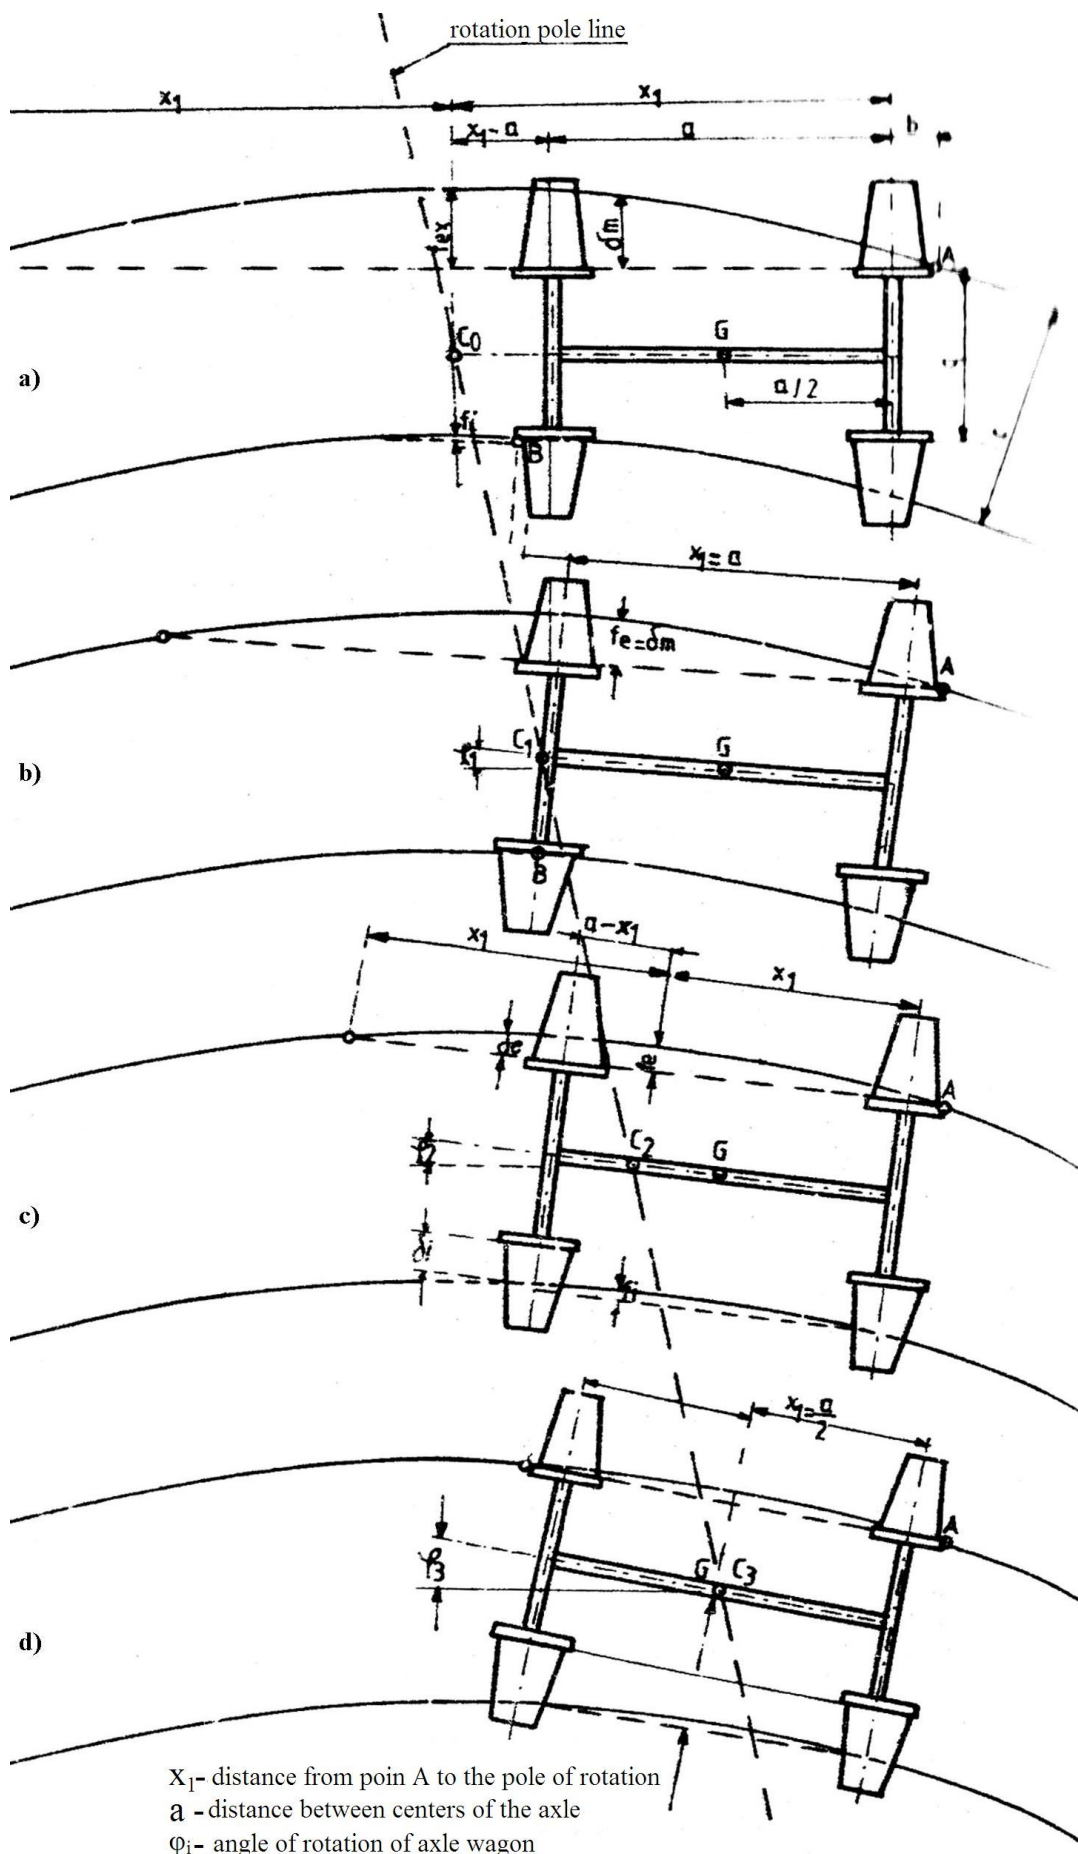
drawing no.2

- because the thickness of the flange of the wheel no. 7 was under the minimum limit accepted by the Instruction no. 250/2005, it led to the increase of the total cross clearance of the pair of wheels 7-8 during the running and implicitly to the increase of the wheel striking angle in relation to the rail and to the stop flange angle of the wheel running profile. In these conditions, when entering in position chord bogie (drawing no. 2, letter d), the outside guiding surface of the profile of the wheel flange no. 7 came into contact with the right lateral stop flange of the left rail, determining the wheel no. 8 to run on the inside curve rail on the running profile with maximum conical tread;

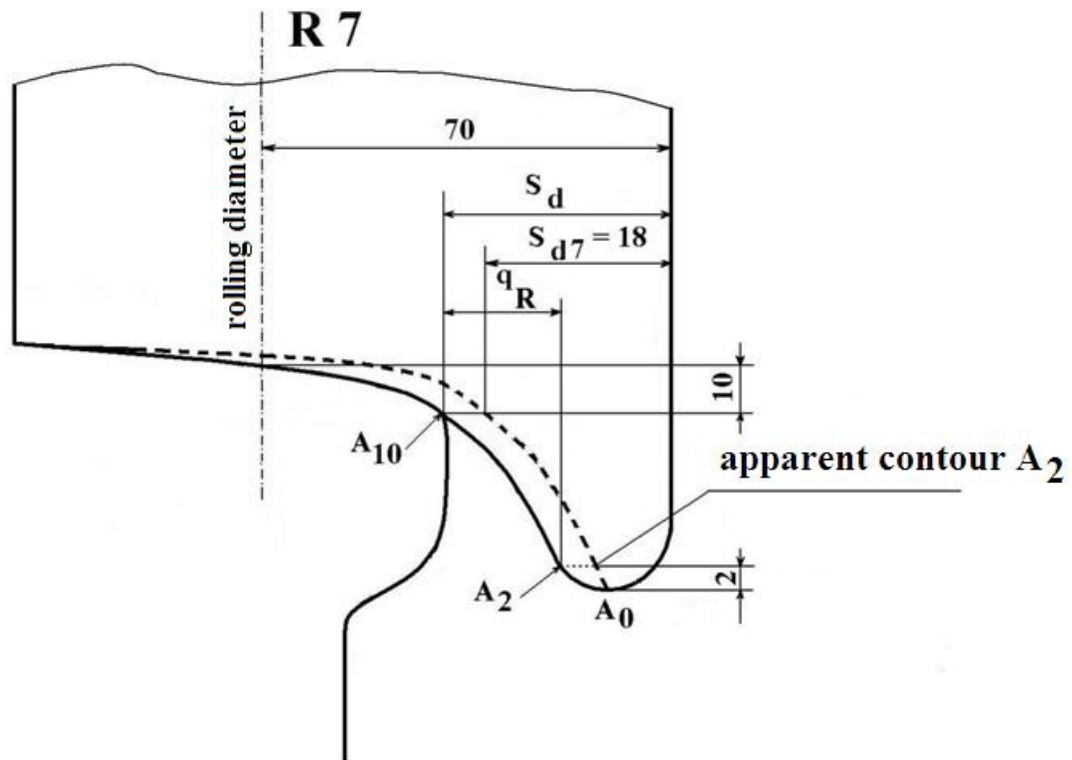
drawing no.3

- taking into account this situation and the existing of circular edgeds on the stop flange of the wheel no. 7, as well as of the increased stop flange angle following the wear of 7 wheel flange, the contact between the outside flange stop of 7 wheel flange and the inside stop flange of the outside rail head was in the point of the apparent profile of the point A_2 , the nearest from the point A_0 (drawing no.3), where the risk that 7 wheel flange overclimbs on the active outside running surface increased very much.

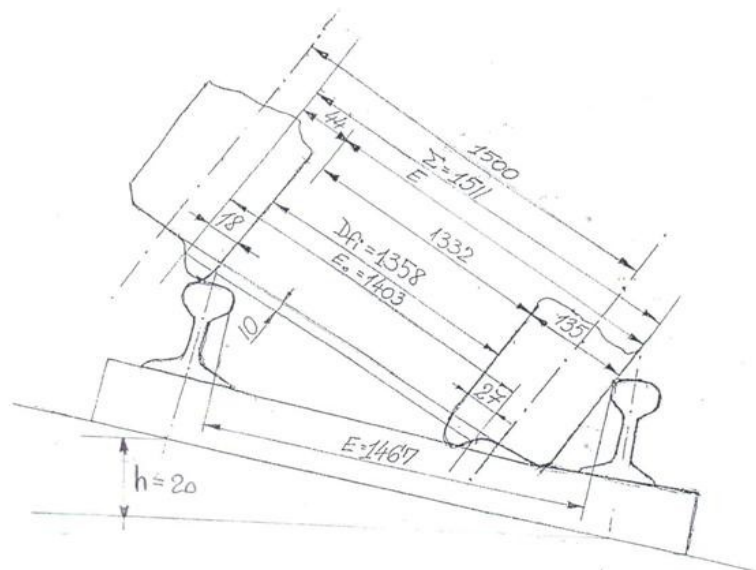
drawing no.4 - axle.no. 7-8 after derailment

After 7 wheel flange overclimbing on the rail, the contact between them was in point A_0 , where the risk that this wheel derail and the wheel no. 8 leave the running surface of the curve inside rail is maximum, followed by its fall inside the tracks (drawing no. 4)
