MINISTERUL TRANSPORTURILOR SI INFRASTRUCTURII  
AUTORITATEA FERROVIARA ROMANA - AFER

ORGANISMUL DE INVESTIGARE FERROVIAR ROMAN

## INVESTIGATING REPORT

of the railway accident occurred on  
02.08.2010 on the non-interoperable running section Timișoara Vest - Crucești

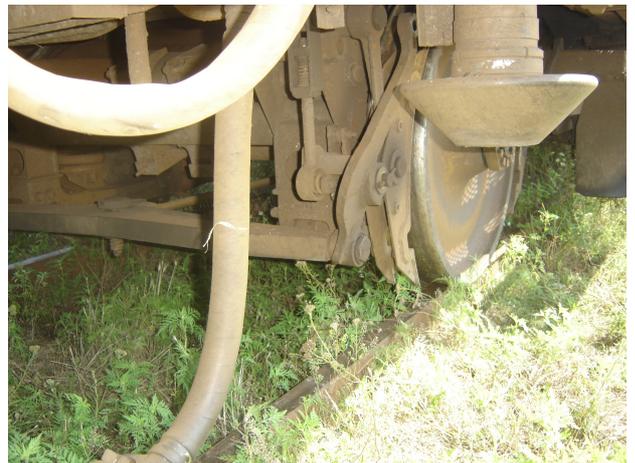
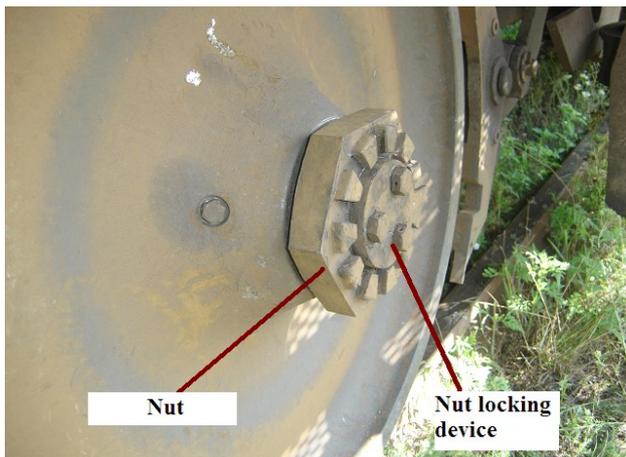
After the railway transport operator SC Regiotrans SRL Braşov - Timișoara working point representatives arrived on-site, they **found that the intermediate axle no. 4 of the passenger motor driven AMX 97-566-6 was derailed at a distance of approximately 10 cm against the rail and the left wheel of the same axle had axial and radial clearance.**

The wheel fixing nut and nut locking device inspected right after the derailment were in the normal montage position without any marks of movement or degradations.

There were no paint markings to emphasize the wheel boss rotation against the axle.

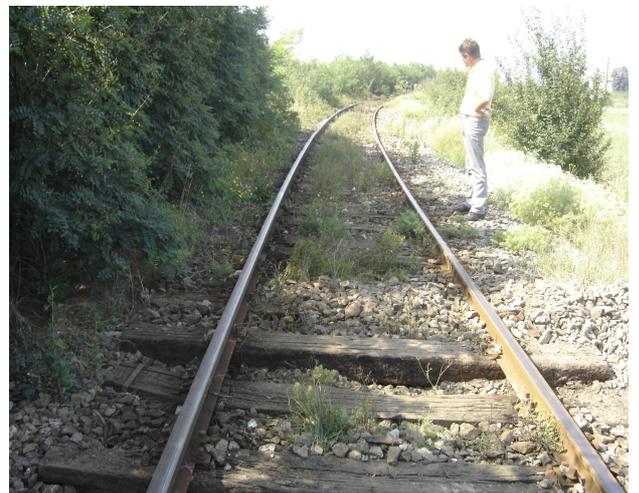
The railway accident spot is on the area of the constant-radius curve with radius R=295 m with a cand of the track h= 75 mm and widening of the gauge s = 15 mm.

This constant-radius curve had the following characteristic points, according to the album curves: AR-km 37+277, RC- km 37+347, CR- km 37+727 and RA- km 37+797.

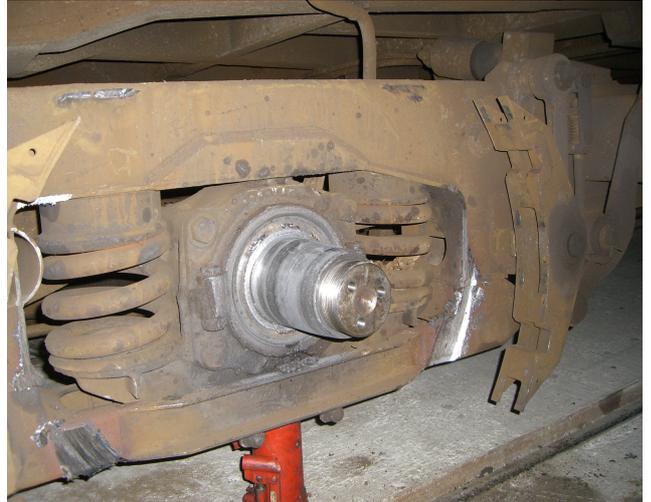
- at the bogie frame on which the axle in question was mounted and on the axle wheel-seat area, track of friction were found due to the wheel position change on the axle centre;

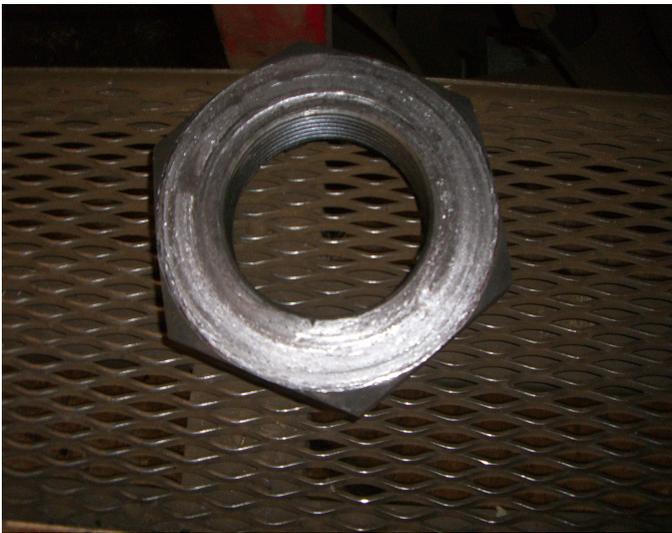
- the wheel fixing nut had intensive traces on the contact surface with the wheel boss.

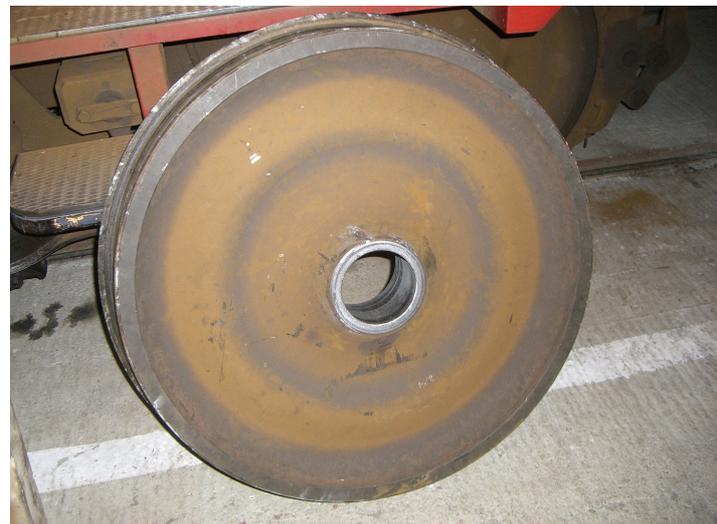
- at the left wheel of axle no. 4 one found friction tracks with increasing the quotas of the conic bore of the wheel boss with 4,3 mm at the big diameter, 2,5 mm at the small diameter and the reduction with 1,8 mm of the length.

- recovery by turning of the wheel running profile with their removal from the axle carries the risk of tightening failure by incorrect assembling (uncleaned contact surfaces; different wears at the hub bore or axle-center wheel-seat) that does not compensate the specific demands of operating;
