MINISTRY OF TRANSPORTS AND INFRASTRUCTURE
ROMANIAN RAILWAY AUTHORITY - AFER

ROMANIAN RAILWAY INVESTIGATING BODY

INVESTIGATING REPORT
of the railway accident happened in the railway station Curtici,
on the 11th of August 2010

Final edition
17.12.2010

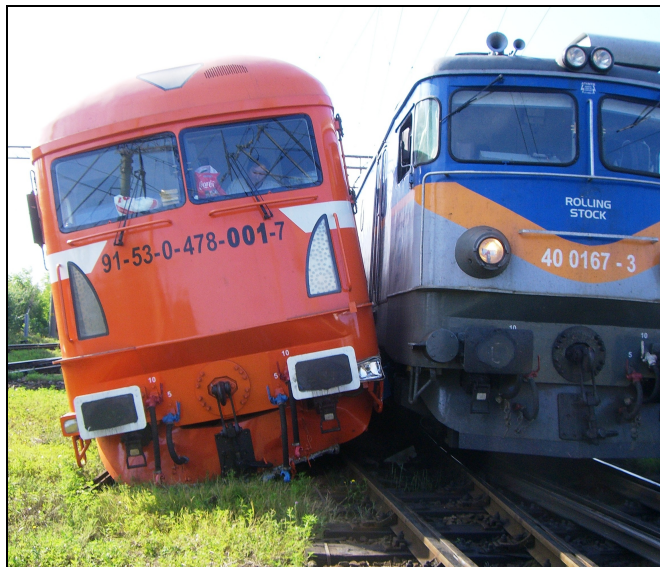
On the 11th of August 2010, around 9:02 hour, in the **Branch of the Railway County Timisoara**, running section Arad – Curtici, in the railway station Curtici, at the passing over the double slip points (TDJ) 19/23 of the freight train no. 39915, by **its collision with the locomotive EA 40 0167-3**, followed by the derailment of all axles of the locomotive EA 91-53-0-478-001-7, hauling the train no. 39915.

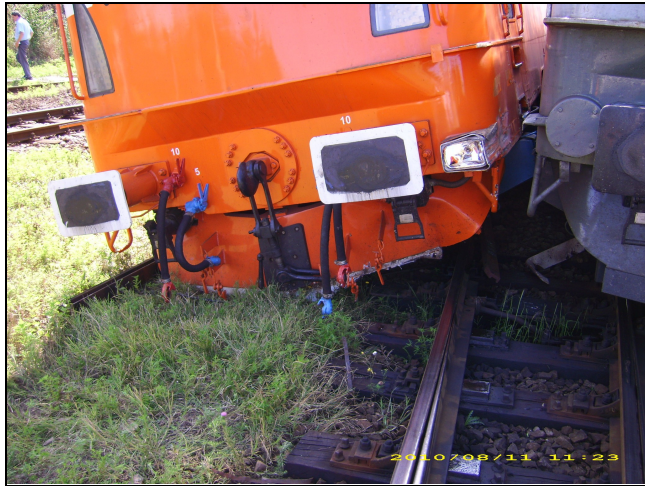
- the locomotive EA 91-53-0-478-001-7, hauling the train 39915 with all axles derailed, reclined on the right side in the running direction;

- the track damaged on about 25 m.

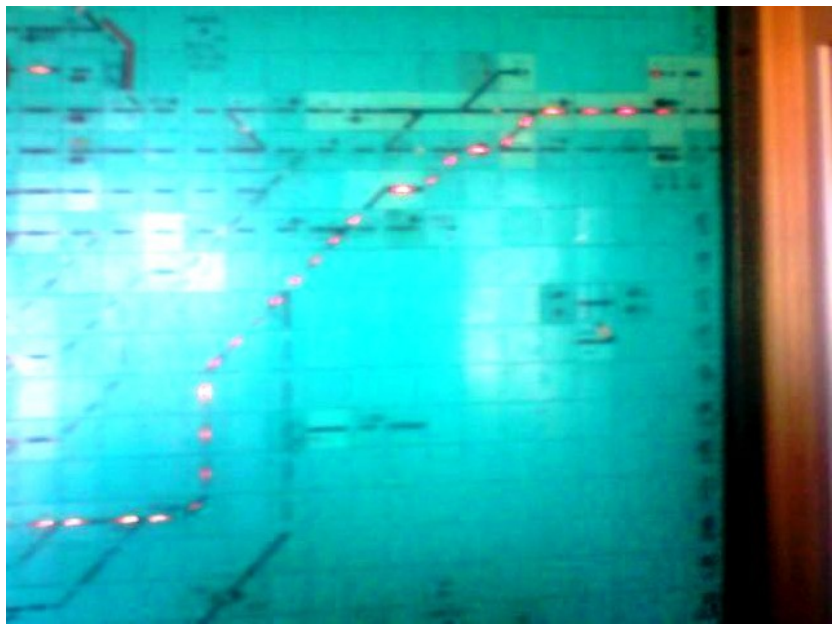
- locked running route made from the entry signal X from the line I Arad – Curtici to the line 11A;

- all the seals from the order desk of the movements office intact;
- the key and the door of the relays hall with the seals intact;
