## INVESTIGATING REPORT

of the railway accident occurred in the railway station Halmeu,  
on the 28<sup>th</sup> of May 2010

Final edition  
The 5<sup>th</sup> of August 2010

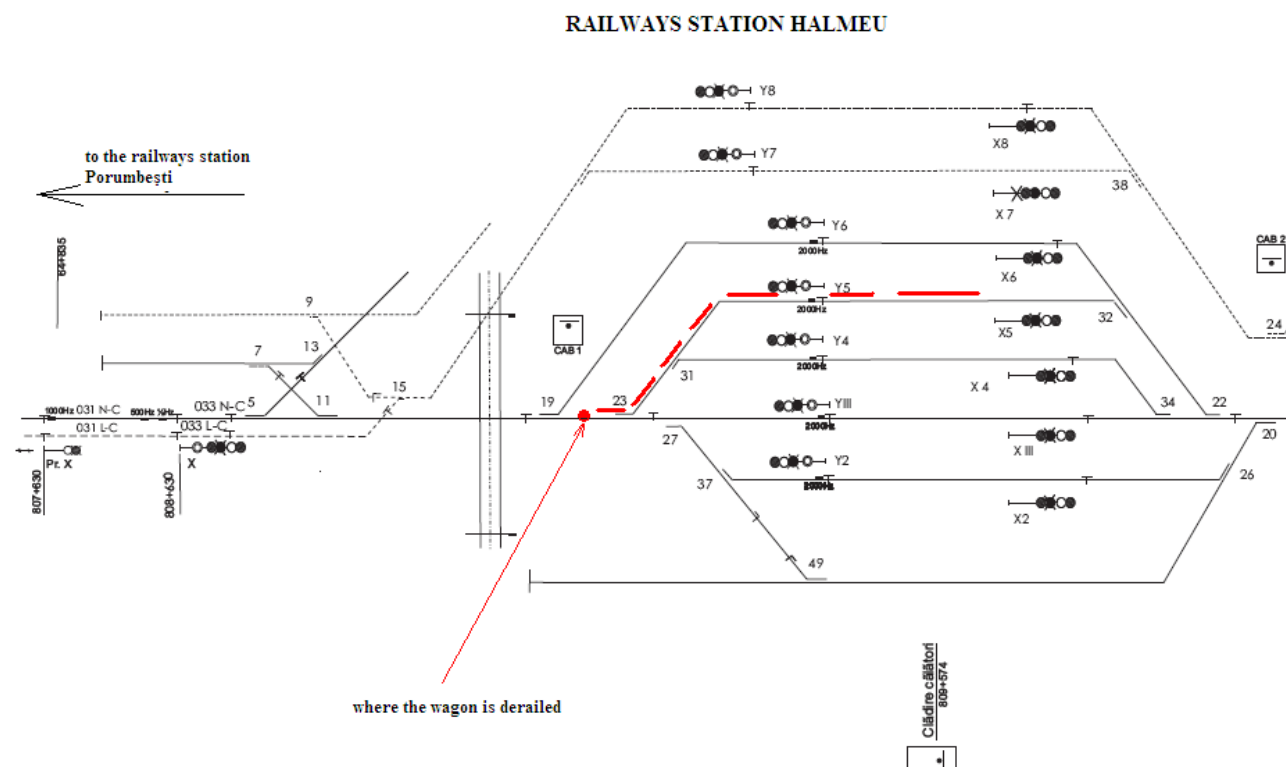
At the moment of the departure of the freight train no. 70728 from the railway station Halmeu to the railway station Porumbesti, at the end X of the railway station, at the passing over the switch 23, trailed the point, the first bogie of the wagon no. 67573287 (the 5<sup>th</sup> in the train formation) derailed, at a speed of 12 km/h.

At the accident place, one found out that the first bogie of the wagon no. 67573287 (the 5<sup>th</sup> of the train) was derailed in the running direction and situated at about 1.5 m left most against the rail head from the right side of the running direction.

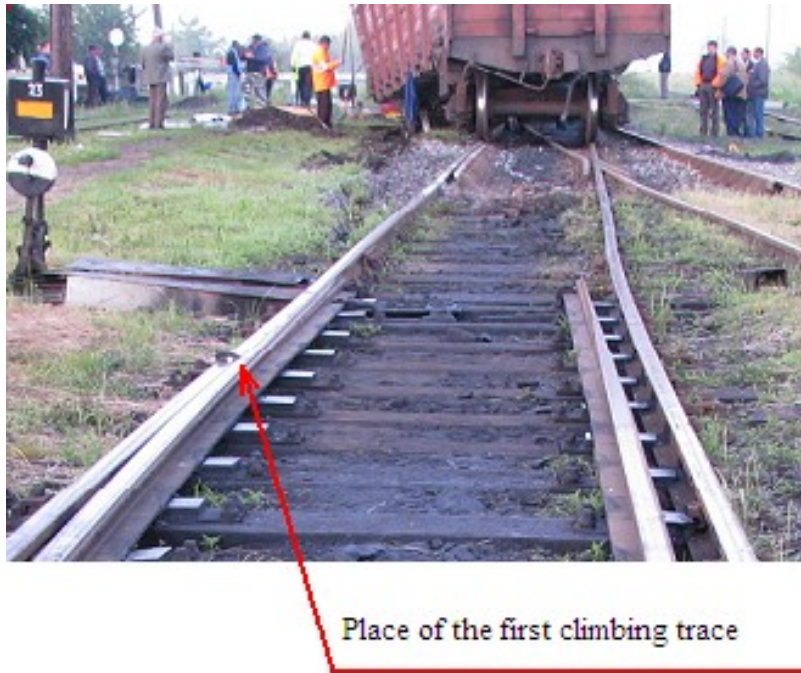
The derailment happened on the curved point of the switch no. 23, from the heel to the tip of it.

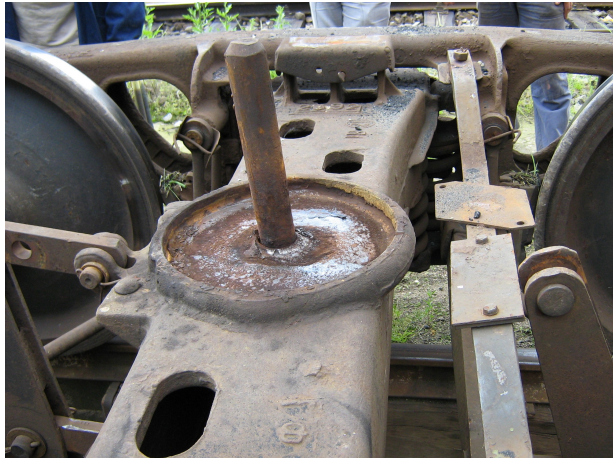
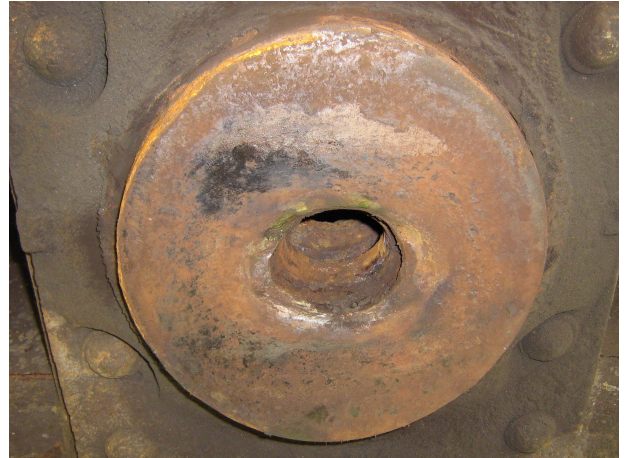
During the lift of the wagon from the bogies, at the centre casting from the derailed bogie there were found out:

- lack of vaseline at the centre casting;
- the upper and lower centre casting had contact traces on about 1/3 from the surface, on the right side in the running direction;
- wear traces on the shoulder of the upper centre casting.

The lack of lubrication and the presence of rust at the centre casting of the derailed wagon led to the conclusion that this ensemble was not lubricated at the movement of the involved wagon from the bogies with large gauge to bogies with standard gauge.

The lack of the lubrication between the upper and lower centre catings led in time to the appearance of the rust in the centre casting and also to the appearance of dry friction between those two parts of this essemble. It led to the increase of the friction forces and implicitly to the very high increase of the friction moment.

SC GRUP FERROVIAR ROMAN SA, as railway undertaking, will ask the State Administration for Ukrainian Railway Transport (UZ) to update the common regulations on the freight transports, that is these regulations stipulate the lubrication of the centre casting during the movement of the freight wagons from the bogies with large gauge on bogies with standard gauge.
