INVESTIGATING REPORT

on the derailment, of two wagons from the passenger train composition no. 4485
owned by SNTFC “CFR Călători” SA, manufactured in the railway station Mogoșeni
on 07th of April 2010

Final Edition

August 17, 2010

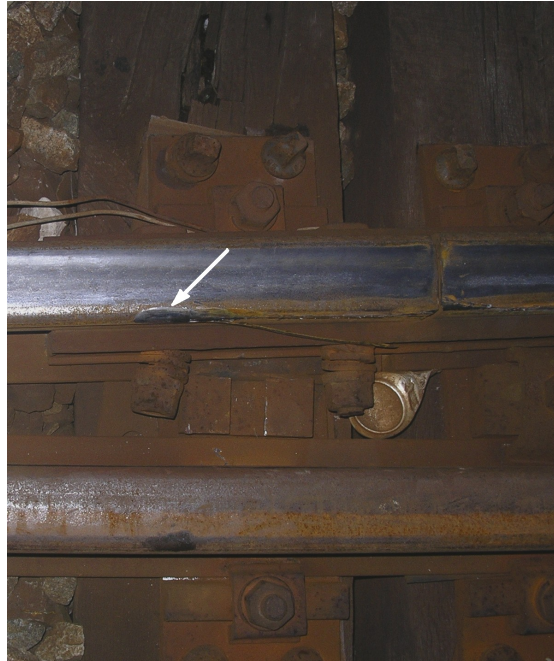
photo no.3

The derailment started from a distance of 80 cm from the right point switch heel (the 14th sleeper), the left wheel of the first axle, in the running direction, of wagon no. 505320476896, the 2nd from the locomotive, get into the space between the lateral surface of the curved stock rail head and the lateral surface of the connecting band from the left side of the direct line of switch no.5 due to the sleeper suddenly yielding on which the metal plate was situated from which the curved stock rail is fixing and the connecting band from the left side of the direct line of switch no.5, followed by the breaking and deformation of the coach screws.

point 0

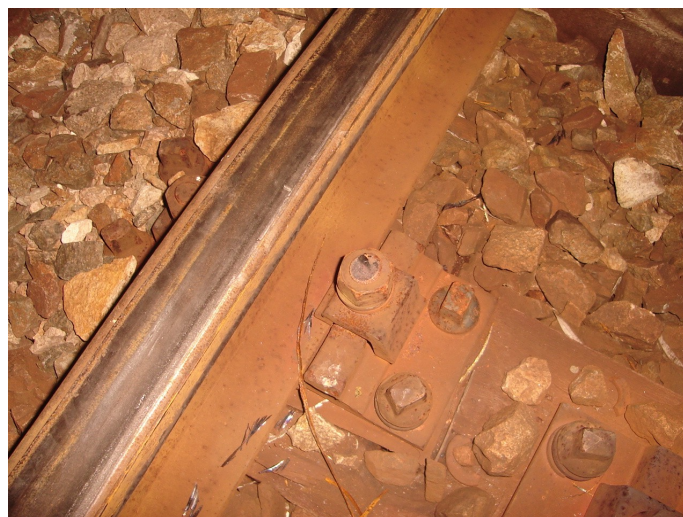
photo no.4

The complete fall of the wheel from the left side occurred within the connecting band (after the curved stock rail heel) in the space between the connecting band from the left side of the switch direct line and the connecting band of the switch no.5 deflecting line, at a distance of 3,0 m after the joint of the curved rail stock heel, the wheel was running and forcing the metal plates shims of the sleepers.

This wheel fall right next to the 20th sleeper from the top joint of switch no.5, at a speed of 24 km/h

the sleeper no.20

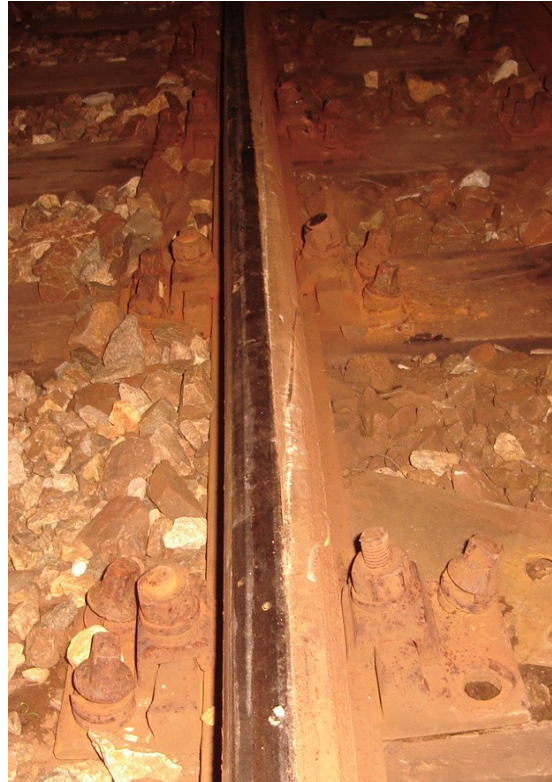
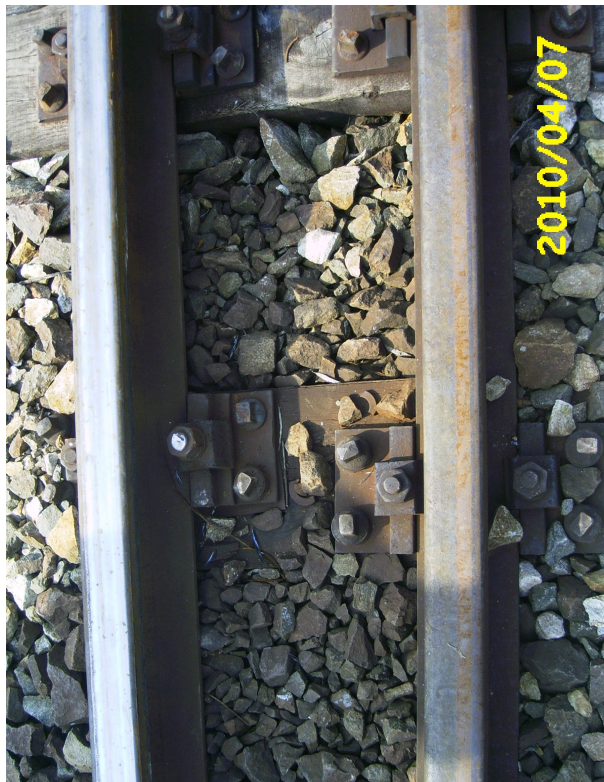
photo no.5

From the fall of the left wheel, the right wheels had run another 2,0 m on the connecting rail on the deflecting section from the right side (the track corresponding to the exterior track of the switch curve), after which the flange of wheel climb over the head of rail falling between the head of rail and the connecting rail from the right side corresponding to the direct line of the switch (between the 23rd and 24th sleepers) and then ran on the metallic elements for fastening of the rail to the metal plates and fastening of the metal plates to the sleepers.

the area of the 23rd and 24th sleepers

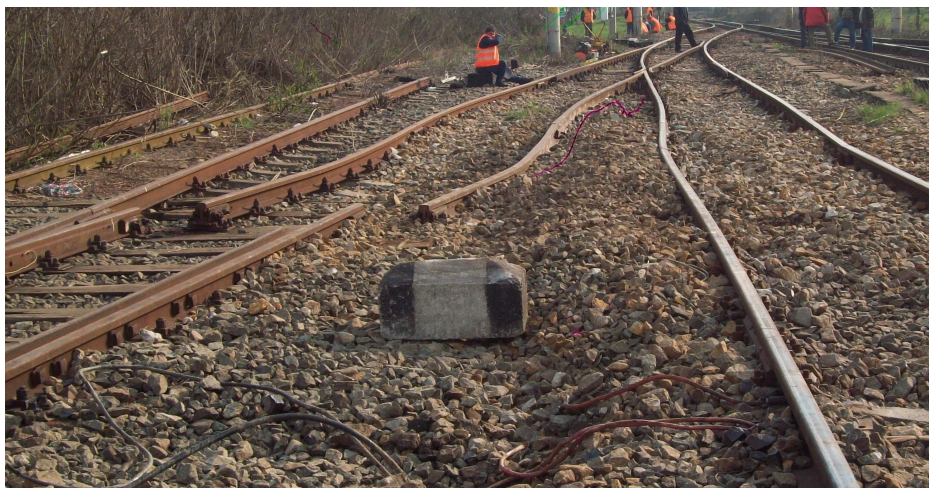
photo no.6

From point “o” the first derailed bogie had run 35 m on the switch sleepers, running with the right wheels on the direct line of the switch no. 5 and with the left wheels on the deflecting section of the same switch. As a consequence of this route was the breaking of the lignofolium fishplates from the section or isolated of the switch no.7 heel, buckling of connecting rail 5-7 and of line 1 as

weel as the sleepers deterioration from the connecting rail 5-7 and the first panel after the heel joint of the switch no.5 center.

the connecting rail 5-7

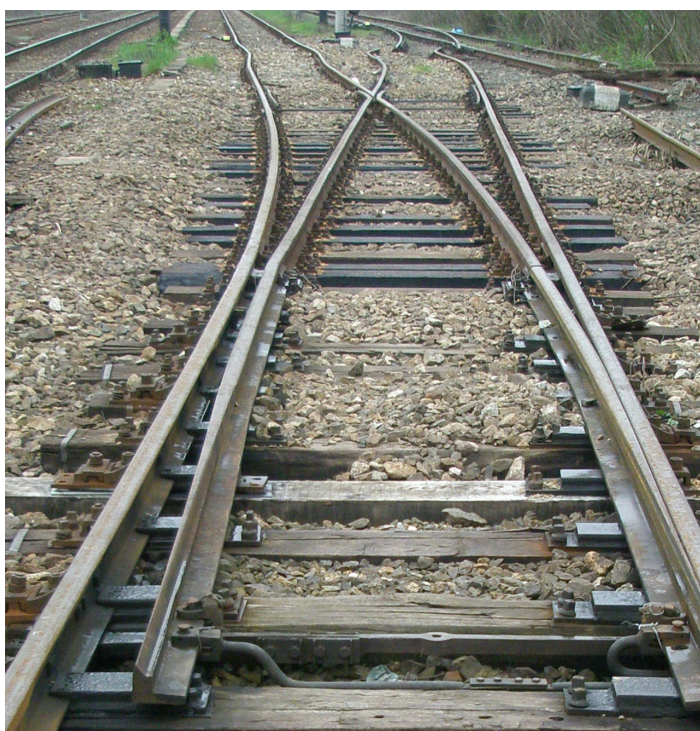
photo no.7

- in the railway station Mogoseni the railway traffic over the switch no. 5 on the direct and deflecting section was closed from 07.04.2010 at 17:33 o'clock, the railway traffic was performed only on direct line II and on the deflecting section 3;
- within the switch no. 5, 14 special timber sleepers were replaced and other 5 were in process of replacing;

replaced sleepers

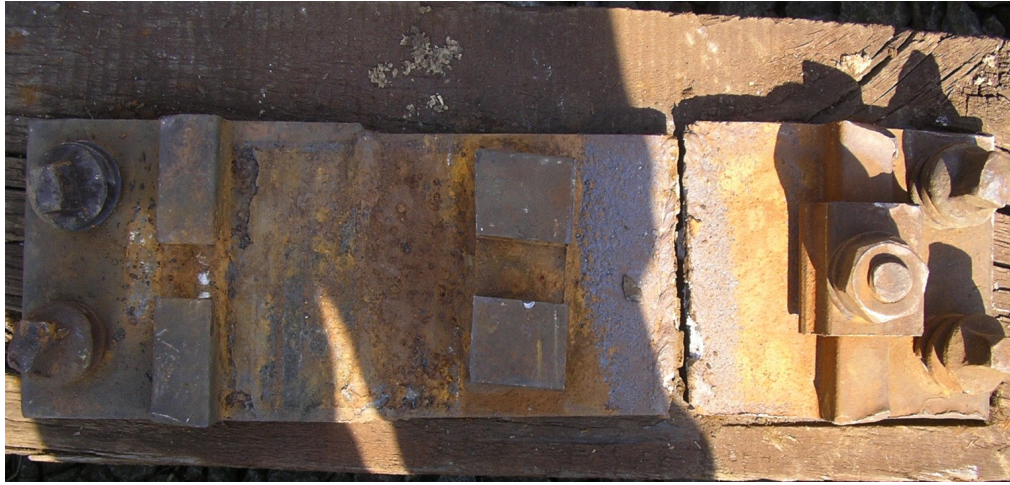
photo no.8

- when replacing the sleeper no. 14 within the switch no. 5 corresponding to point „o” one found out that the common metal plate for fastening on the sleeper of the curved stock rail and the connecting band on the left side was broken. The fracture occurred through the wealding seam, which in constructive terms was situated under the curved stock rail base;

broken metal plate

- the welding seam break under the curved stock rail heel corroborated with the guiding force increase (horizontal) had determined the falling of the left wheel of the first axle, in the running direction, of the wagon no. 505320476896 (the 2nd from the locomotive) between the lateral surface of the curve stock rail and the lateral surface of the connecting rail from the left side of the direct line of switch no.5;
- the measured values of the track gauge and transversal level to the derailment point couldn't influence the climbing of the right wheel of the first axle of wagon no. 505320476896.

1. Checking the VPA works and the constructive welding integrity of the special metal plates for fixing the point switch and stock rail;
2. For the cases in which the instruction time for replacing the inadequate reviewed sleepers in points and crossing is not respected, the management of the Regional Branch CF Cluj with one accord with Lines Department within CNCF „CFR” SA will establish the running conditions for each case.

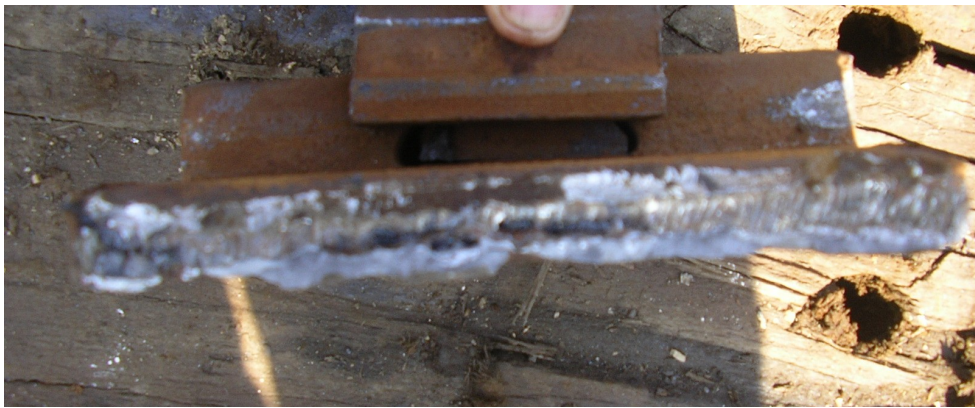
photo no.9

Metal plate breakage due to the welding seam yielding due to the guidance force on the first axle, at running in curve, together with the vertical fastening yielding of the metal plate on the timber sleeper.

broken welding seam

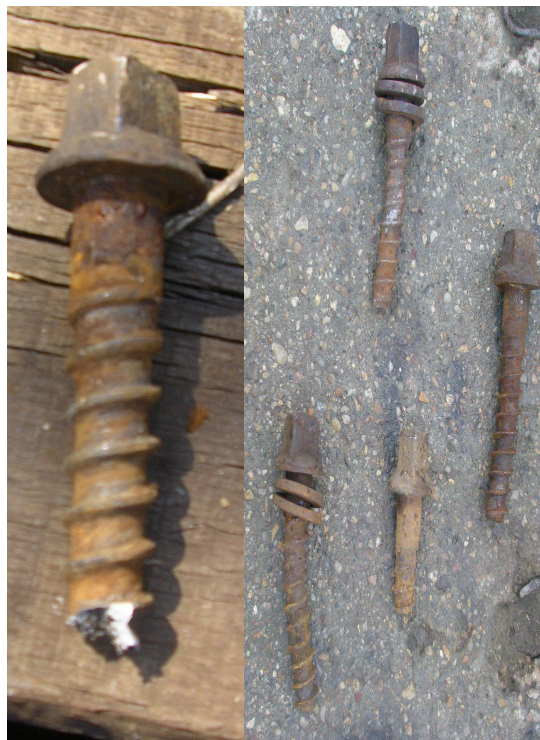
photo no.10

- when replacing the sleepers no. 14, 15, 17, 18, 19 and 20 one found out that some coach screws had the thread rod bended and others had the thread rod broken in the first third;

broken and bended coach screws

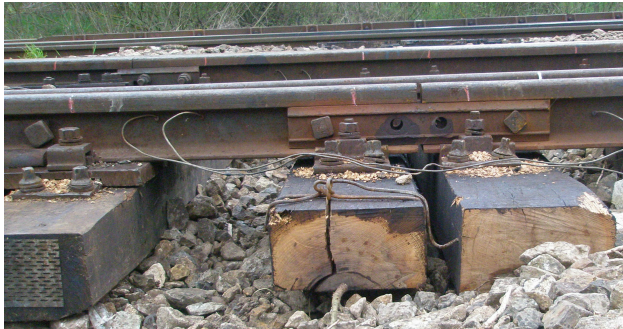
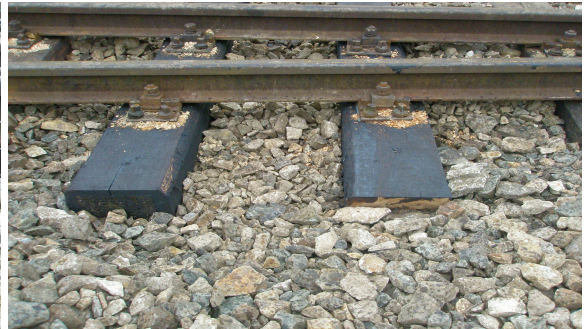
photo no.11

- following the investigation of the new timber sleepers mounted on the switch no.5 one found out that their impregnation was superficial performed, the antiseptic liquid penetration depth is of 1-2 mm on the entire length of the sleeper. STAS 9302/5-90 stipulates that the penetration depth of the impregnation solution for normal sleepers to be of minimum 30 mm at the end and of minimum 10 mm in the middle. Also, some sleepers had cracks on the extremities, reason for which they were tied with wire;

how to impregnate new sleepers mounted at the switch no.5

9. The new sleepers fitted in the track after derailment aren't imbued with antiseptic substances, favoring rapid deterioration by rotting. The provisions of point 4.4.1. - STAS 9302/5-74 Wood- Impregnation with oily antiseptic and OMT 290/2000

3. The Romanian Railway Safety Authority shall check by state inspection actions the way that the railway critical service suppliers „wood products treatment with chemicals (sleepers and sleeper plugs)” meet the technological processes of preparation for preservation (impregnation), preservation and of checking for the preserved sleepers quality.
After the action end, the Romanian Railway Safety Authority will transmit to the Romanian Railway Notified Body the report on the non-conformities found and the measures disposed to be taken to remove those.
