MINISTRY OF TRANSPORTS AND INFRASTRUCTURE  
ROMANIAN RAILWAY AUTHORITY - AFER

**INVESTIGATING REPORT**  
of the railway accident occurred on the 29<sup>th</sup> of July 2010,  
in the railway station Palas

Final edition  
the 20<sup>th</sup> of October 2010

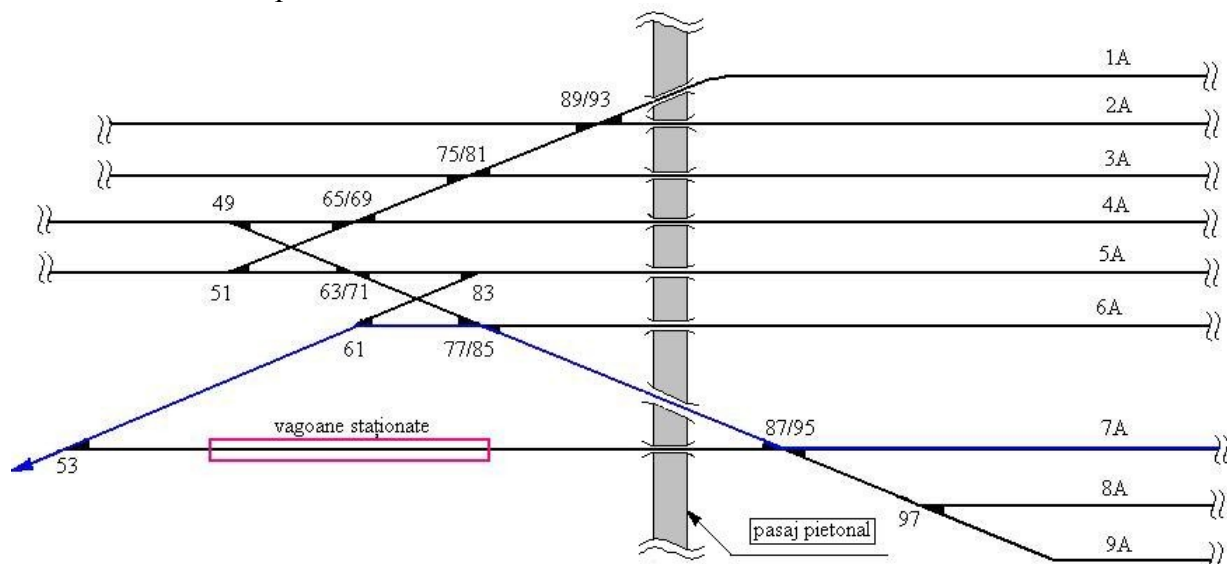
THE RAILWAY STATION PALAS ZONE A

After the train starting to run from the line 7A and its access on the insulated track section no. 061A and running of about 570 m, at the passing over a double slip points no. 85/77, both bogies of the wagon no. 31534542088-1, loaded with containers (the 21<sup>st</sup> in the running direction) and the first bogie of the wagon no. 31534542083-2, loaded with 2 containers (the 22<sup>nd</sup> in the running direction of the train) derailed.

Within the distance from the railway station Palas and the derailment place, the train run with 14 km/h maximum speed.

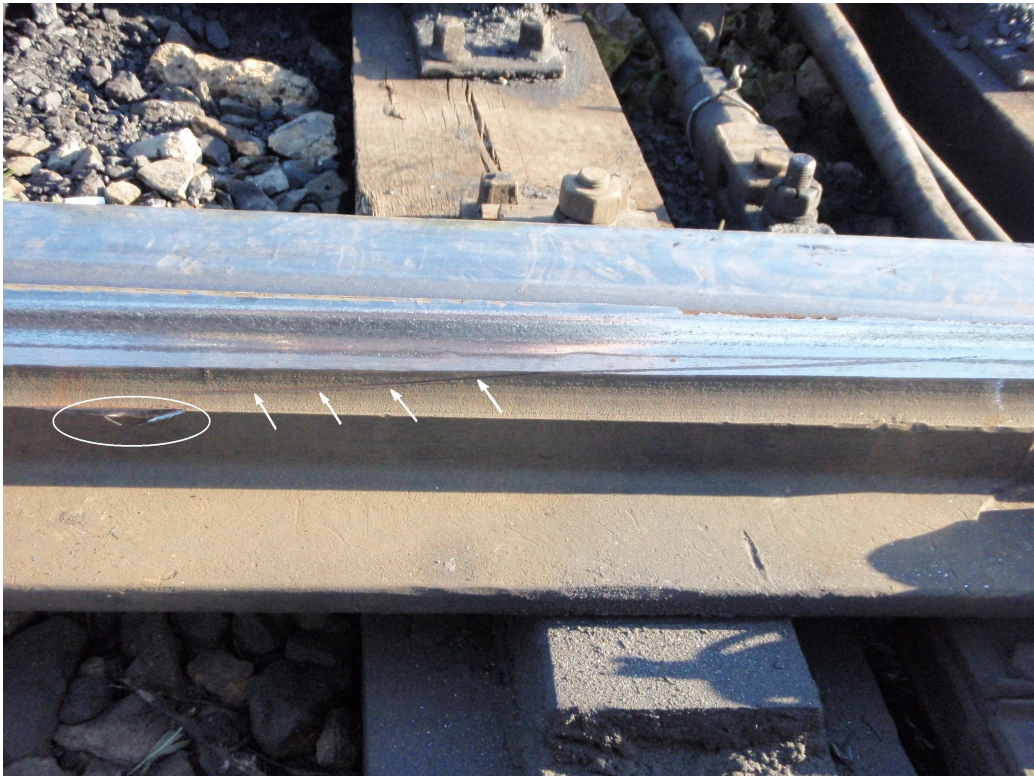
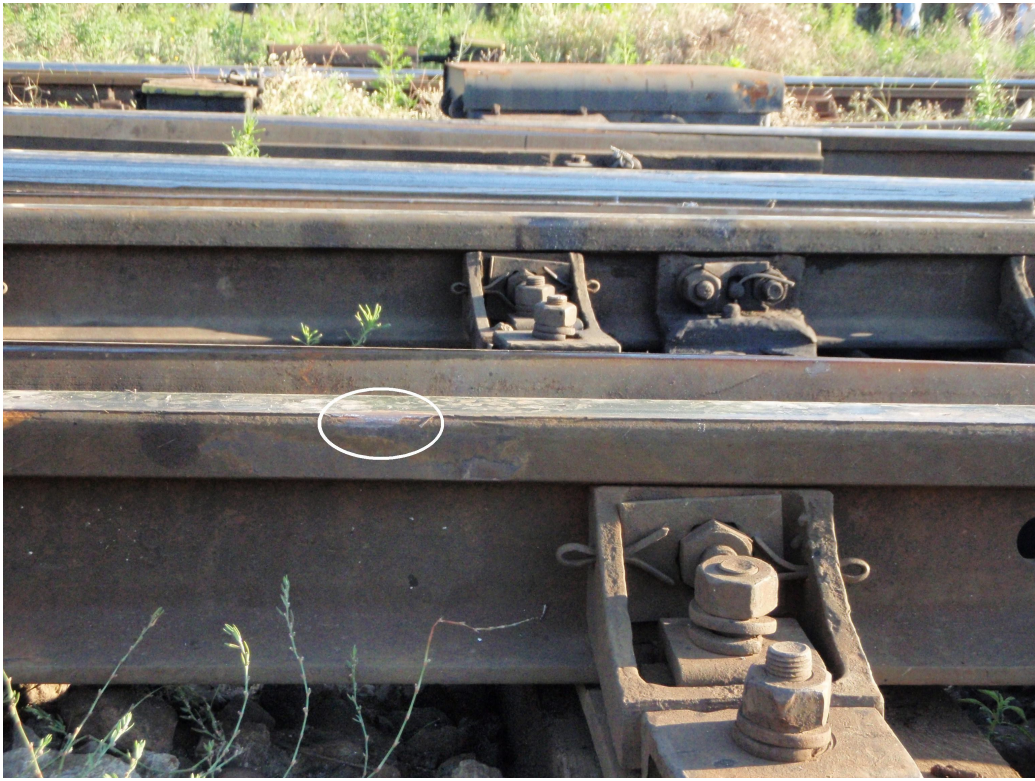
The first derailment trace (fall of right wheels between the tracks, in the running direction) was found at the point of switch tongue from the direction I, at the passing over the switches of the double slip points TDJ 85/77, trace situated at 1240 mm, measured from the tip joint of the switch no. 85 to the heel of blade. At this trace, on the left side, in the running direction of the train, on the left lateral surface of the curved stock rail (lateral surface from the outside of the track) there was found a trace of left wheels fall.

Within the double-slip points no. 85/77, both between the tracks and out of it, there were found traces left by the wheel tyres running on the fastening elements of the metallic parts on the sleepers corresponding to the points and switches.

After passing over the common crossing of the switch no. 77, the derailment traces exist up to the train stop, both between and out of the tracks (on the left side in the running direction).
