MINISTRY OF TRANSPORTS AND INFRASTRUCTURE  
ROMANIAN RAILWAY AUTHORITY - AFER

ROMANIAN RAILWAY INVESTIGATING BODY

## INVESTIGATING REPORT

of the incident in which was involved the light engine DHC 235,  
belonging to SNTFC “CFR Calatori” SA, in the running of the train no. 17958,  
occurred on the running line II Ruginoasa – Targu Frumos,  
at the km 25+300, on the 6<sup>th</sup> of June 2010

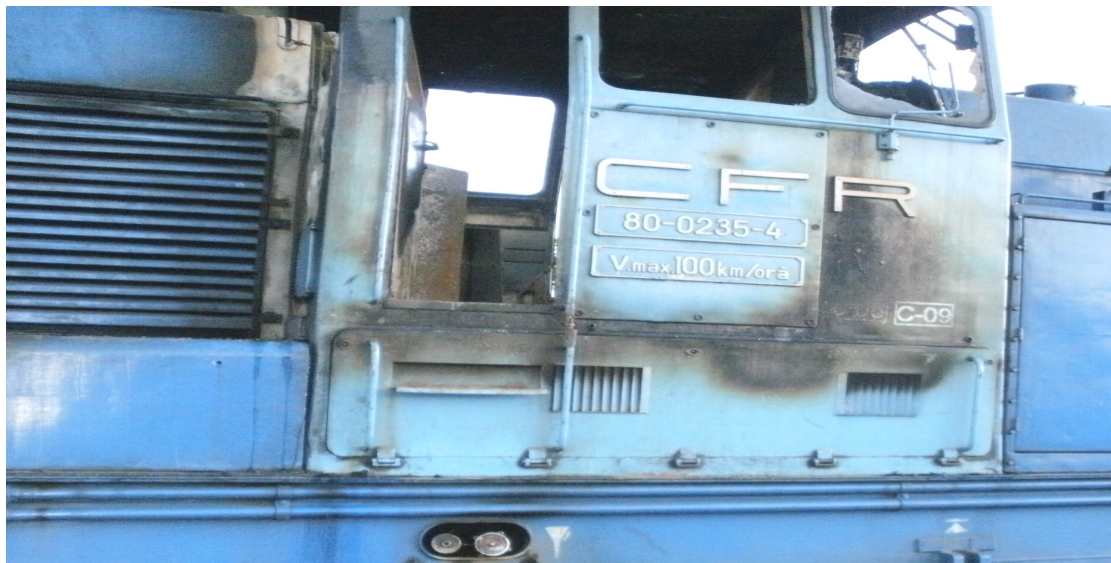
The thermic influence of the fire from the bateries niche, left side of the locomotive.

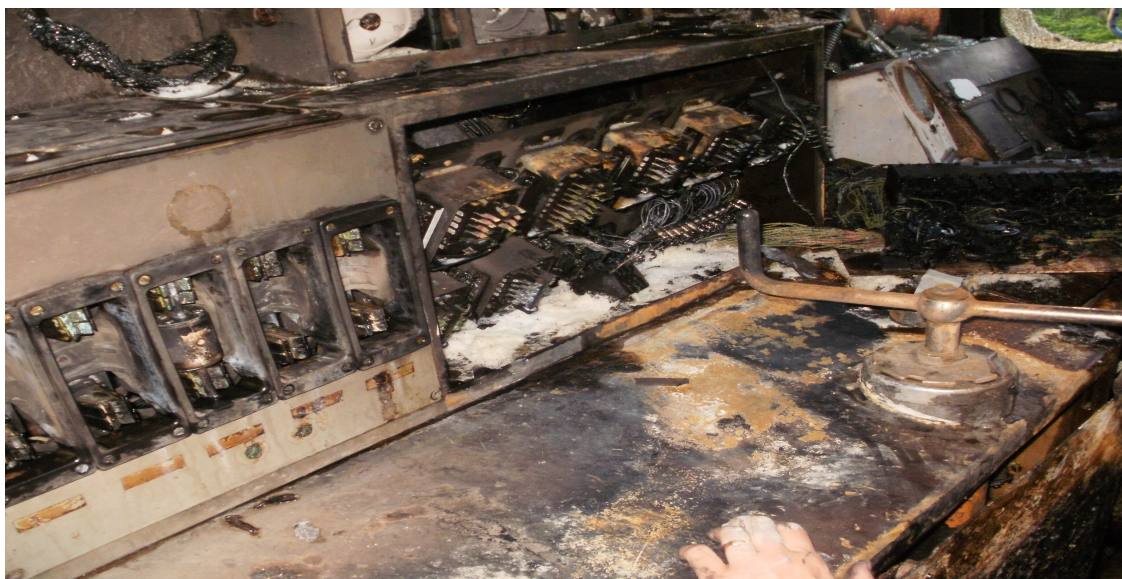
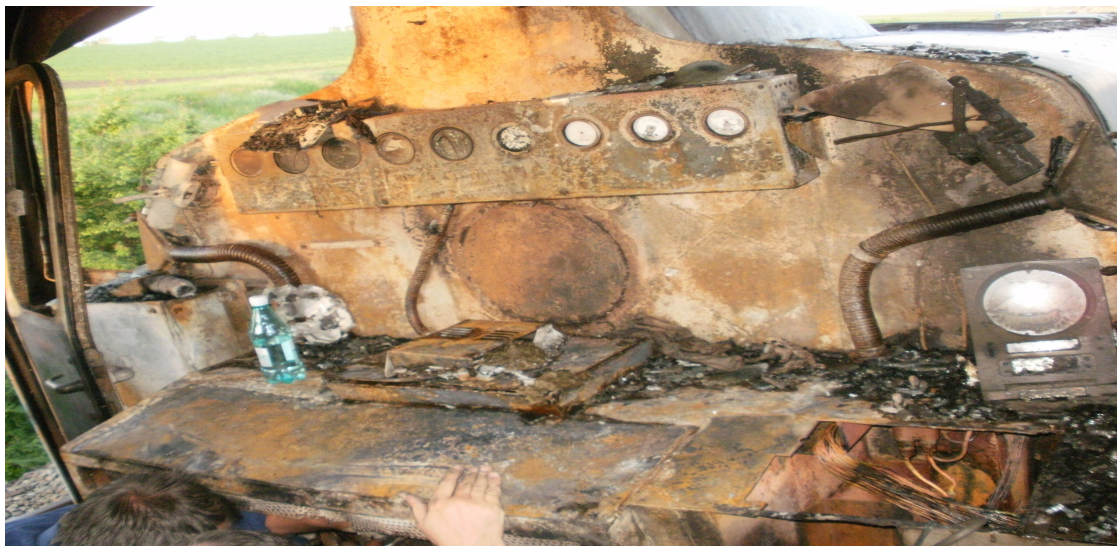
The fire effects on the equipment for the control, indication and protection of the driving cab.

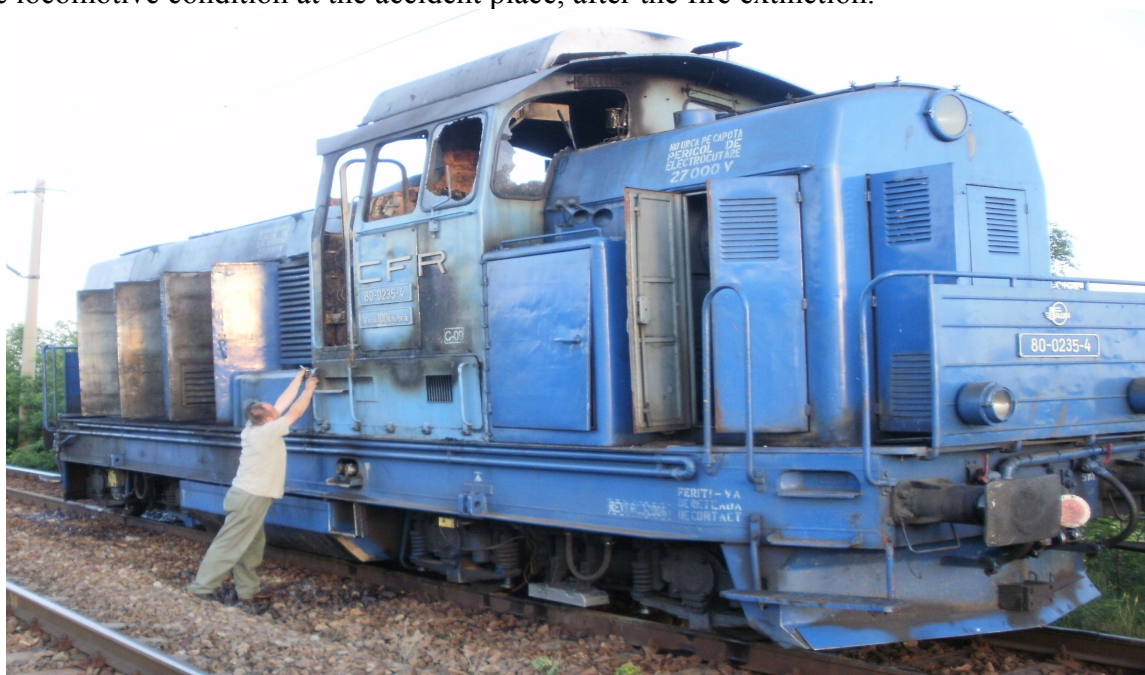
The locomotive condition at the accident place, after the fire extinction.

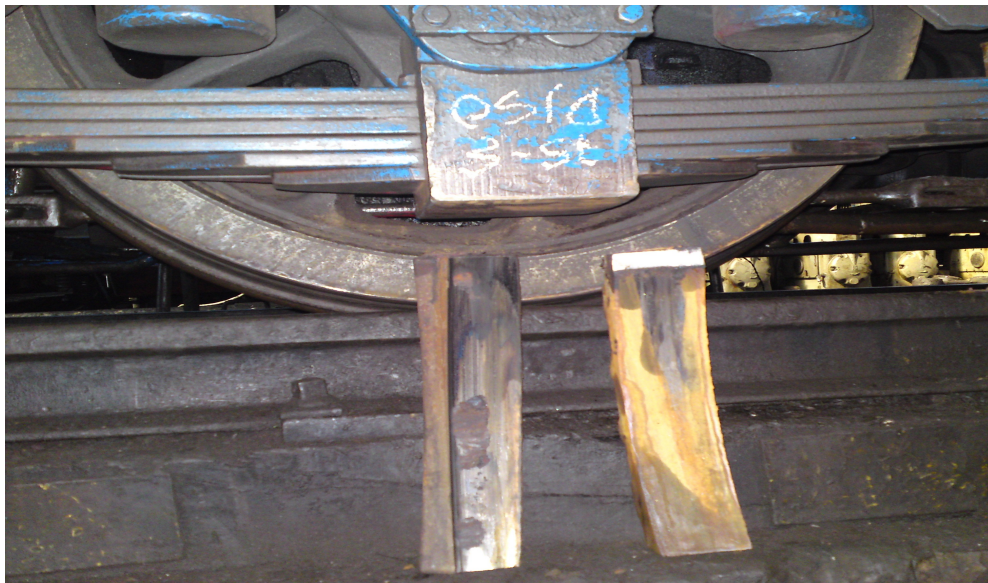
Condition of the running gears and of the brake blocks:

There is no trace of thermic influence of the brake blocks and tyres that could lead to the fire.

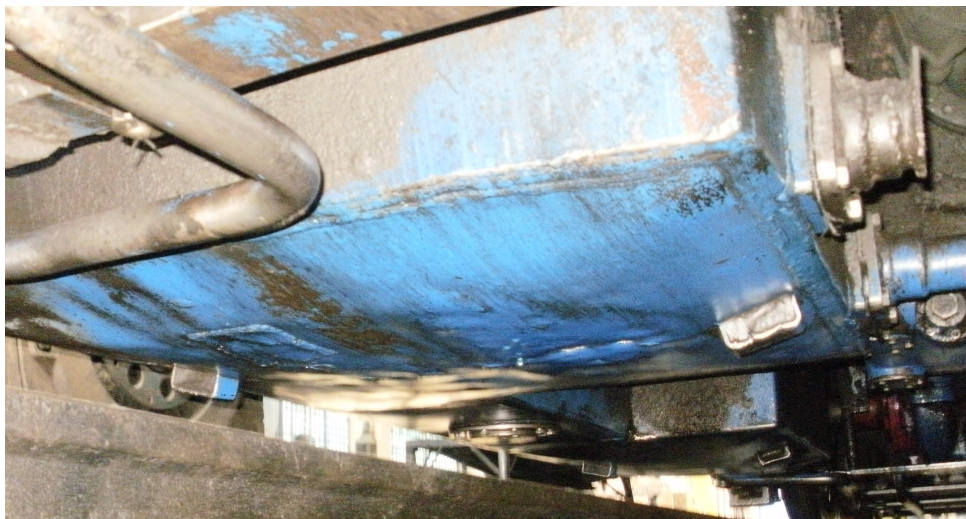
Condition of the fuel tanks:

- the auxiliary tank as well as the afferent pipes were intact, without traces of recent intervention and thermic influence;
- the main tank was distorted by the over-pressure generated by the heating of the gas and the right compartment (driving cab A) has 2 holes below because of the metal breaking from the outside wall, in the area of the welding points of the counter-waves;

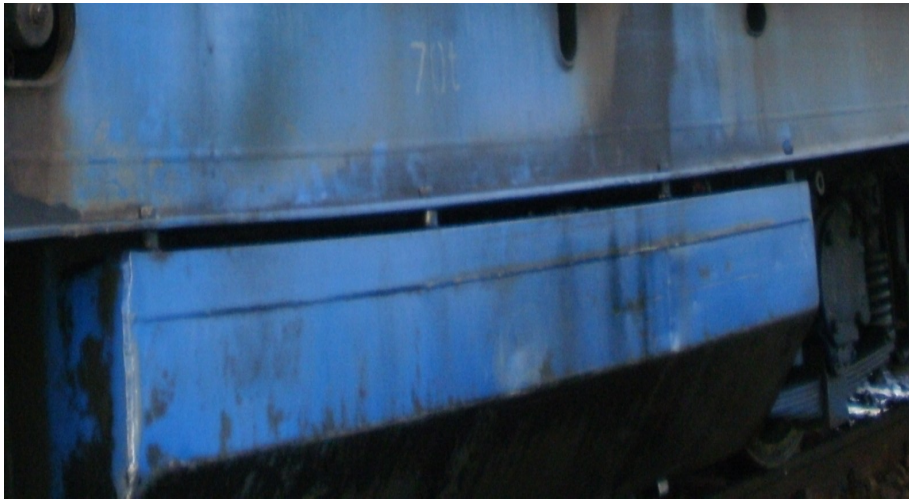
- above the same compartment from the main gas tank there are two fastening pins broken following the distortion of the upper part;
- the distortion of the main tank compartments did not affected the structure clearance.

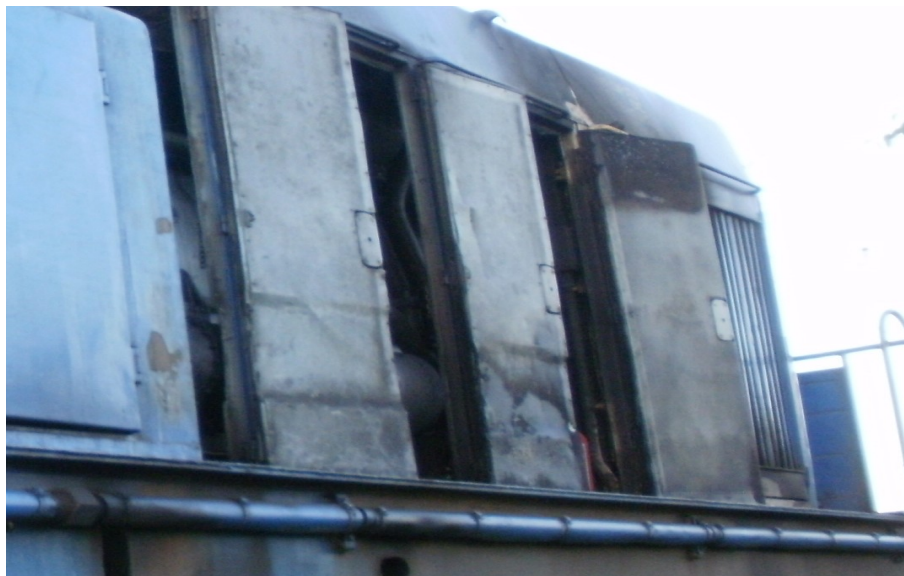
- one disassembled and checked the compressor, dynastarter and the transfer pump and did not find any cause that could lead to the fire (photo);
- dynastarter has small traces of thermic affecting;
- in the area of the cooler of the right diesel engine, the paint is thermic affected because of the burning of the packings from the support frame.

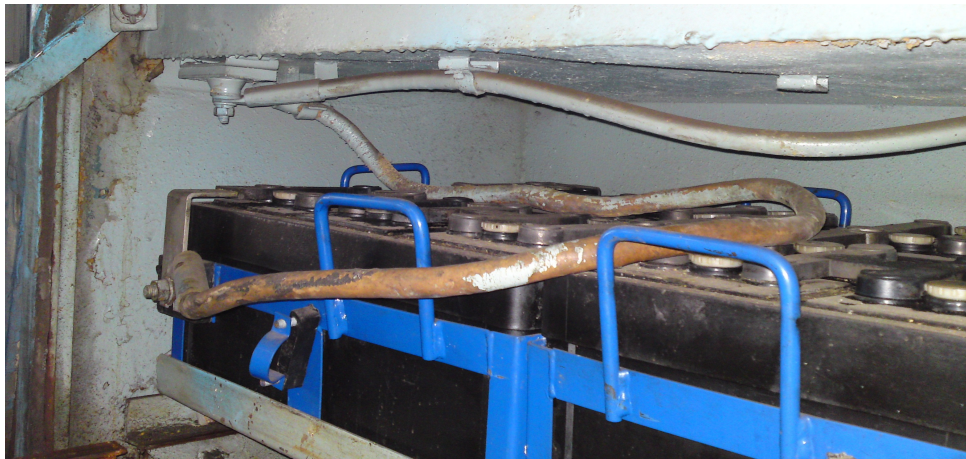
- the right batteries niche (boxes 1-4) afferent to the driving cab A were intact, not being affected by the fire;

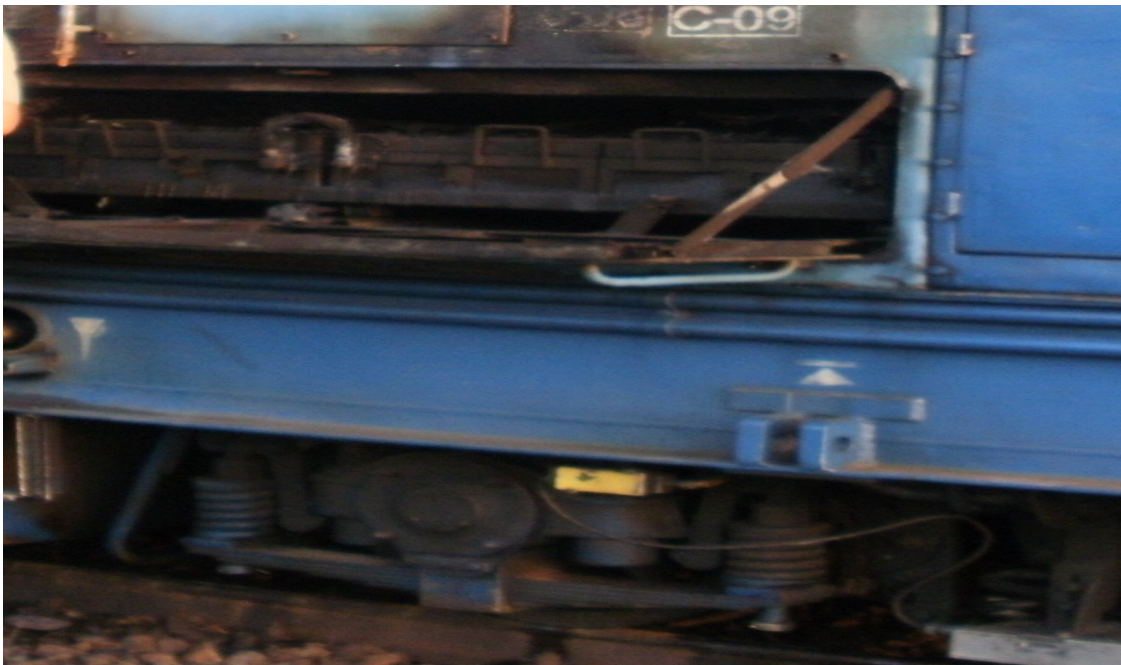
- the left batteries niche (boxes 5-8) afferent to the driving cab B has visible traces of thermic affecting and the batteries boxes 5,6,7 and 8 are burn on the top having the lead connections type H between the elements melted, and the covers and the water proofing materials from the top are complete burn , as well as the insulation of the serial connections flexible between the boxes.

The fire started on the left side of the driving cab, inside the niche of the batteries afferent to the boxes 5-8, appearing a short-circuit between the cable that is the connection between the right and left niches and a serial element of the elements of the battery no. 6.

The short-circuit generated the fire of the cable insulation, then of the covers and waterproofing material from the elements of the batteries 5,6,7 and 8.

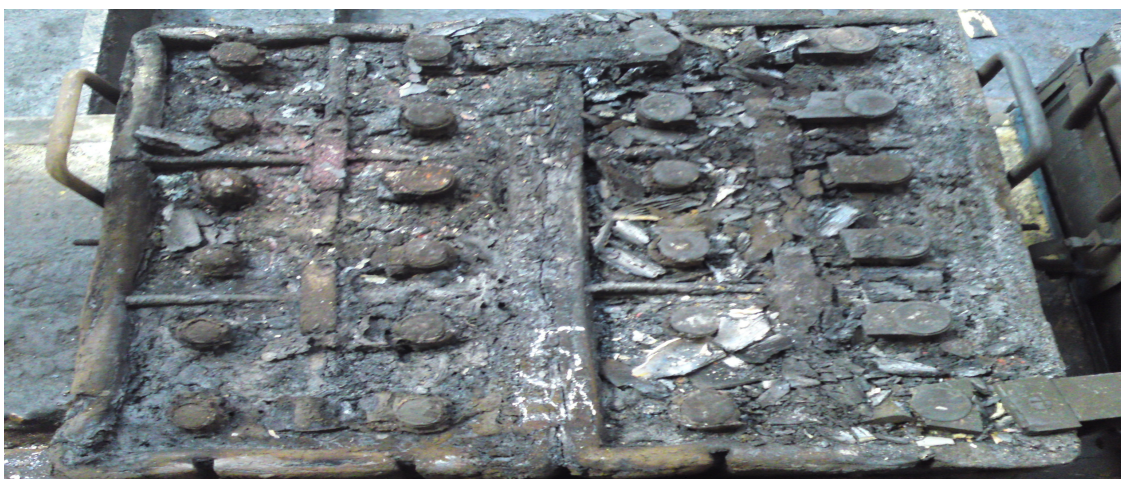
Condition of the batteries no. 5 after the fire

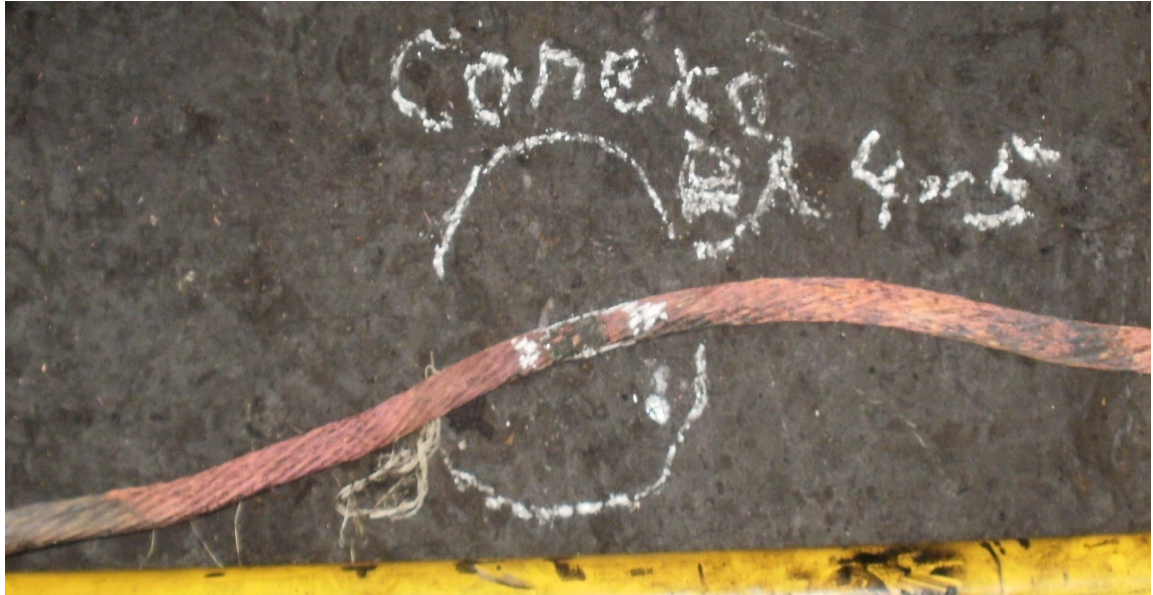
- the serial connection between AB boxes 4 and 5 that ensures the connection between the right and left niche, has the insulation burn on 40 mm length, that is from the entrance and inside the passing pipe under the cab floor;
- on the serial connection between the batteries no. 4 and 4 one find out trace of short-circuit at 750 mm from the connection lug with the battery terminal connection no. 5;

Appearance of a fire inside the niche of the left batteries (boxes 5-8) generated by a short-circuit between the connection between the niches and a serial equipment from the battery box no. 6, that led to the fire of the cables insulation and the covers of the elements of the batteries no. 5-8, followed by the fire of the cables insulation and the fuel deposits appeared in time from the locomotive operation, above the niche of the batteries no. 5-8.

1. Identification and implementation of some solutions for the protection of the connections of the batteries, including between those two niches;
2. Supplement of the actions for the periodical technical inspection of the insulation capacity of the connection cables of the batteries, after the performance of the operations stipulated in the technological processes for the maintenance and operation of the batteries, up to the achievement of the protection solution stipulated previously;
3. Periodical removal of the fuel deposits from the places susceptible to the accidental fires of the locomotive, operations to be included in the technological processes of the periodical inspections.

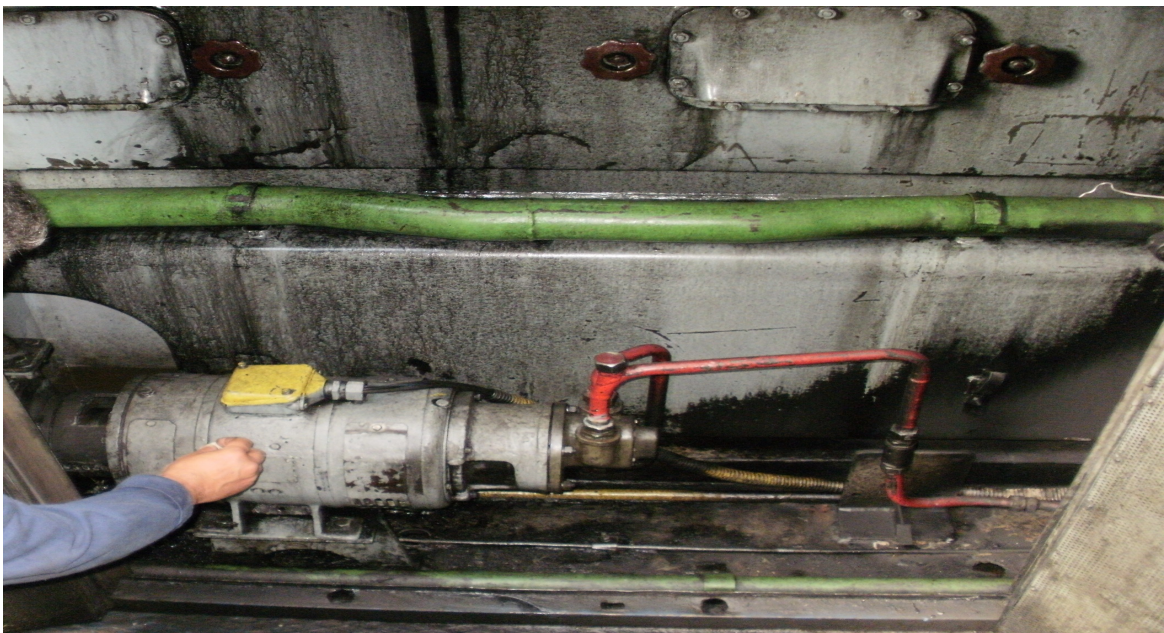
The condition of diesel engine, hydraulic transmission, reduction gear –reversing gear, axles passing, running gears, brake rigging, steam set type GAT 08S1, small cover and the other mechanical equipments:

- one did not found any degradation, distorsions or thermic affecting, generated by the fire, that influence their operation;
- traces of water and oil losses on the cover and crankcase.
