INVESTIGATION REPORT

Concerning the fire occurred at the locomotive DHC 321 belonging to SNTFM “CFR Marfă” SA, in the running of the freight train no.80090, in the branch of Regional Center of Operation, Maintenance and Railway Repairs Brasov, in the station Bărăbănt, on 22 august 2011

FINAL EDITION

26 october 2011

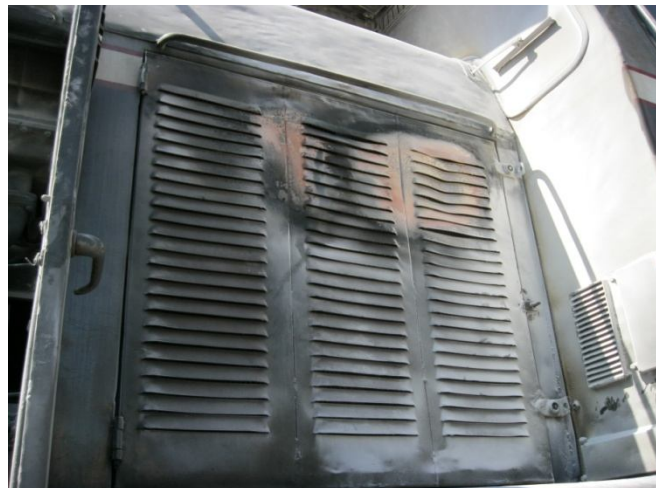
Thermic influence of fire in the over- supplied air filters area left side of the locomotive

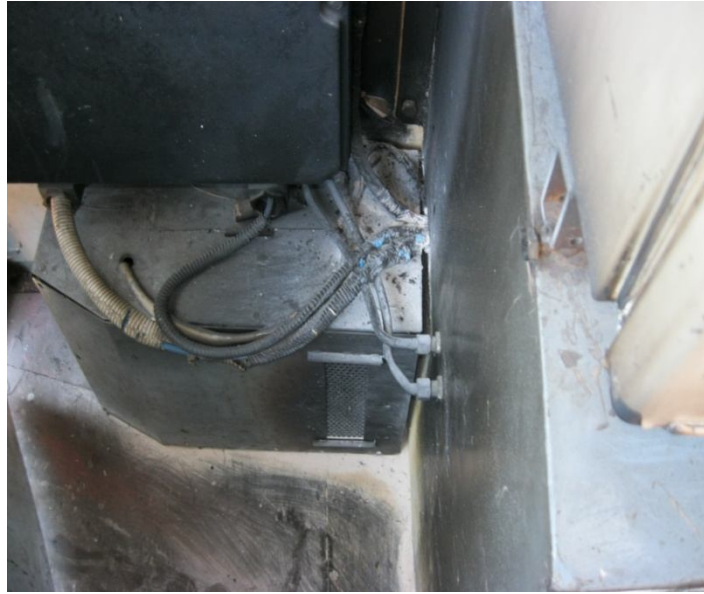
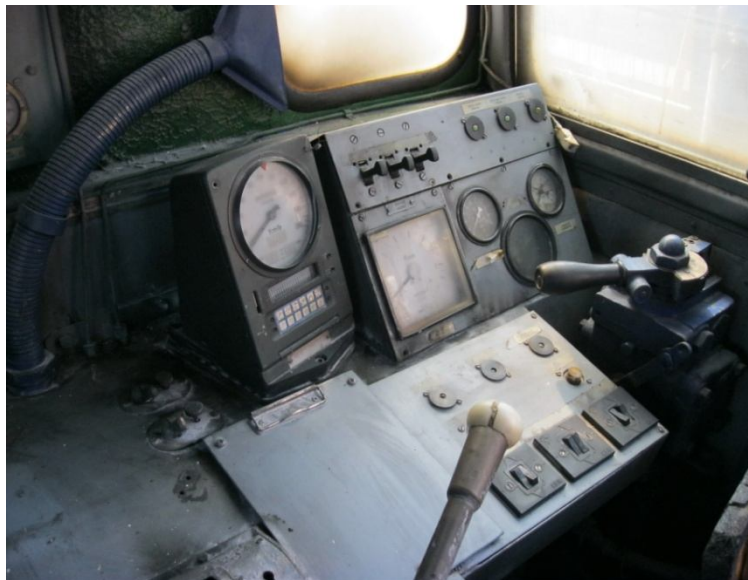
Fire effects on the driver's cabin equipment

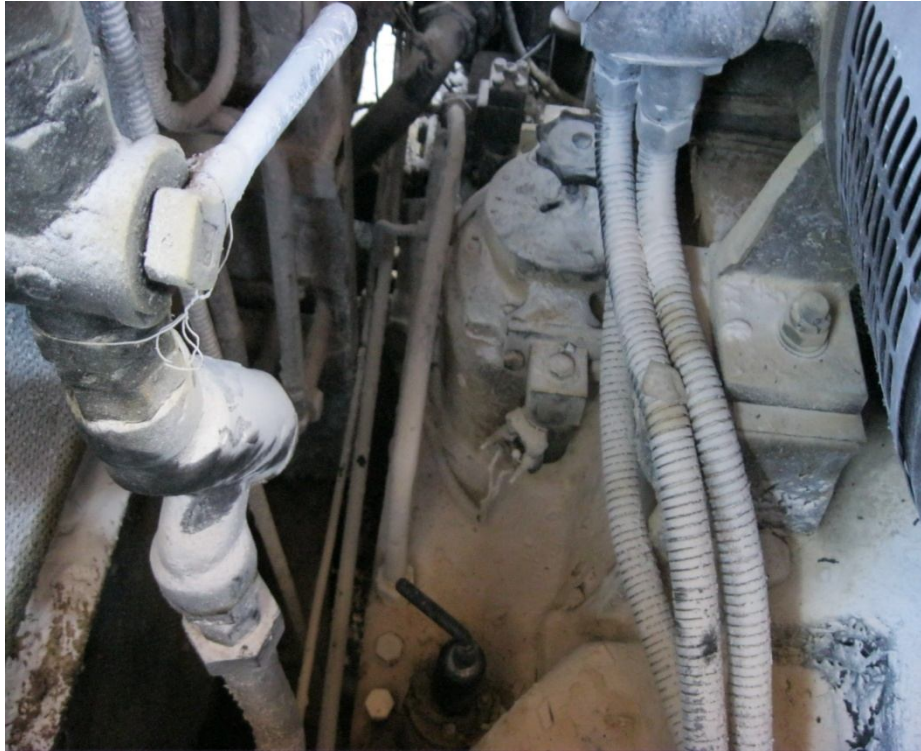
Fire effects on equipment from the TH distribution area and oil gauge

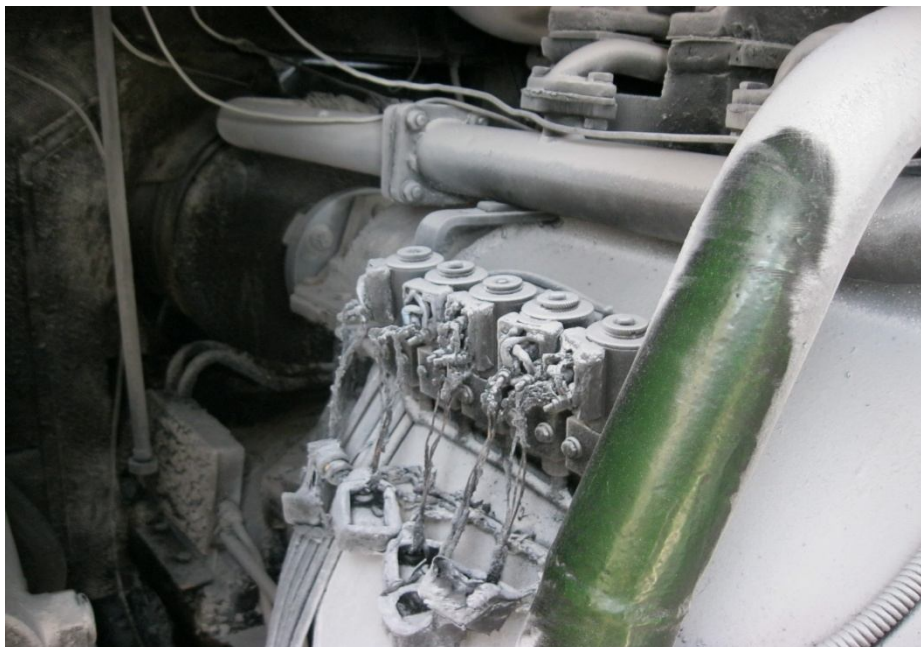
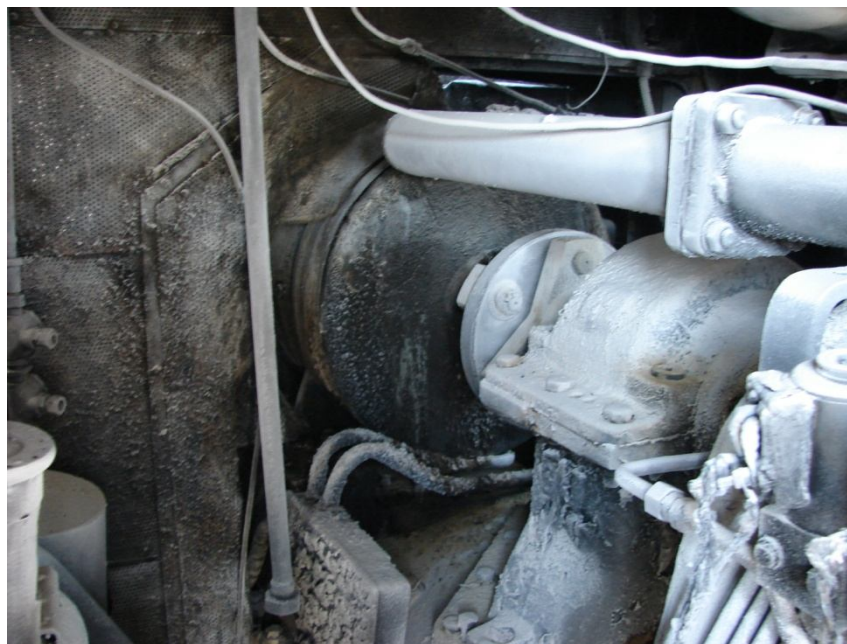
Fire effects on equipment from electro valves S4-S8
