INVESTIGATING REPORT

on the fire occurred on the 6th of June 2011

on the range of CF Timisoara Regional Branch, between h.m. Bocsig and the railway
station CFR Ineu

at the locomotive DA 60-0930-2 (belonging to SNTFC “CFR Calatori” SA)

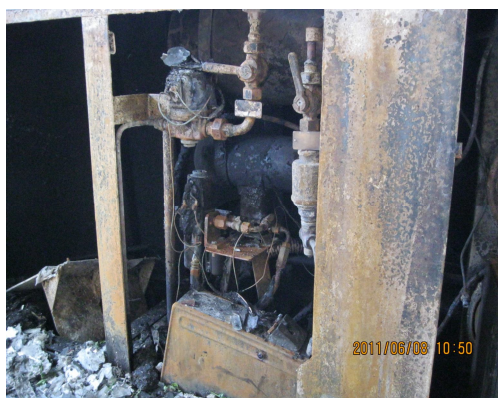
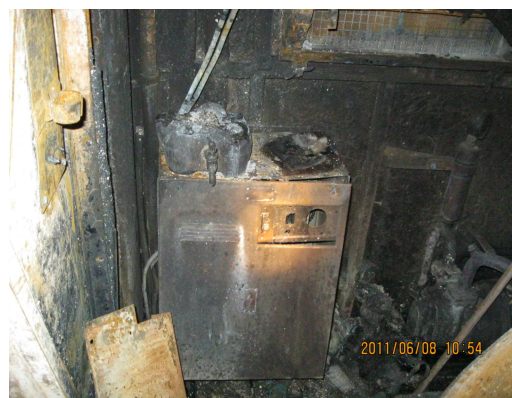
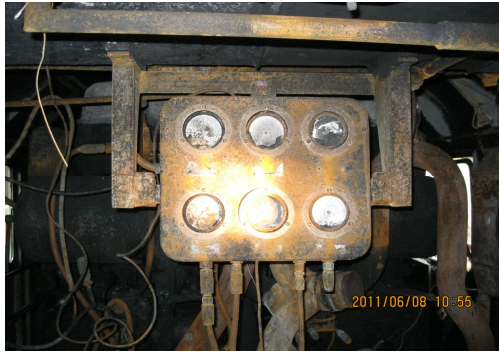
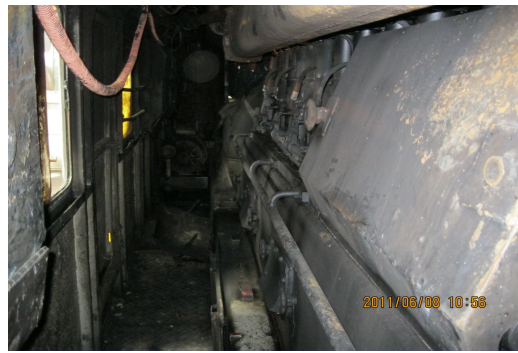
Fire effects on the equipments in the engines box.

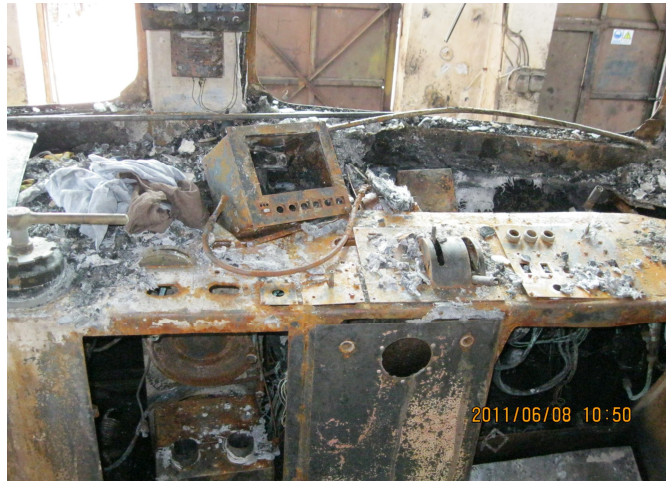
Fire effects on the equipment of control, indication and protection in the driving station no. II

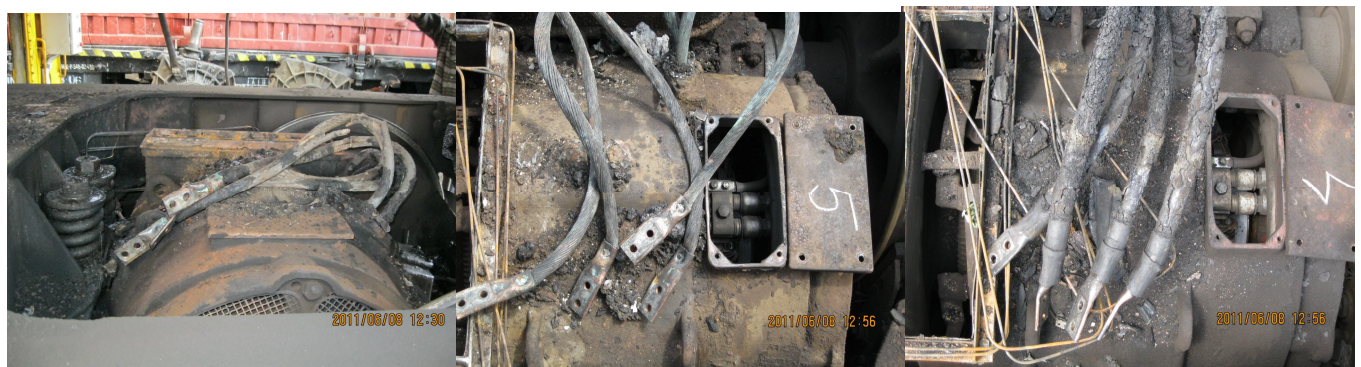
The electric traction engines no. 4, no. 5 and no. 6, had the supply wiring thermally affected. They did not have inside signs of short-circuit, insulators flashover or insulation piercings

The supply conductors of the electric traction engines no. 4, no. 5 and no. 6 did not have signs of overheating in the area of the pads fixing and of conductors crimping in the pads.

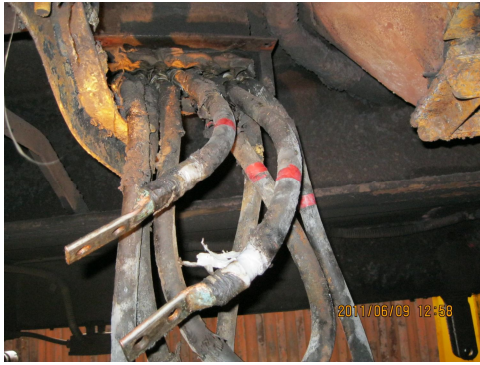
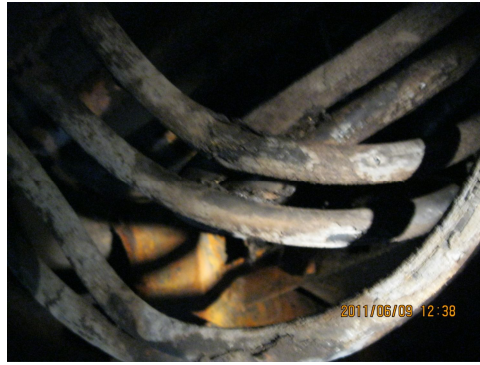
The wiring of series registration and supply of the electric traction engines no. 4 and no. 5 had burnt insulation between the fixing pads in the doses and the fixing yokes in the wiring channel.

At the conductor 778 of serial registration of the electric traction engine no. 2 with the electric traction engine no. 5 was found **a segment of missing insulation of about 80 mm at the entry in the yoke of the wiring channel**. The non-insulated portion was in contact with the conductor 781, the other supply cables of MT4 and MT5 showing thermally damaged insulation.

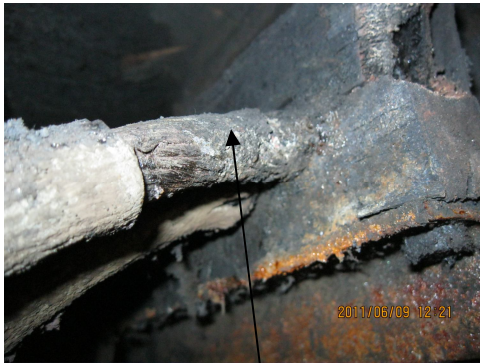
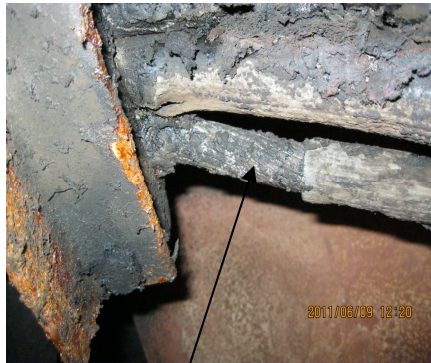
The conductor 778 of serial registration of the electric traction engines no. 2 and no. 5, with the portion of 80 mm of missing insulation at the entry in the yoke of the wiring channel

Release of sparks from the electrical discharges between the conductor 778 (of serial registration of the electric traction engines no. 2 and no. 5) and the conductor 781 (of connection with the drive inverter), in the area of exit of the cables associated to the electric traction engines no. 4 and no. 5, in the area placed after the yoke of their fixation on the locomotive chassis. This was possible due to a portion of missing insulation of about 80 mm from the conductor 778, that was in direct contact with the conductor 781 showing aged insulation.

Missing of a portion of the fireproof insulation mantle of about 80 mm on the conductor 778 of serial registration of the electric traction engine no. 2 with the electric traction engine no. 5, in the area placed at the entry in the yoke of the wiring channel, under the existence of the direct contact with the conductor 781 that had the insulation aging, favored the initiation of the fire occurrence.

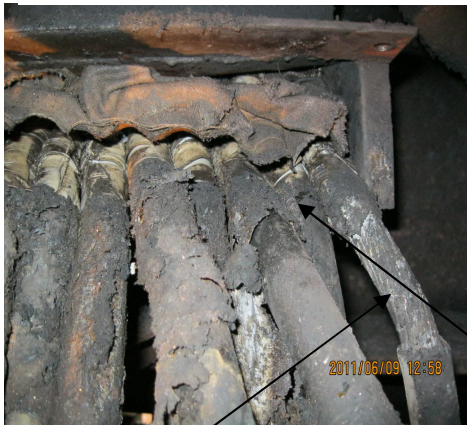
The conductor 778

The conductor 781

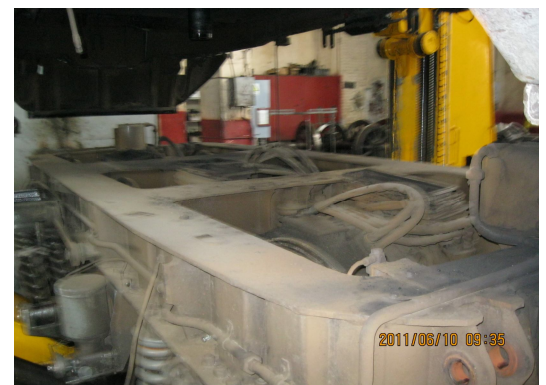
On the frames of the bogie no.1 and on the side unaffected thermally of the bogie no.2 and also the bottom side of the locomotive chassis, the power wiring, at the findings after lifting in winches, there were deposits of dust mixed with oil products.

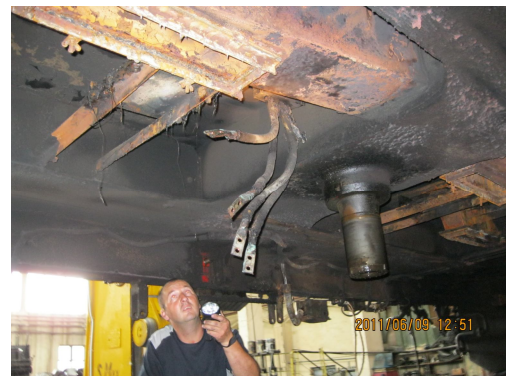
The electric engine of the water pump and of the transfer pump, without signs of short-circuit, with the insulation and the inner wiring thermally affected as consequence of the external fire.

There were not found signs of short-circuit, cuts in the areas of pads to any of the power cables.

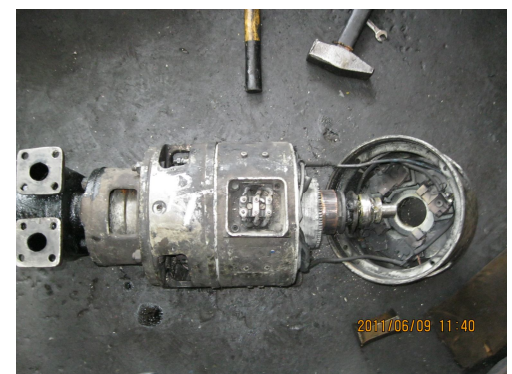
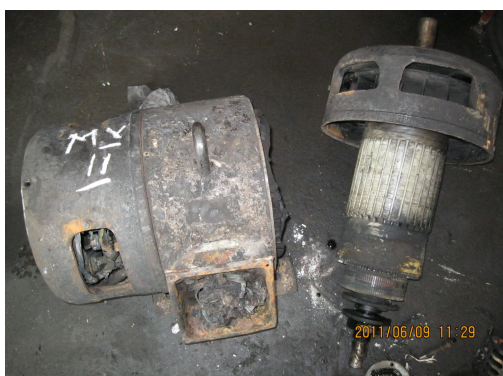
- the housing of the electro-motor of acting the pump of transfer and pre-lubrication had slight signs of thermal affectation, without signs of short-circuit, flames, inside flashovers;

- the engine of forced ventilation of the bogie no. 2 had signs of thermal affectation outside and inside the housing, without signs of short-circuit, flames, inside flashovers;

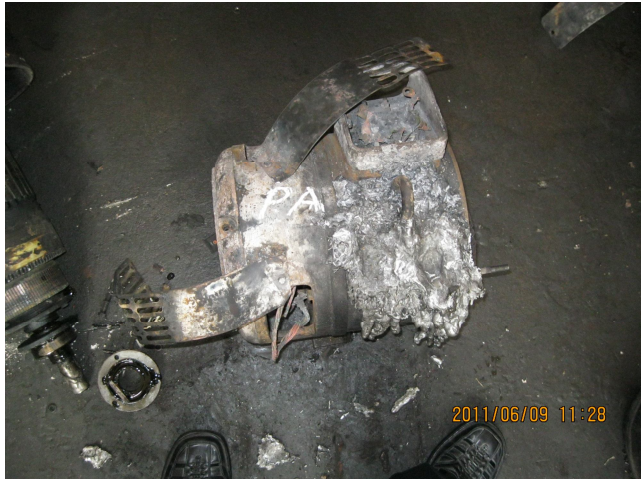
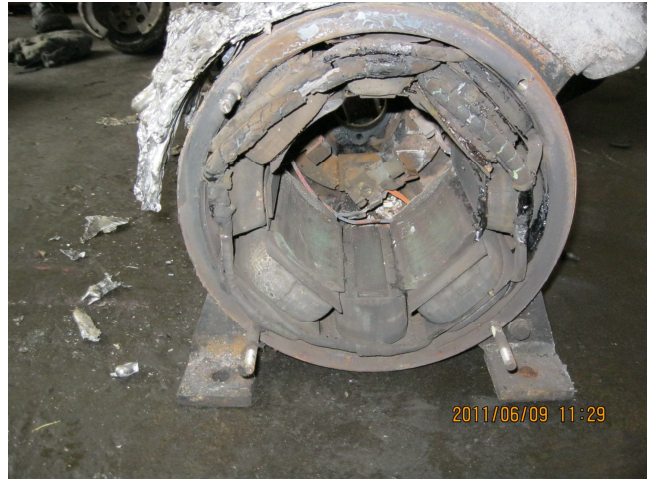
- the electro-motor of the water pump shows strong signs of thermal affectation inside and outside and also the terminals box, without signs of short-circuit, flames, inside flashovers;

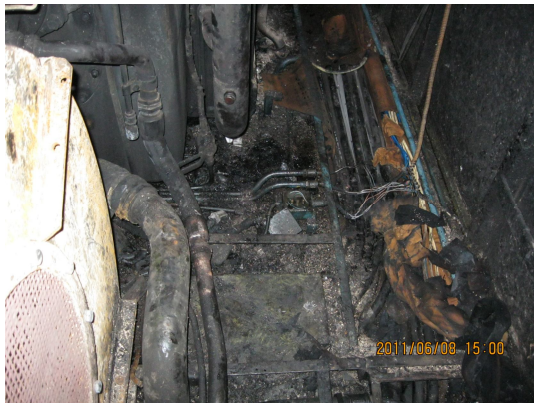
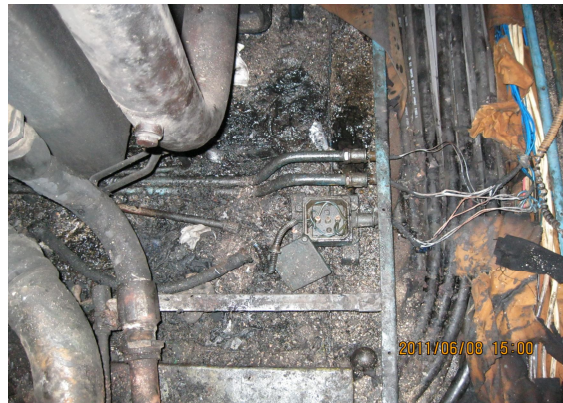
After dismantling of the culverts in the engines box were not found at the locomotive wiring to supply the electric traction engines signs of short-circuit or thermal affectation on the portion placed before the exit from the area of the locomotive floor.

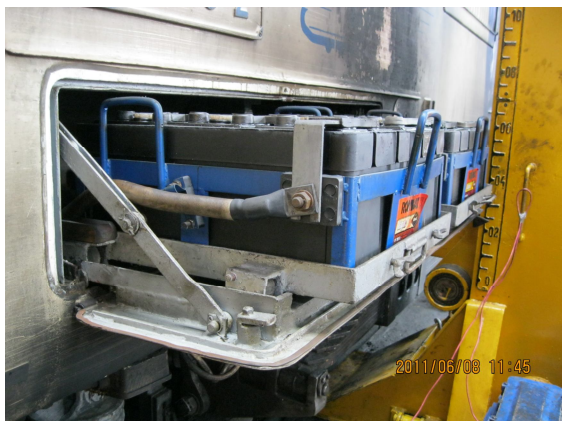
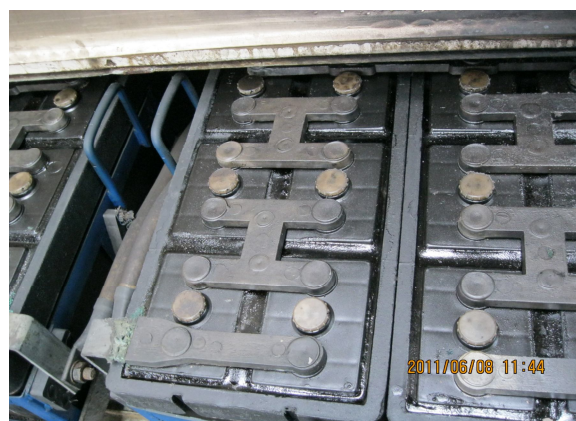
- the batteries pack and the compartment where these are placed, the insulation of the flexible serial registration connections between the boxes did not show signs of short-circuit or thermal affectation;
