MINISTRY OF TRANSPORTS AND INFRASTRUCTURE  
ROMANIAN RAILWAY AUTHORITY - AFER

ROMANIAN RAILWAY INVESTIGATING BODY

## INVESTIGATING REPORT

on the railway accident occurred on the 19th of January 2011 on the range of activity of CF Bucharest  
Regional Branch in the railway station CFR Bucharest Triaj

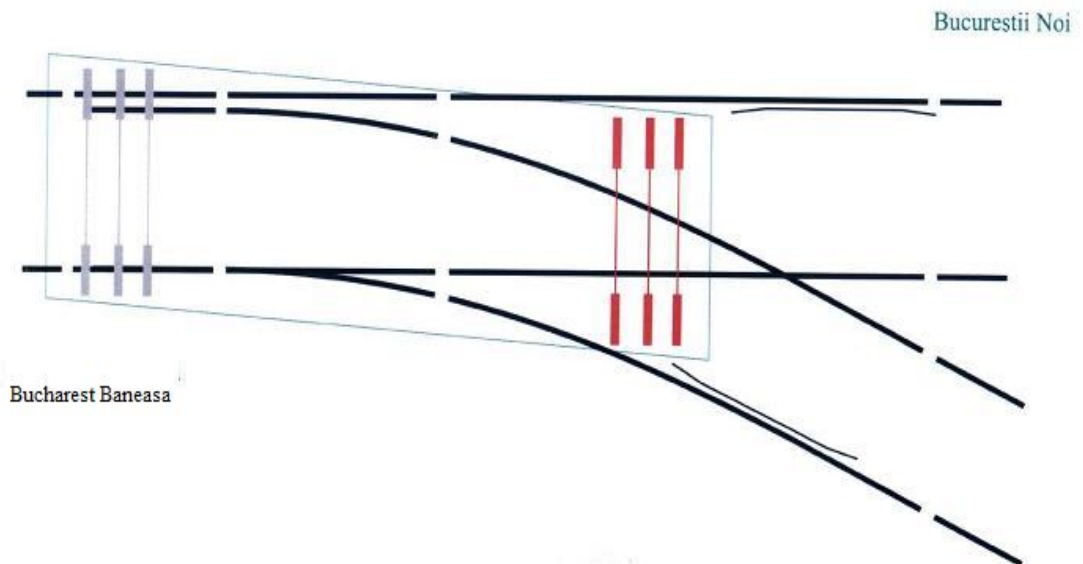
### The drawing of the derailment after the accident on the switch 45 railway station Bucharest Triaj, Station 17, on the 19<sup>th</sup> of January 2011

The derailment occurred as consequence of the non-handling of the switch 45/53 for passing path in the direction Connection Pajura towards Bucurestii Noi (group C) through Bucharest Triaj station 17 by the movement inspector provider (from the group A2 of the railway station Bucharest Triaj), having as consequence the entry of the locomotive EA 474-027-4 towards the switch 51 (with access towards the lines 1A2, 2A2 from the technical group of the railway station Bucharest Triaj). Due to the lack of the metallic straps from the heel joint of the switch no. 51 occurred a side threshold which favored the escalation of the rail by the wheels of the first bogie of the locomotive and then their derailment.

The derailment of the locomotive EA no. 474-027-4 occurred as consequence of the non-handling by the movement inspector provider from the group A2 of the railway station CFR Bucharest Triaj of the switches no. 45/53 on appropriate position for the passing of the train 24794-1 towards the railway station CFR Bucurestii Noi – group C, corroborated with the lack of the metallic straps from the heel joint of the crossing core of the switch no. 45 handles with access towards the lines from the group A2 of the railway station.

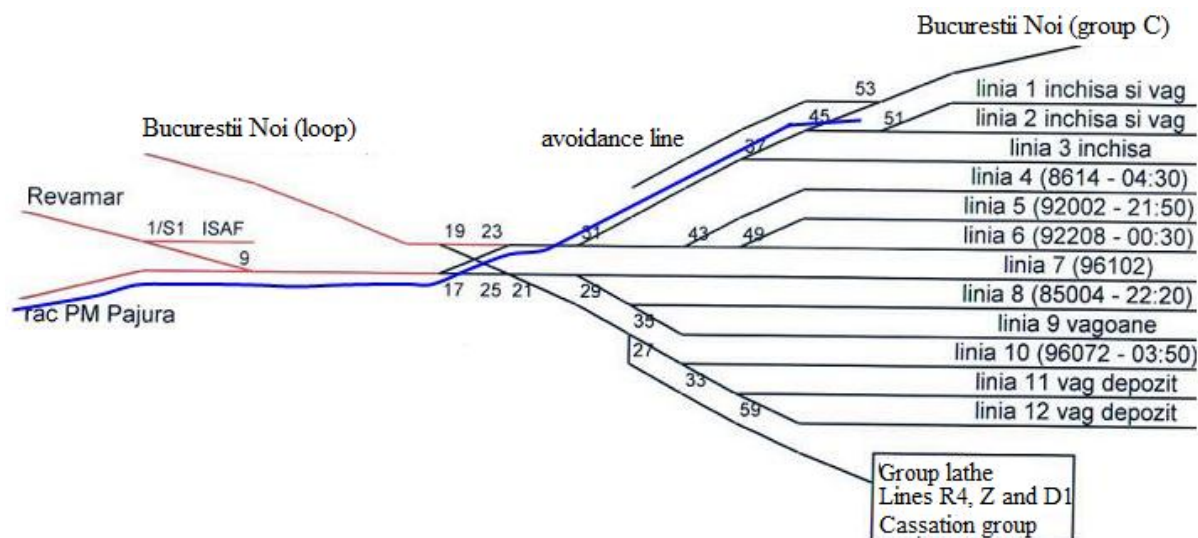
To perform the passing path of the freight train no. 24794-1 through the railway station CFR Bucharest Triaj – Station 17 towards the railway station CFR Bucurestii Noi, the movement inspector provider from the group A2 of the railway station CFR Bucharest Triaj proceeded to the appropriate handling of the switches 19/25, 17/23 (switches placed on isolated path sections which on the lumino-scheme from the control panel of the installation CED were occupied even if on spot these were free), 31 and 37. The switches no. 45/53 were not handled on appropriate

position for the mentioned path, remaining on the position with access towards the lines 1 and 2 from the group A2 of the railway station Bucharest Triaj.

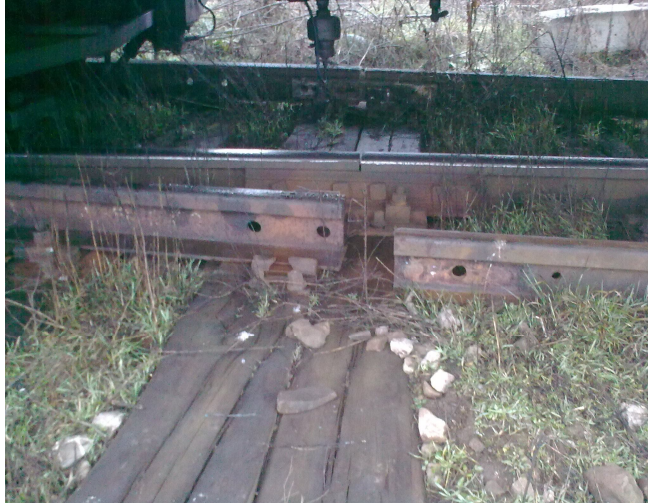
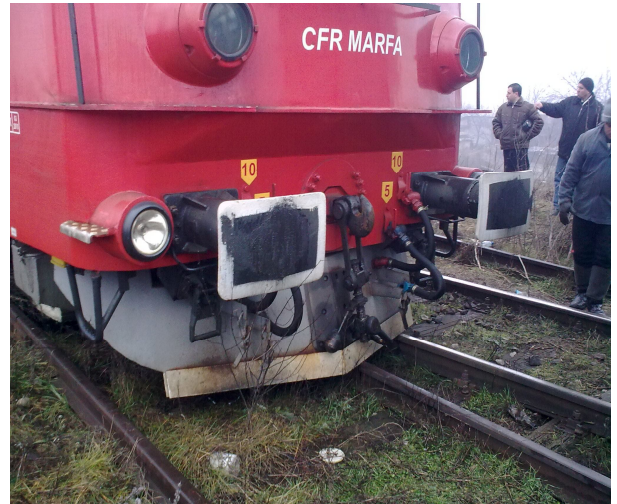
- in 2001 was closed the traffic over the switch no. 45 on the position on deviation (with access towards the switch no. 51), as consequence of a railway event occurred over the switch no. 51 Station 17 Bucharest Triaj. The cause of the event was the inappropriate construction position of the switch no. 51 which gives access at the lines 1A2 and 2A2 from the group A2 of the railway station Bucharest Triaj.
- in 2007 were stolen by non-identified persons component parts of the switches no. 45 and 51;
- because the switch no. 45 (on the position on direct) insures the path on the section Bucharest Baneasa – Bucurestii Noi there was taken the action of completing the metallic parts missing on this direction;
- because of the lack of railway fines (straps) was not insured anymore the continuity of the line at the heel joint of the switch no. 45 on the position on deviation.
