INVESTIGATING REPORT

for the railway accident happened on the 27th of July 2011, consisting in the derailment of two wagons from the freight train no. 64702-1, belonging to SNTFM “CFR Marfa” SA, on the line 4 from the railway station Campia Turzii

**Final edition
September 2011**

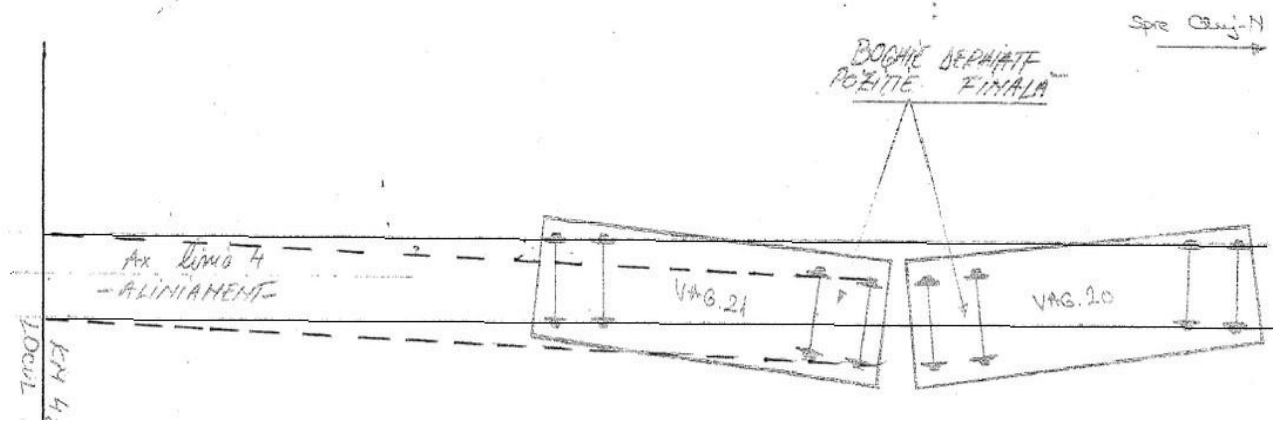
Picture 3: Derailment outline

The train passed the exit signal X₄ on permissive position, with the locomotives and 5 wagons, then the train preparer on duty informed by the radio equipment the driver to stop the train because he heard a curious noise at one of the train wagons. After the train stop, one found out that the first bogie of the wagon no. 31535474833-9 (the 20th in the train consist) derailed in the running direction.

At about 37 m from the first derailed wagon to the rear of the train, between the lines 3 and 4, one found an unloading clack with hit traces, fallen from the wagon 31535474833-9.

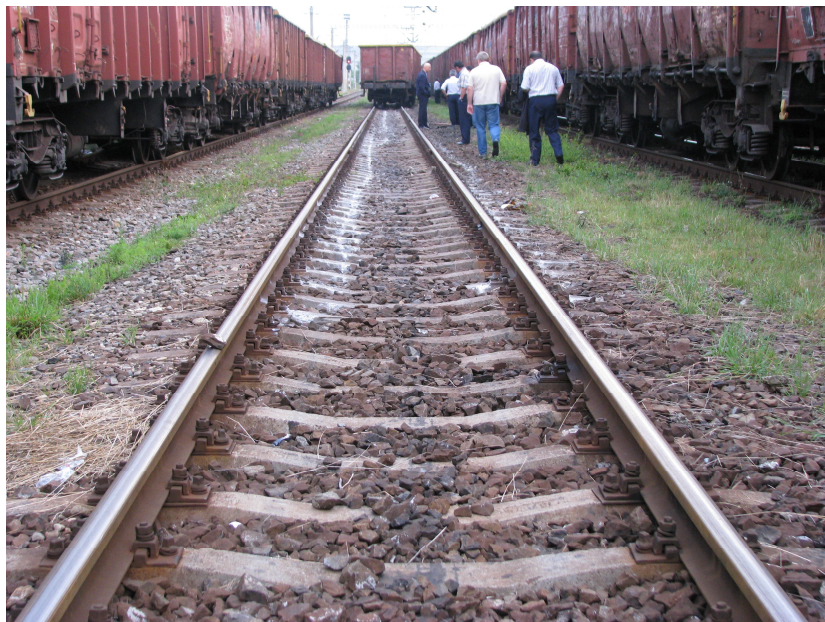
Picture 1. Line where happened the accident

The line where happened the accident (picture 1) consists in rail type 49, concrete sleepers T₁₃, indirect fastening system type K, active and complete, in a straight line and on the flat, welded track, complete broken stone bed, running speed 30km/h, electrified line.

The technical condition of the involved railway infrastructure was right in the derailment area.

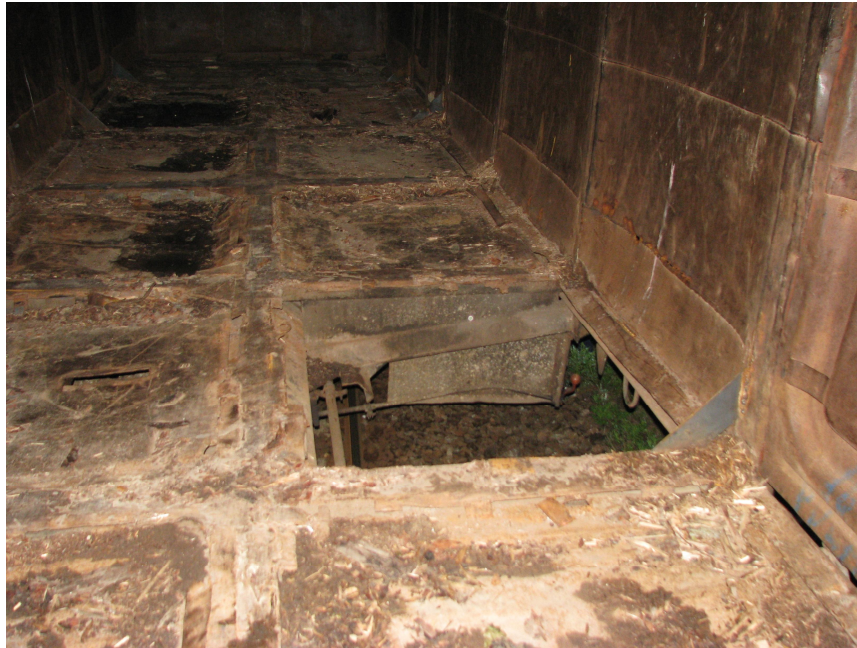
Picture 2 - unloading clack missing

- at the wagon no. **315354748339** missed the **unloading clack** (**Picture 2**) .

At the wagon no. 315354748339, one of the unloading clack was of another type than that necessary and fitted up improperly during the running repair made at SIRV Sibiu on the 27th of June 2011.

Assembly of an unloading clack of another type than that necessary for the wagon 31535474833-9 during the running repair in the Section IRV Sibiu, on the 28th of June 2011;

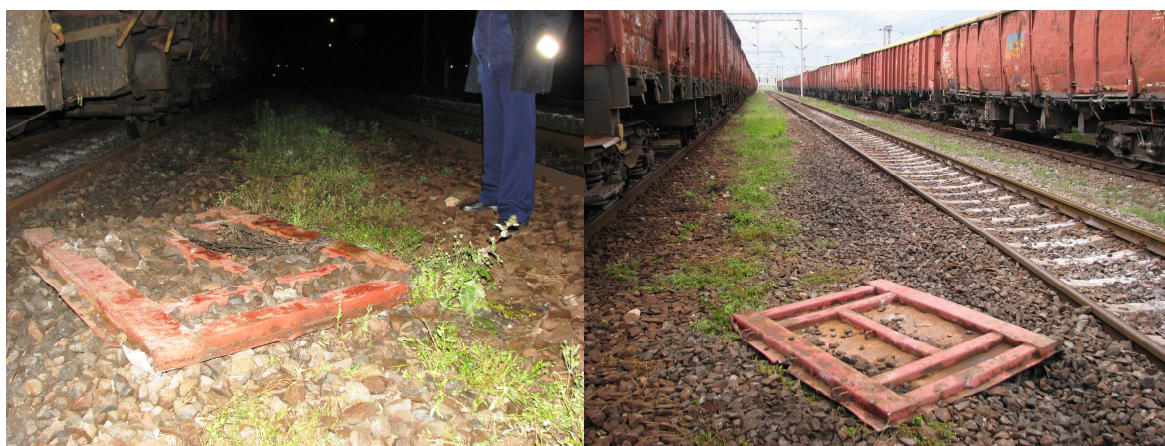
Picture 3 - Place where the unloading clack was found

- the clack was found fallen between the tracks 3 and 4 (Picture 3) at about 37 m from the first derailed wagon to the rear of the train. The welding traces from the found clack correspond to those from the wagon body, resulting that the fallen clack is from the derailed wagon no.315354748339. The fallen clack has traces and distortions left by the wagon wheels on it ;

- the found clack is from another type of wagon than those to which it was fitted up, being improperly fixed on the floor by the joints and springs and stroke-arresting devices as the

constructive wagon was equipped. The fastening of the clack on the wagon floor was improvised with tapee pieces attached by welding ;

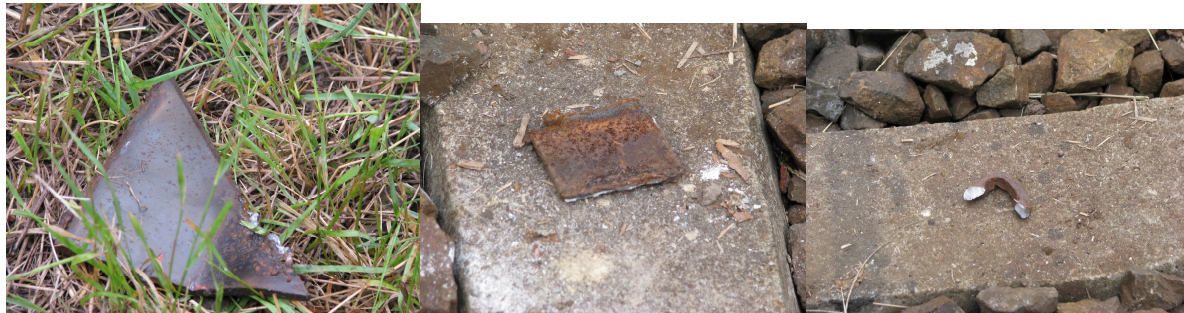
Picture 4 - metallic pieces detached from the derailed wagon and the fallen clack

- at point “0” of the derailment one found metallic pieces detached from the derailed wagon and the fallen clack (picture 4) ;
