MINISTRY OF TRANSPORTS AND INFRASTRUCTURE
ROMANIAN RAILWAY AUTHORITY - AFER

ROMANIAN RAILWAY INVESTIGATING BODY

INVESTIGATING REPORT

on the railway accident
occurred on the 8th of February 2011, in the railway station Capu Midia

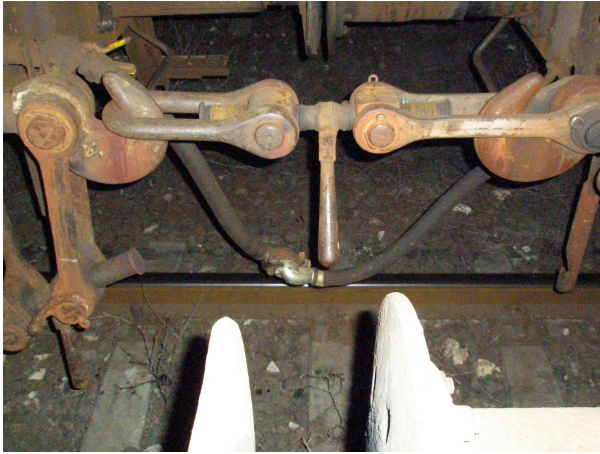
photo 1

- between the 8th and the 9th wagon in the running direction, the couple was not equalized, the pads on the left with the pans in contact, these on the right distanced with about 15 cm, according to the photo (photo 1);

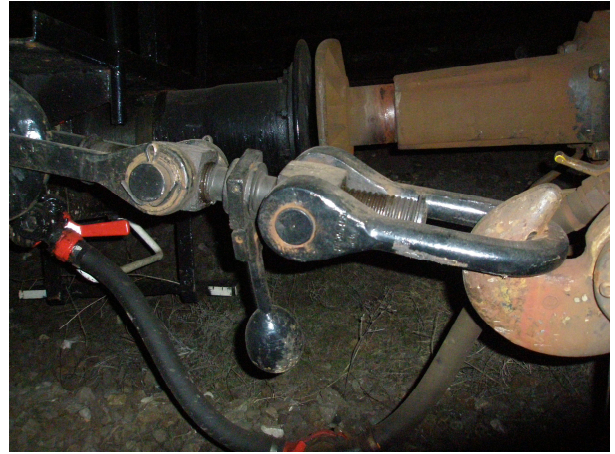
photo 2

- between the 19th and the 20th wagon, the active couple of the 20th wagon tighten almost to maximum position (photo 2);
- between the 20th and the 21st wagon the snare of the active couple (from the 21st wagon) was broken, the snare nut being at about 14 turns from the thread from the end of the couple screw, characteristic to a non-equalized couple (photo 3);

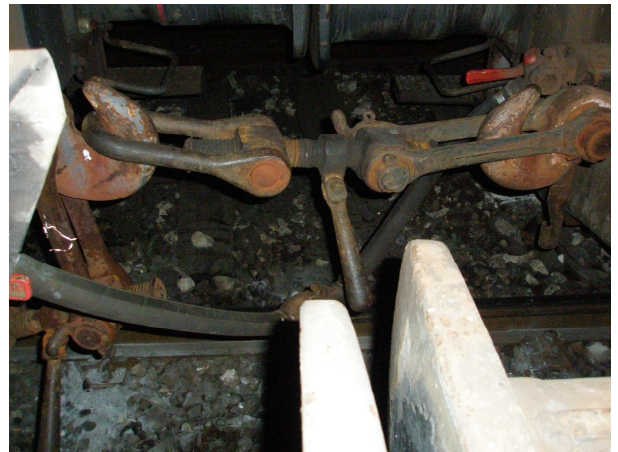
photo 4

- Between the 21st and the 22nd wagon, the active couple (from the 21st wagon) was not equalized and the couple screw was rusty (photo 4).

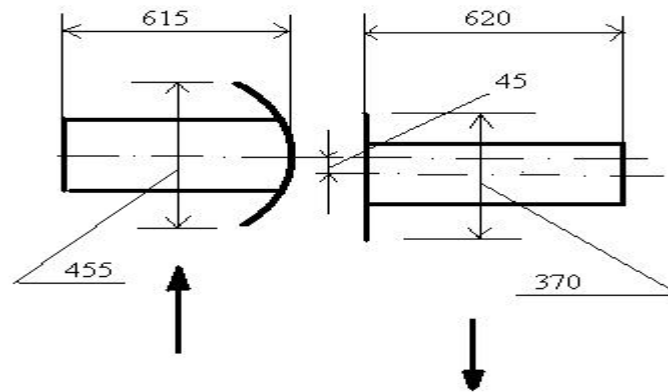
drawing 1

From the presented table results that between the pads centers in contact of the two wagons there is a vertical misalignment of 45 mm which, even if respects the values provided in the Instructions for technical inspection and maintenance of wagons in operation no. 250/2005, favors the overlapping tendency of the pads (see drawing 1).

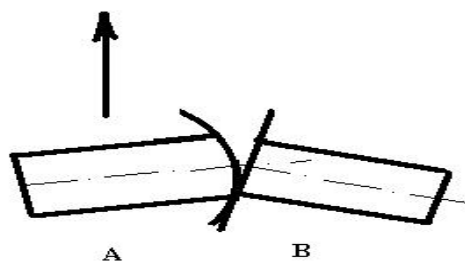
drawing 2

- after passing of the freight train no. 82961 by the input signal of the railway station Capu Midia, at a speed of about 26 km/h, entering on an area of curve with radius of 260 m, under the conditions in which the link between the 3 involved wagons was at the maximum limit admitted by the Instructions for technical inspection and maintenance of wagons in operation no. 250/2005 and the linking device between the wagon no. 37807923043-9 - the 20th in the composition of the train and the wagon no. 33807920395-0 – the 21st in the composition was non-equalized, the active strokes of the impact devices placed towards inside the curve consumed near the maximum limit of the active stroke;
- this situation favored the overlapping tendency of the pad A, belonging to the 20th wagon by the pad B belonging to the 19th wagon according to the drawing 2;
