## **INVESTIGATING REPORT**

on the derailment

of a wagon in the composition of the freight train no. 39462

belonging to CF Brasov Regional Branch, on the 25<sup>th</sup> of November 2010

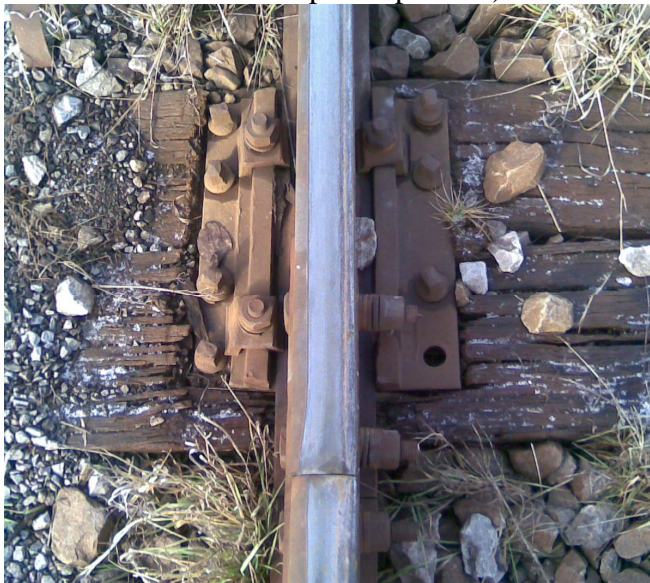
- Increase of the vertical force on the running surface inside the curve (right in the running direction) favored by the existence of an excessive over-elevation corresponding to the running speed limited to 30 km/h, which resulted of the wooden sleepers wear under the metallic clamping plates (plates immersion in the sleepers – photo 1).

**Photo1:** *Metallic plate immersed in the sleepers on the inner wire of the curve*

- Increase of the horizontal force value that operates in the running plane of the rail inside the curve (right in the running direction) favored by the existence of an excessive over-elevation corresponding to the running speed limited to 30 km/h, which resulted of the accelerated wear of the system of clamping the metallic plates under the rail on the wooden sleepers. (photo1)

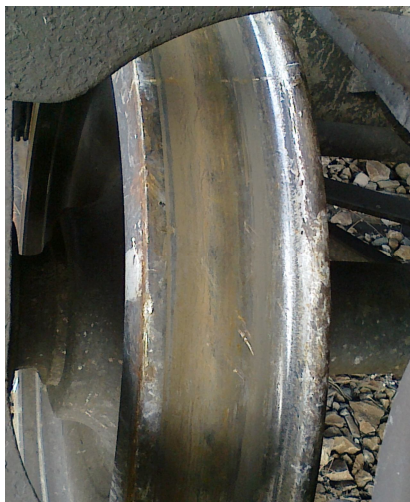
**Photo 2:** *Bandage of the axle no. 3 in the running direction*

- Values of the bandage rates  $q_r$  of the axle no. 3 in the running direction (the derailed axle), at the minimum limit of 6.5 mm at the wheel no. 4 and of 6.6 mm at the wheel no. 3, which favored the escalation of the rail on the outer wire of the curve and influenced the entry of the bogie into curve (photo 2).

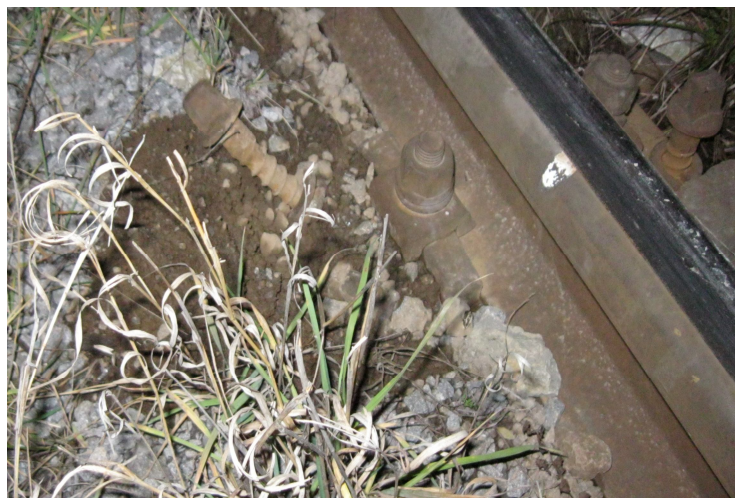
The derailment started at km 0+300 on the inner wire of the circular curve, with  $R=200$  m, by the fall of the wheel on the right of the first axle, of the bogie 2, in the running direction of the wagon no. 845359347521 the second by locomotive, inside the rail. (photo.4)

**Photo 4:** *Place of the beginning of fall of the right wheel between the rail wires*

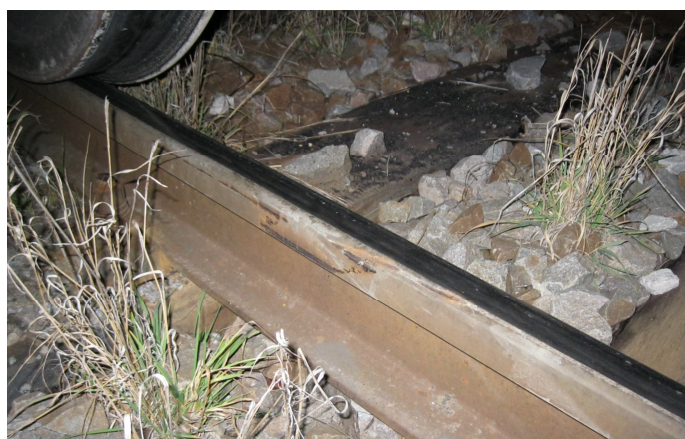
After a distance of 4.68 m with the right axle on the ends of the vertical screws of clamping the rail on the metallic plates, the left wheel escalated the rail on the outer wire of the curve, on the left in the running direction, and then fell outside the rail. (photo.5)

**Photo 5:** *Mark the left wheel at fall outside the rail*

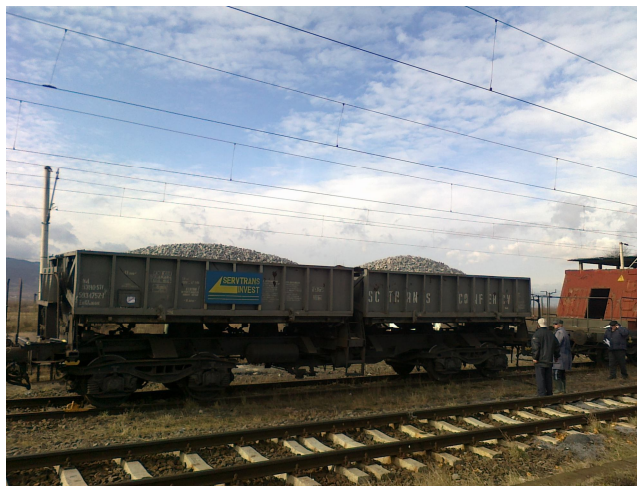
The freight train no. 39462, had in composition the locomotive EA 837 belonging to SNTFC “CFR-Calatori” SA leased by SC SOFTRANS SA and 20 wagons belonging to SC SERVTRANS INVEST SA, wagons loaded with broken stone by SC LAFARGE AGREGATE BETOANE SA Bucharest – Suseni Quarry (photo 6).

**Photo 6:** wagon no. 845359347521 derailed

At the wagon, the derailed axle had to be turned to remove the defects due to the derailment.
