ROMANIAN RAILWAY INVESTIGATING BODY

INVESTIGATING REPORT

on the railway accident
occurred on the 1st of April 2011, in the railway station CFR Chisineu Cris

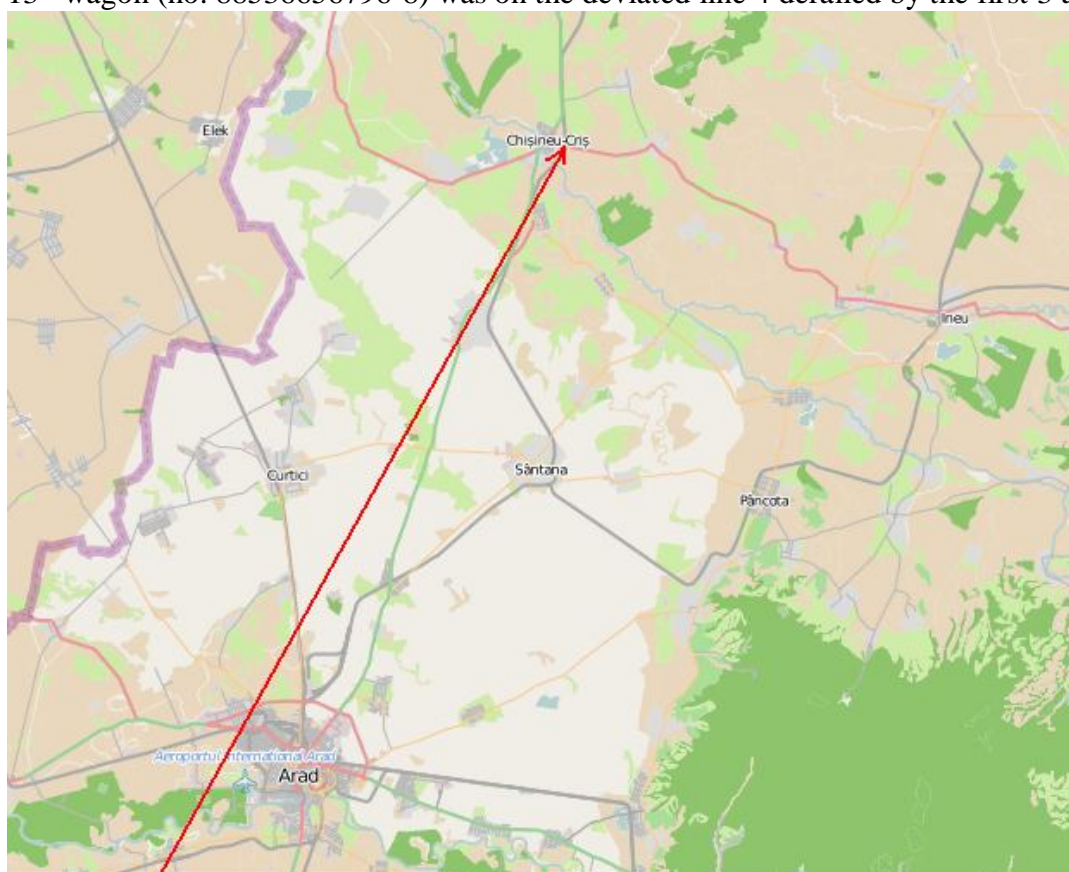
Place of the accident

- the 5th wagon in the composition of the train (wagon no. 88536656453-6 – first derailed) had the coupling hook towards the 4th wagon broken and was overturned on the right (in the running direction), being linked by coupling to the 6th;
- the 6th wagon (wagon no. 88536656616-8) was placed transversely to the direct line III axis, on the right in the running direction, exceeding the structure gauge of the line 4 deviated;
- the 7th wagon (wagon no. 88536656640-8) was placed parallel to the 6th wagon;
- the wagons the 8th (no. 88536656667-1), the 9th (no. 88536656783-6), the 10th (no. 88536656815-6), the 11th (no. 88536656682-0) and the 12th (no. 88536656517-8) in the composition of the train were derailed on the line 4 deviated, being inclined to the vertical plane;
- the 13th wagon (no. 88536656796-8) was on the deviated line 4 derailed by the first 3 axles.

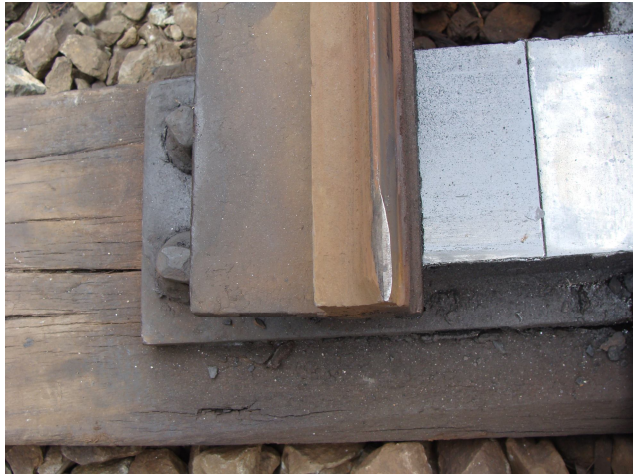
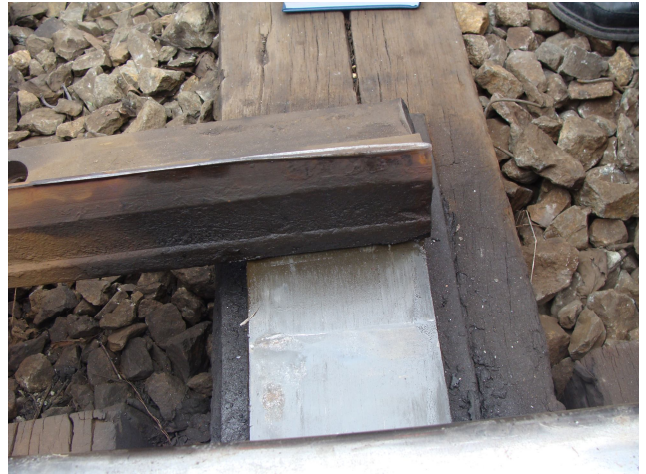
The top of the right needle had fresh signs of impact on a length of 39 mm at the top side, on 3

different plan oriented towards the curved counter-needle.

The curved needle, starting from the top had a compaction on a length of 114 mm with a depth of 3 mm and a width of 5 mm, with burr on both sides of the needle and on the counter-needle was marked the sign of the burr, the surface of this compaction was dark colored in the middle and with metallic luster towards the outside.

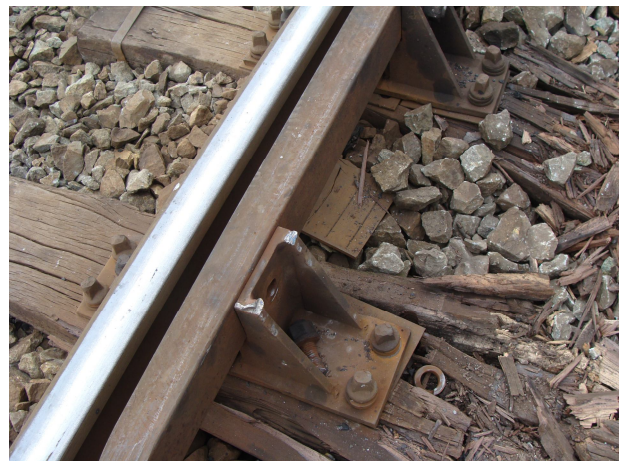
On the fixing elements of the checkrail corresponding to the right counter-needle from the crossing core of the switch no. 3 were noticed signs of strong impact, came from the contact in the bottom of the axle box corresponding to the wheel on the left of the third axle in the running direction of the train from the wagon no. 88536656453-6.

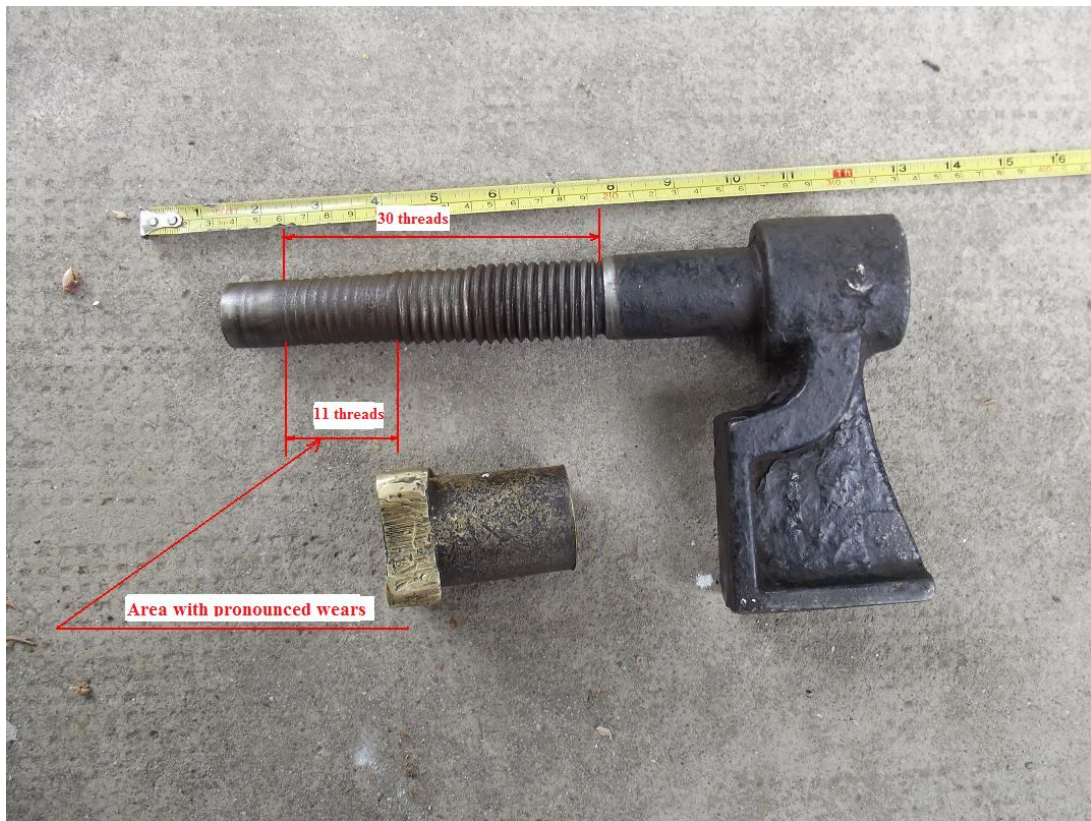
Also was checked the beak, the axis and the sleeve in the lock on the date of the railway accident occurrence – 1st of April 2011. With this occasion was found that the axis of the lock had pronounced wears of the thread, especially in the area opposite to the lock beak (from the total of 30, a number of 11 threads were worn and 7 were deformed).

- the technical condition of the beak and of the axis from the lock on the curved counter-needle (3+) of this switch (pronounced wears of the thread on the side towards the lock sleeve) and also the position in which these were found lead to the conclusion that, during the period between the last handling of the switch and the accident occurrence, this subassembly was permanently subjected to progressive forces strong enough to seriously deform the axis thread (the 7 deformed threads) and, finally, pull it out from the lock. Also, these forces were not as strong as in the shocks produced by the side forces transmitted to the needle not stuck to the wheels of a railway vehicle in the case of attacking in false a locked switch (couponing), case when, according to the projection principles of such lock (mentioned in the work “Description of the installations signaling, centralizing and blocking used at CFR” by Marius Maris, edition 1949), there should have break the beak, the pin or its sleeve;

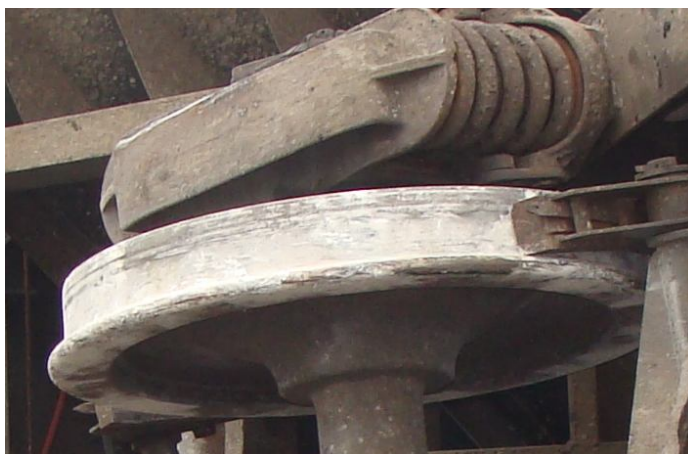
After the derailment of the wagon no. 88536656453-6, at the axle no. 377658 (the third in the running direction), on the inner surface of the axle box, left side, in the running direction, were noticed signs of impact, came from the contact with the clamping elements of the check rail from the cross core of the switch no. 3. We mention that from the place of the derailment to the concerned check rail are 15 m and this impact occurred after the derailment of the wagon.
