## INVESTIGATING REPORT

on the fire occurred at the locomotive DHC 80-0152-1  
belonging to SNTFC “CFR Calatori” SA, in the running of the train no. 3008, on the  
current line II Chitila – Bucharest North Gr. B at the km 2+100, on the 24<sup>th</sup> of  
December 2010

Final EDITION

The 21<sup>st</sup> of February 2011

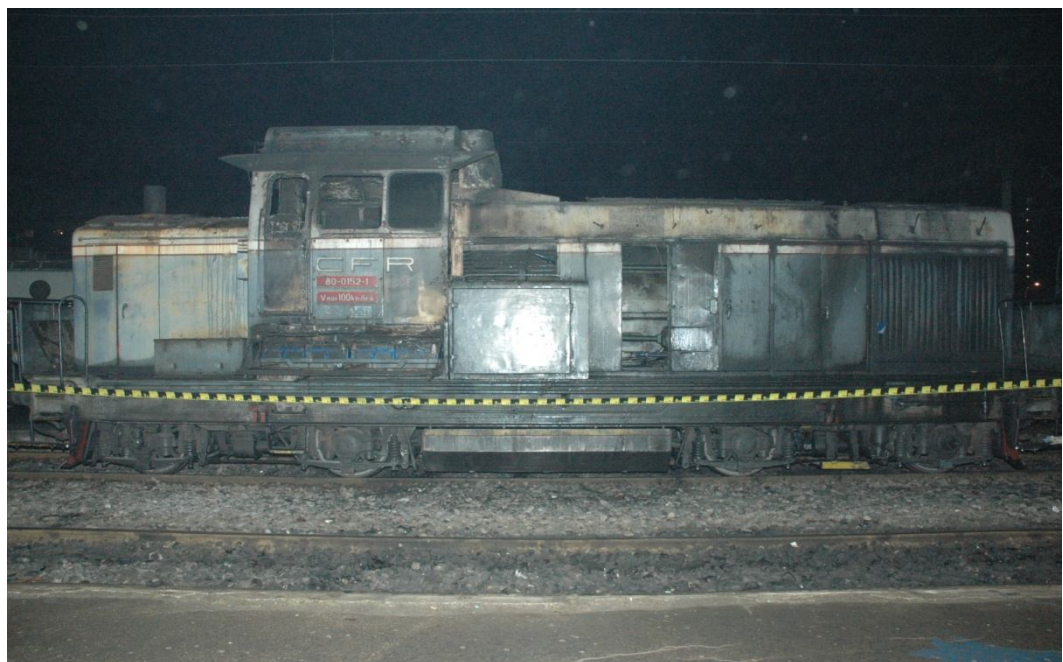
Thermal effect of the fire in the batteries pack niche left side of the locomotive (Photo 1)

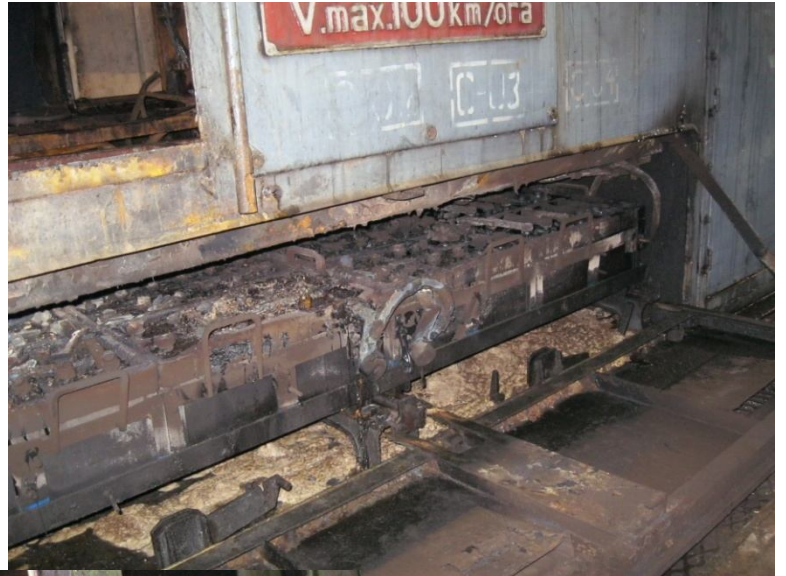
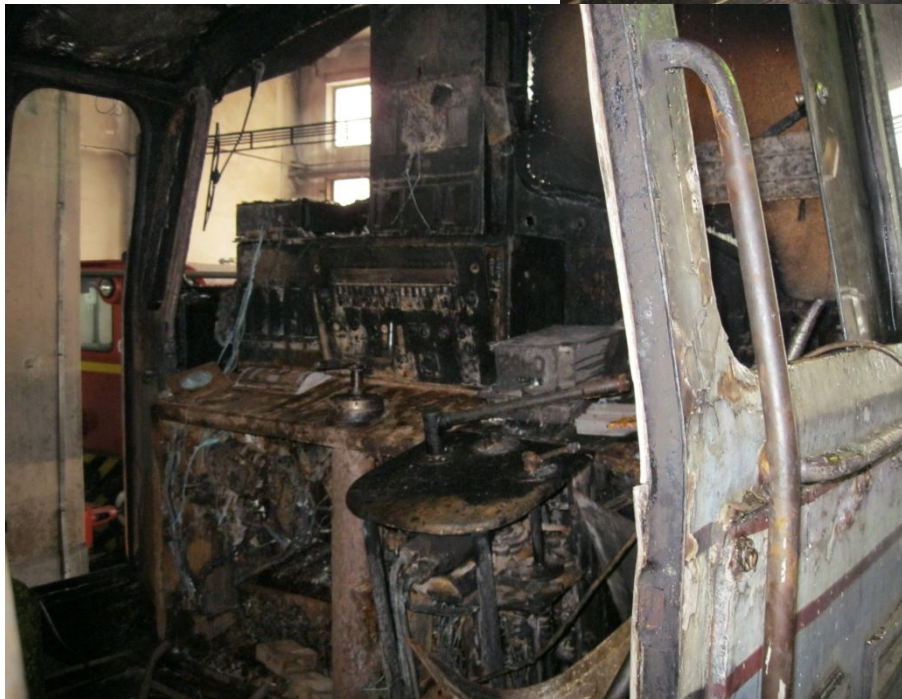
Photo 2

Fire effects on the equipment of command, indication and protection in the driving cabin seen from the right side of the locomotive; (Photo 2)

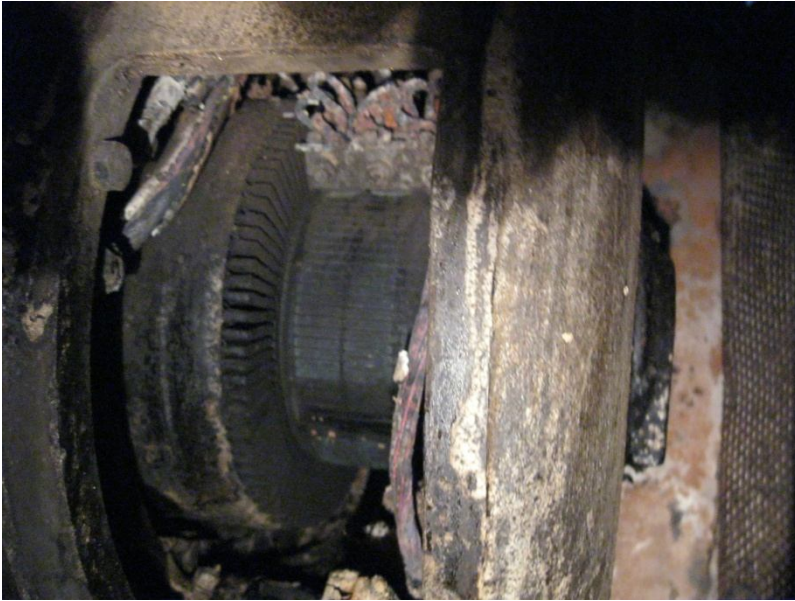
Photo 3

At the initial check on the 28<sup>th</sup> of December 2010, were not found signs of short-circuit at the collector, the brush-holder crown or the flexible connections of the dynastarter (Photo 3)

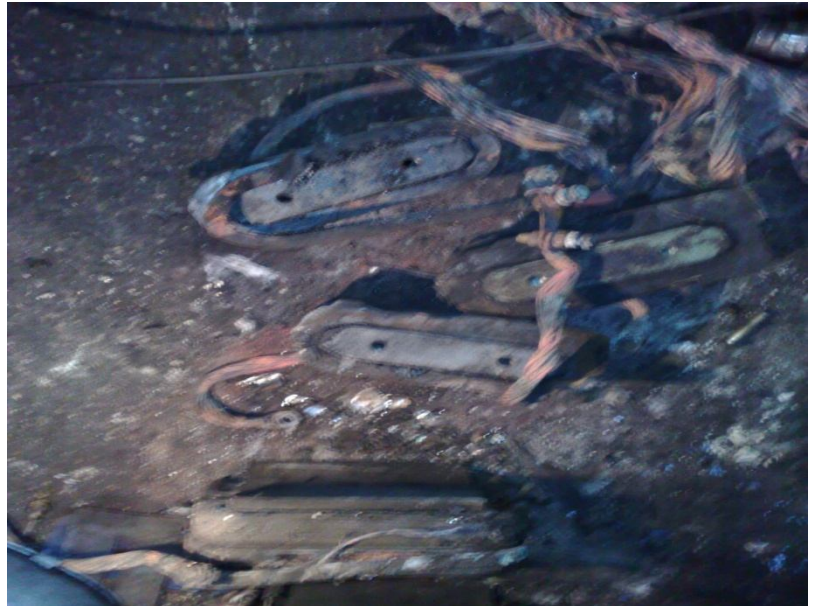
Photo 4

From the examination of the thermal influence areas and the dynamic of the fire propagation, the investigation commission ordered the complete dismantling on the 5<sup>th</sup> of January 2011 in Ploiesti Depot of the dynastarter that had signs of overload operation, with thermal affectation; (Photo 4 and 5)

There were not found signs of short-circuit or insulation piercings at the rotor and stator windings; (Photo 4 and 5)

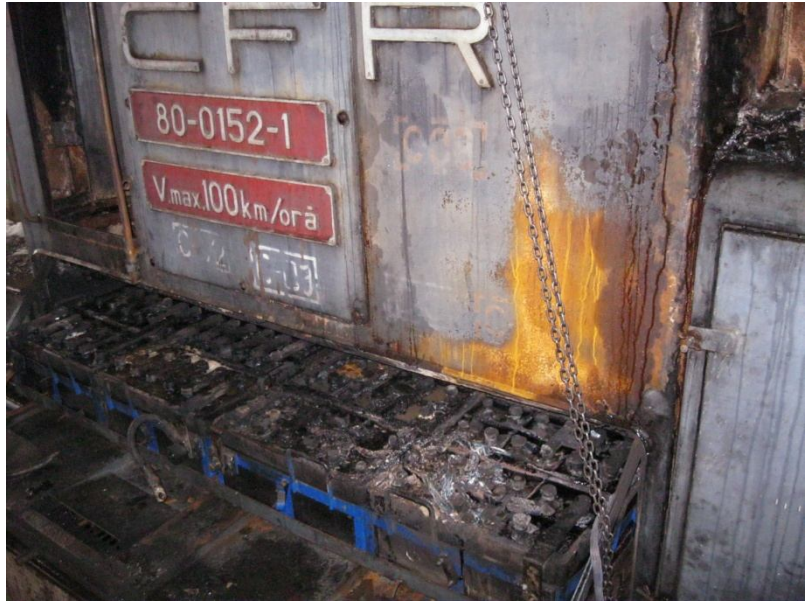
**Photo 6**

Niche of batteries pack on the right (boxes 1-4) associated to the station A with thermal damage of the batteries boxes no. 3 and 4 affected by the fire; (Photo 6)

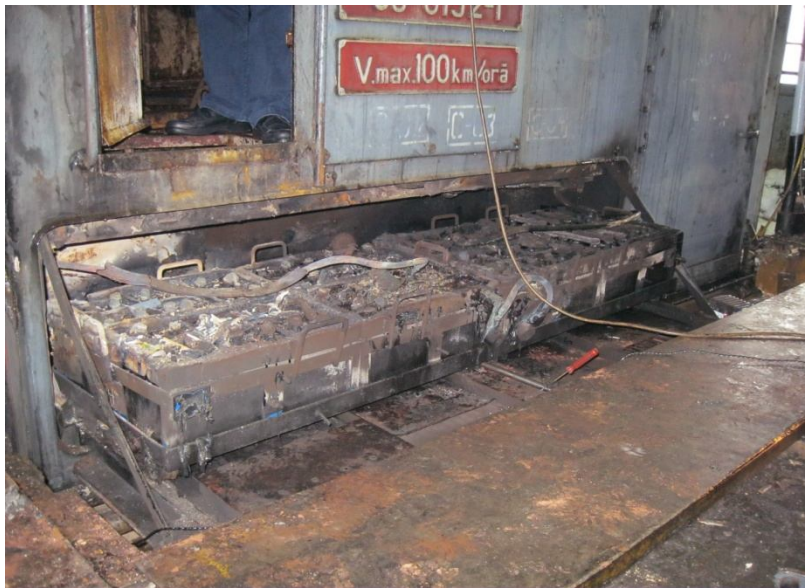
**Photo 7**

Niche of batteries pack on the left (boxes 5-8) associated to the station B has obvious signs of thermal affectation and the batteries pack boxes 5, 6, 7 and 8 are burnt at the upper side having the lead connections type H between the melted elements and the covers and the sealing materials from the upper side are totally burnt and also the insulation of the serial registration flexible connections between the boxes; (Photo 7)

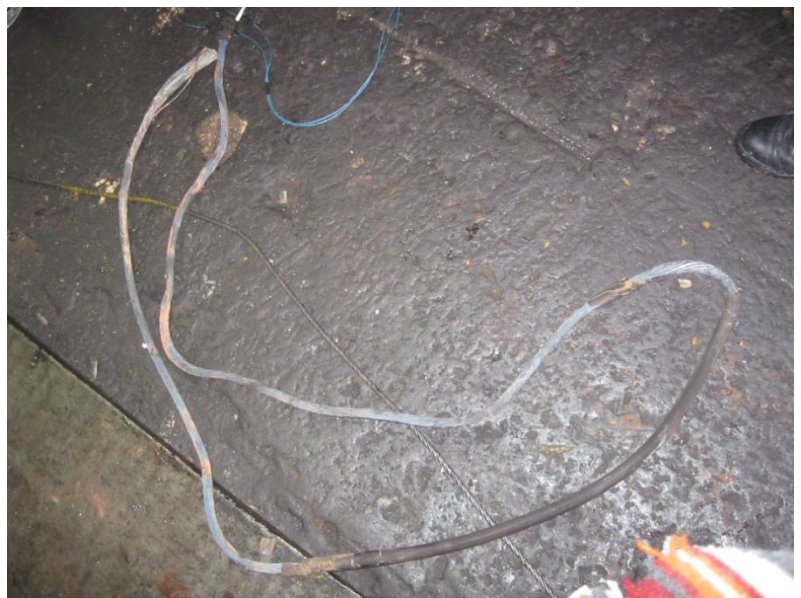
**Photo 8**

The serial registration connection between the boxes BA no. 4 and 5 that insure the connection between the niche on the right and the niche on the left, with the insulation burnt on the entire length inclusively inside the crossing pipe under the cabin's floor, without signs of short-circuit; (Photo 8)
