ROMANIAN RAILWAY INVESTIGATING BODY

INVESTIGATING REPORT

on the railway accident
occurred on the 13th of January 2011, in the railway station CFR Dej Triaj

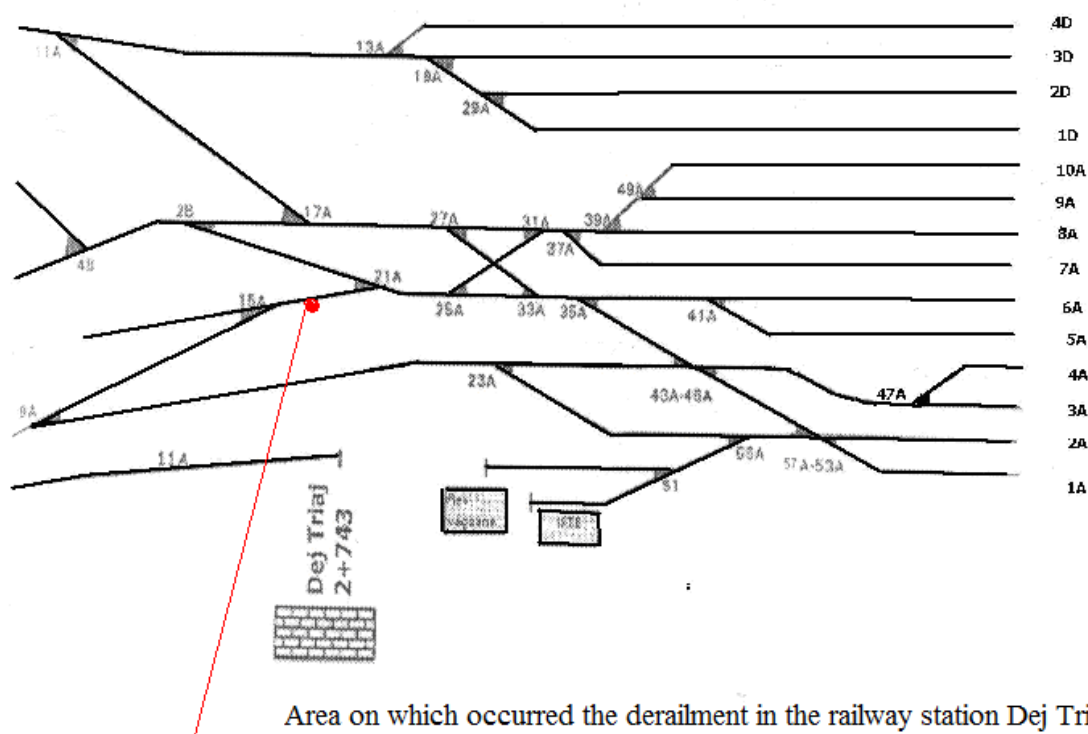
The derailment occurred at about 14.7 m from the first joint on the top of the path device by the escalation of the right wire of the path (in the running direction) in the area of the mechanic joint placed in this point. After the derailment the locomotive continued to run for about 50 m.

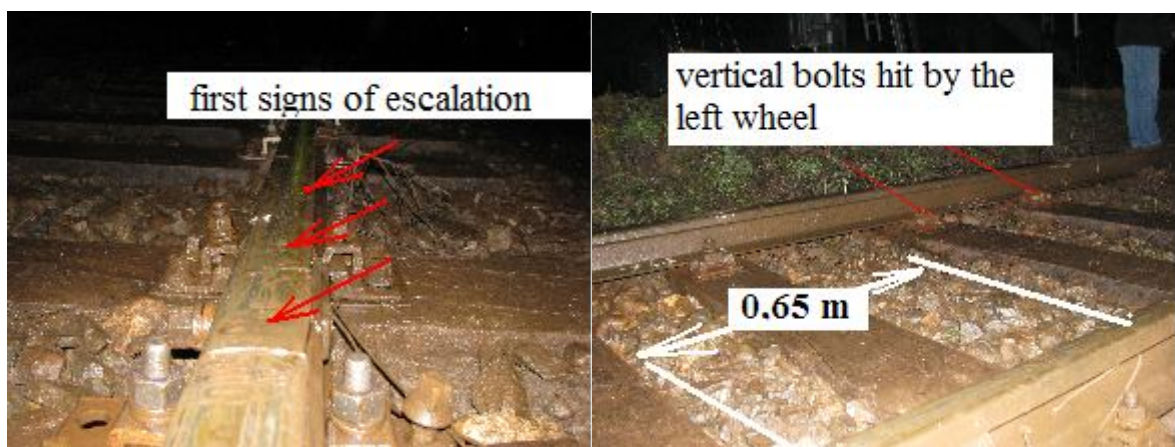
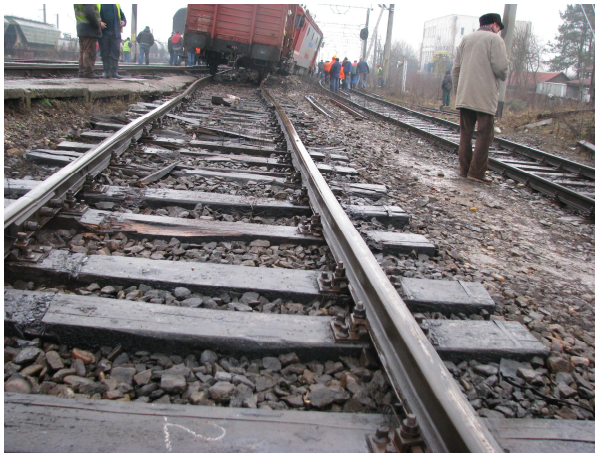
- the first escalation sign was found on the rail on the right of the 3rd panel counted from the top of the switch no. 15A;
- on the wire on the left of the path the first derailment sign is noticed at about 0.65 m from the corresponding point of the mechanic joint on the other wire.
- From the place of the first derailment sign in the opposite of the running direction of the train were performed with the rail measuring pattern checks of the gauge (E) and of the cross level of the path (N), in points having the equidistance of 2.5 m. Also were performed on the derailed area, placed after the point “o”. The values of these measurements are listed in table no. 1:
- the measurements were performed with the rail measuring pattern type ROBEL in the equipment of ISF Cluj.

On the wire on the left, the first falling sign is noticed at about 0.65 m from the corresponding point of the mechanic joint on the other wire. Further, it is noticed on the first 5-6 m from the derailment signs of rolling on metallic plates and on the vertical bolts from inside the path, then on the sleepers between the path wires and also outside the path (on the right in the running direction).

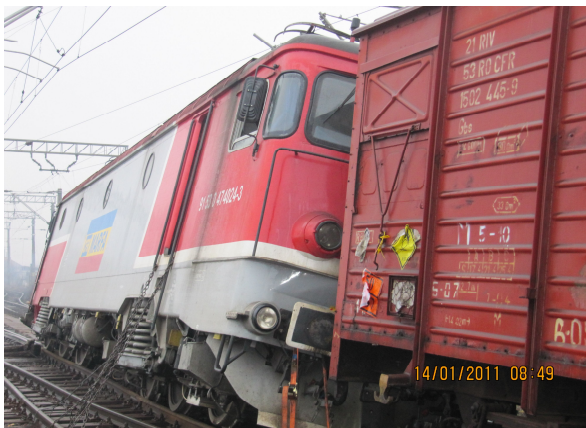
- the locomotive ED nr. 91530474024-3
 - derailed in the area of the connection rail of the switch needle 21A attacked to the heel,
 - the wheels on the left in the running direction derailed and suspended and those on the right were derailed and at about 1 m outside the rail on the right. The last were buried in the prism of broken stone;

- plow of the locomotive was leaning on the cable channel of SCB installation;
- the locomotive was vertically inclined to the right in the running direction at about 35°- 40°;

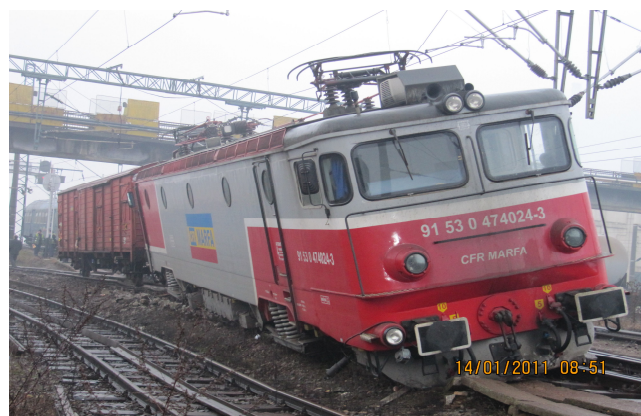
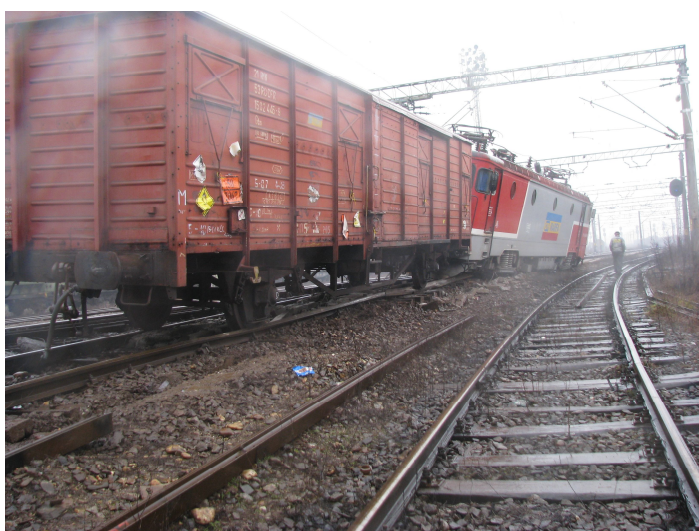
- wag. no. 21531502445-9
 - derailed by both axles;
 - the first axle suspended as consequence of the impact pads action on the right in the running direction;
 - the air front valve of the general pipe pulled and with the thread damaged because of the pull;
