ROMANIAN RAILWAY INVESTIGATING BODY

## INVESTIGATING REPORT

on the railway accident occurred on the 15<sup>th</sup> of November 2010  
on the range of activity of CF Craiova Regional Branch in the flag station Galateni

*FINAL EDITION  
The 4<sup>th</sup> of April 2011*

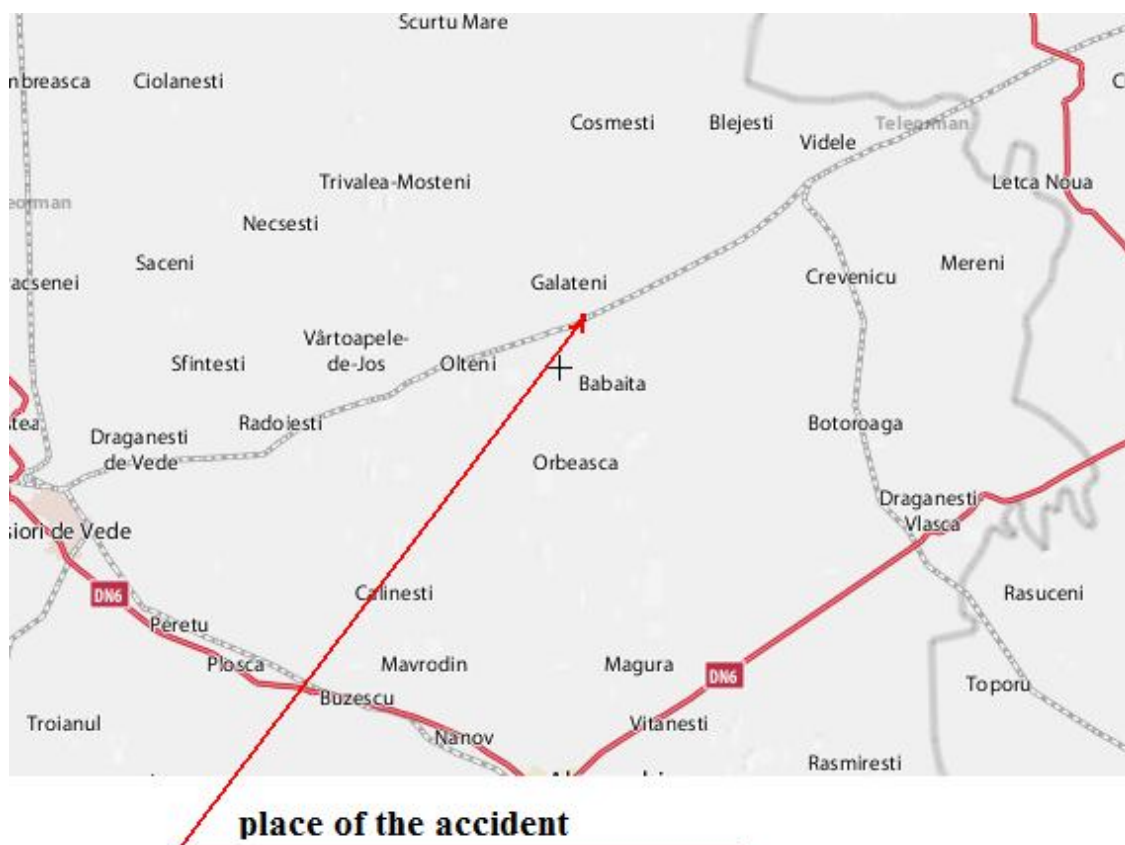
On the **15<sup>th</sup> of November 2010**, at **4:25a.m.**, on the range of activity of **CF Craiova Regional Branch**, in the **flag station Galateni**, a railway accident occurred consisting of **the derailment by the second bogie in the running direction of the wagon no. 31835300065-2** (the third by locomotive) in the composition of the **freight train no. 60182-1** (belonging to the railway undertaking SC Grup Transport Feroviar SA), on the area of the switch no. 7 from the X end of the flag station.

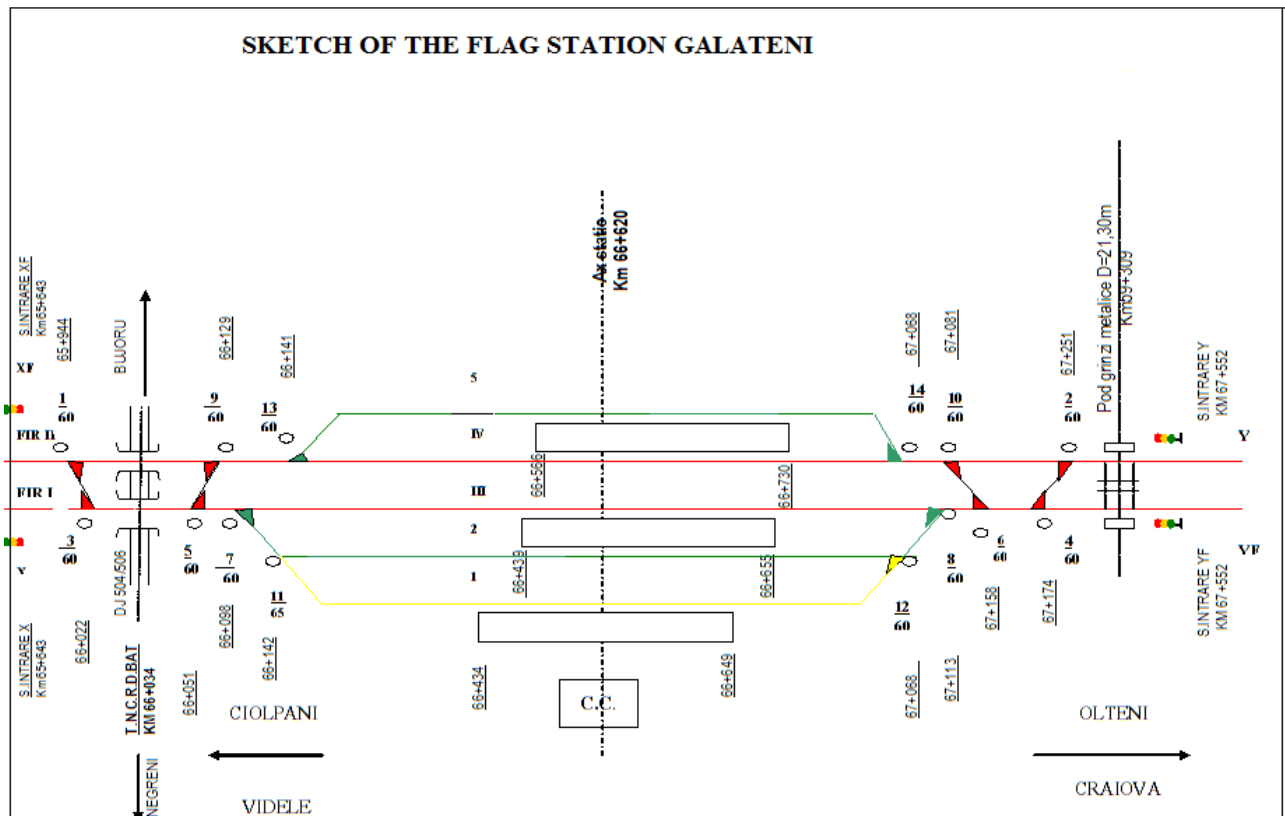
The wagon ran in derailed condition about 200 m, stopping at km 66+320, due to the emergency braking occurred as a result of the braking of the traction bar from this wagon and then of the general air pipeline from the wagon no. 35835320206-4 (first wagon by the derailed one – the fourth by locomotive).

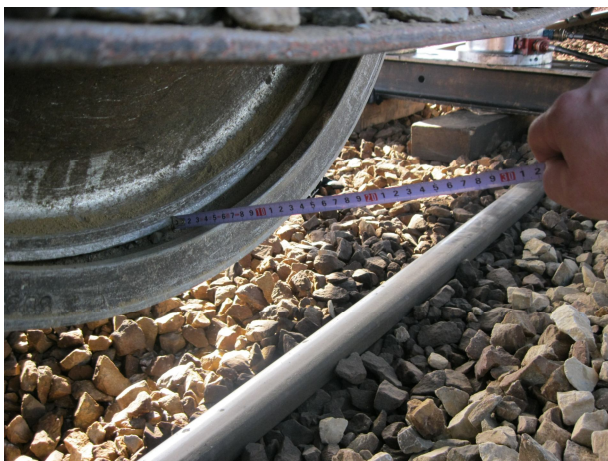
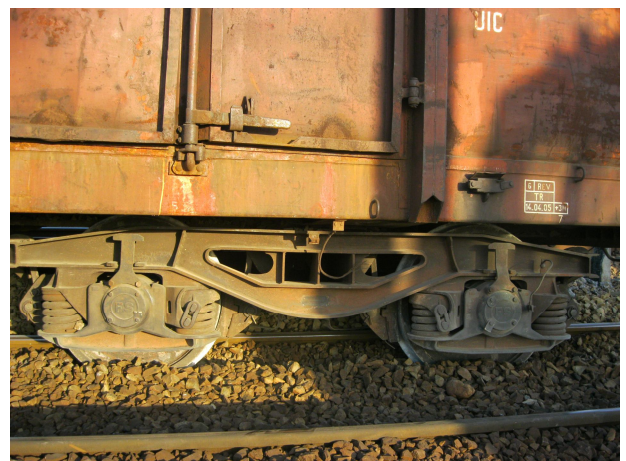
**The direct cause** of the accident is the axial movement of the wheel no. 6 bandage on the wheel rim, which led to the derailment of the mounted axle corresponding to wheels no. 5-6 of the wagon no. 318353000065-2.

- the wagon no. 31835300065-2, the third by fuse – was derailed by the second bogie in the running direction (the bogie corresponding to axles 3-4);
- at the wheel no. 6 (from the first axle in the running direction of the derailed bogie) was found that the bandage was axially displaced on the wheel rim and between the bandage and the rim were signs of strong friction (metallic luster);

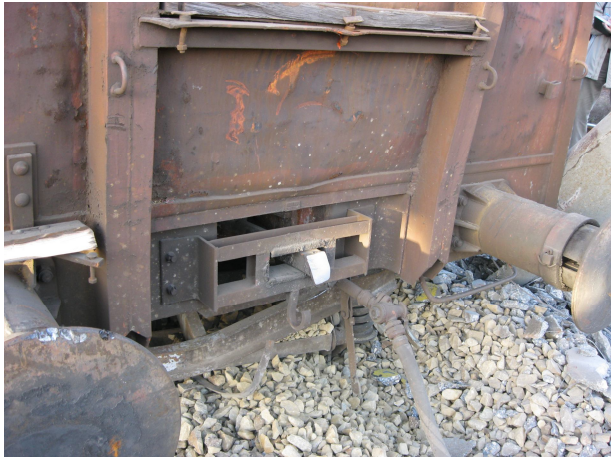
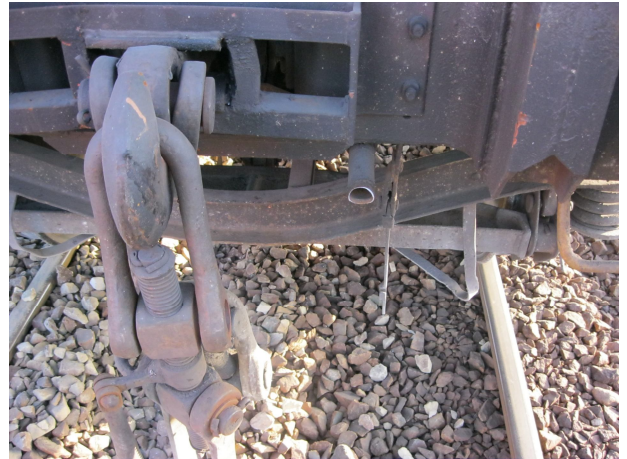
- all the brake shoes of the involved wagon had dimensions within the limits provided in the specific regulations;
- the shoes and the bandage of the wheel no. 6 did not have signs of overheating as a result of braked running;
- the rod of the traction hook in the end from the train signal had a 100% new break;
- the general air pipeline was broken next to the supporting clamp in the end of the wagon no. 4 in the composition, to the derailed wagon (section 100% specific of the new break).

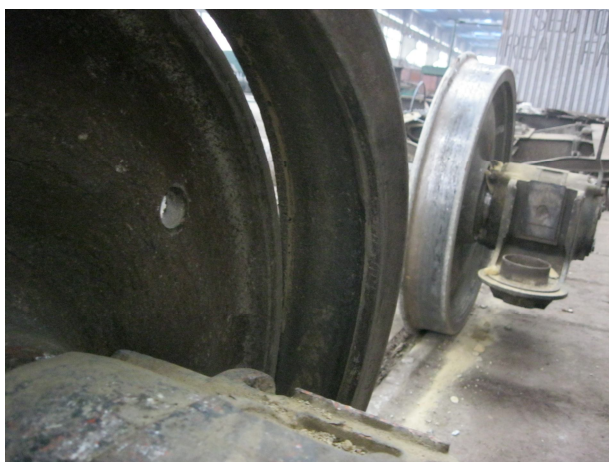
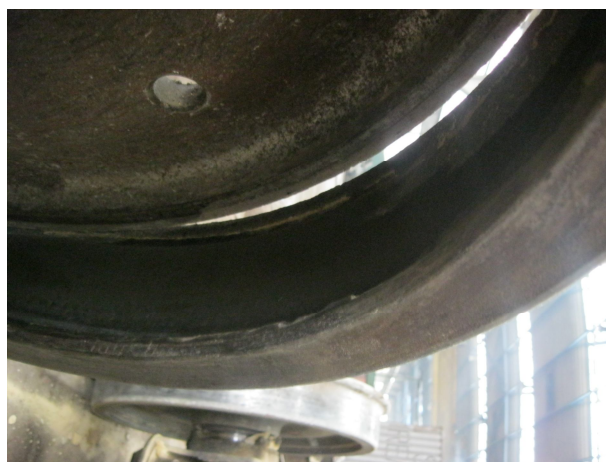
- in the axle boxes dismantled (wheels 5 and 7) was found grease in sufficient quantity and with unchanged color and smell;
- at the wheel no. 6 were found the following:
  - the circlip mounted between the bandage and the rim was polished to the upper side of the mounting channel from the bandage, due to the rotation of this bandage on the rim;
  - on the two tightening surfaces on the rim and on the bandage is a sign of strong friction with avulsion of material.

- the bandage width in the rolling circle plan from the wheel no. 6 of the wagon no. 31835300065-2 being close to the minimum value admitted by the *Instructions on technical inspection and maintenance for wagons in operation no. 250/2005 (30 mm)*, corroborated with the operation time of the mounted axle (40 years), favored the dismantle of the bandage from the wheel rim;
