MINISTRY OF TRANSPORTS AND INFRASTRUCTURE
ROMANIAN RAILWAY AUTHORITY - AFER

ROMANIAN RAILWAY INVESTIGATING BODY

INVESTIGATING REPORT

on the railway accident
occurred on the 20th of May 2011 in the railway station CFR Gheorghieni on the range of activity of
CFR Brasov Regional Branch

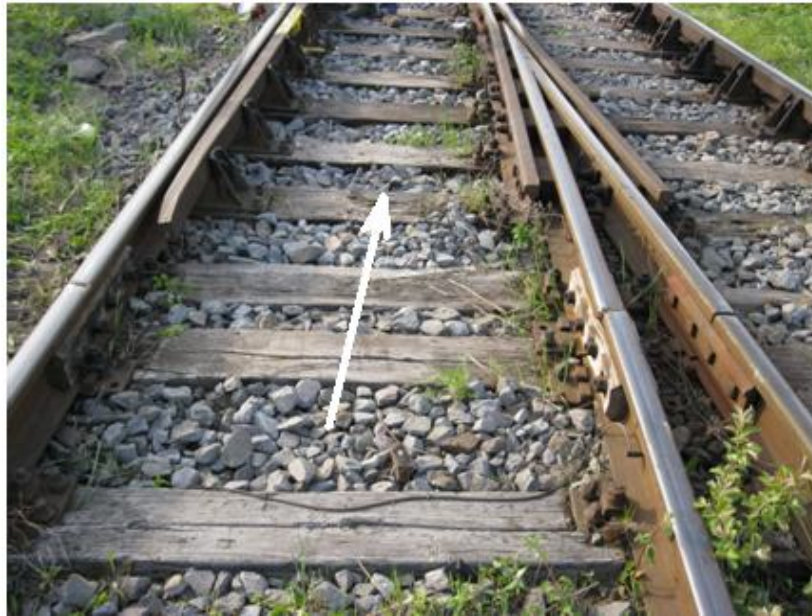
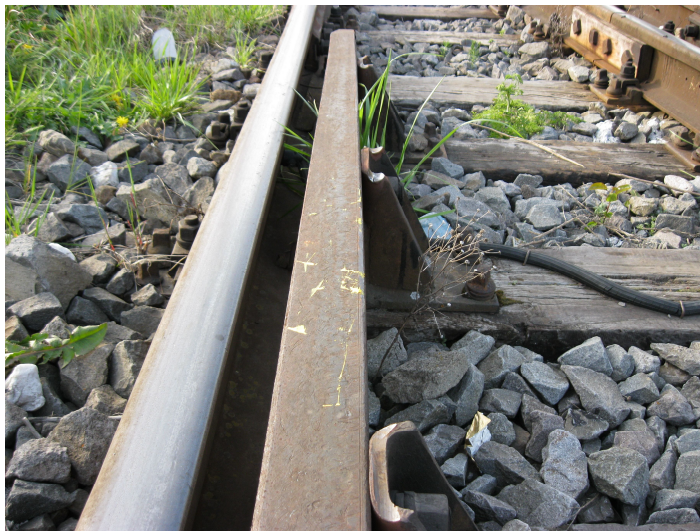
When the wheel on the right of the first axle of the first bogie of the locomotive hit and escalated the end of the graft rail of the crossing core of the switch no. 6 from the direct, the bandage rim of the wheel on the left of the same axle hit the end from the transition coupon of the checkrail near the core from the direct, escalated the checkrail and rolled on its top side to the area of the first 3 supports of the checkrail from the top joint of the core.

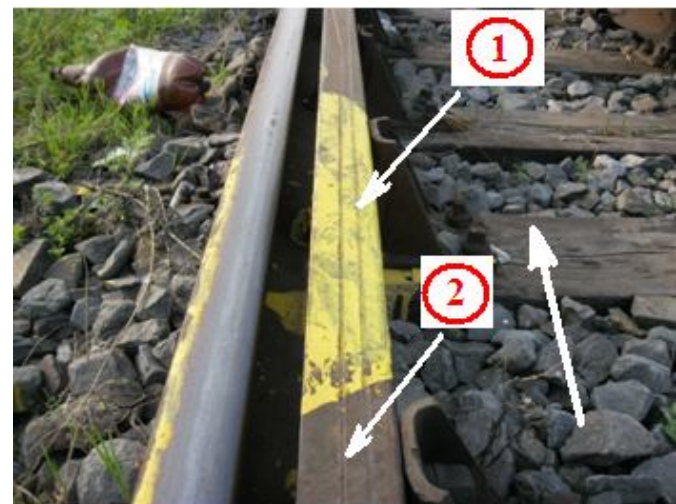
The axle no. 3 of the first bogie of the locomotive rolled with the bandage rim of the wheel on the left on the top side of the checkrail near the core from the direct, to the middle of this checkrail, then it went towards the rail on which was fixed this checkrail, rolling normally on it. As long as the bandage rim of the wheel on the left of the 3rd axle of the first bogie of the locomotive rolled on the top side of the checkrail near the core from the direct, the wheel on the right of the same axle was suspended. After getting back on the rail of the wheel on the left, the wheels of the 3rd axle rolled normally to the stop of the train.

- 1 – sign left by the bandage rim of the wheel on the left of the first axle of the first bogie
- 2 - sign left by the bandage rim of the wheel on the left of the 3rd axle of the first bogie

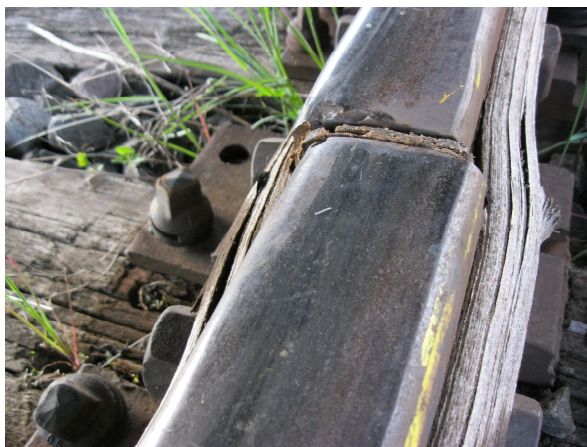
The escalation of the crossing core of the switch no. 6 by the wheel on the right of the first axle of the locomotive (in the running direction of the train) occurred at the joint on the right from the core heel on the direct of this switch.

photo no. 1 – joint on the right of the running direction where occurred the escalation

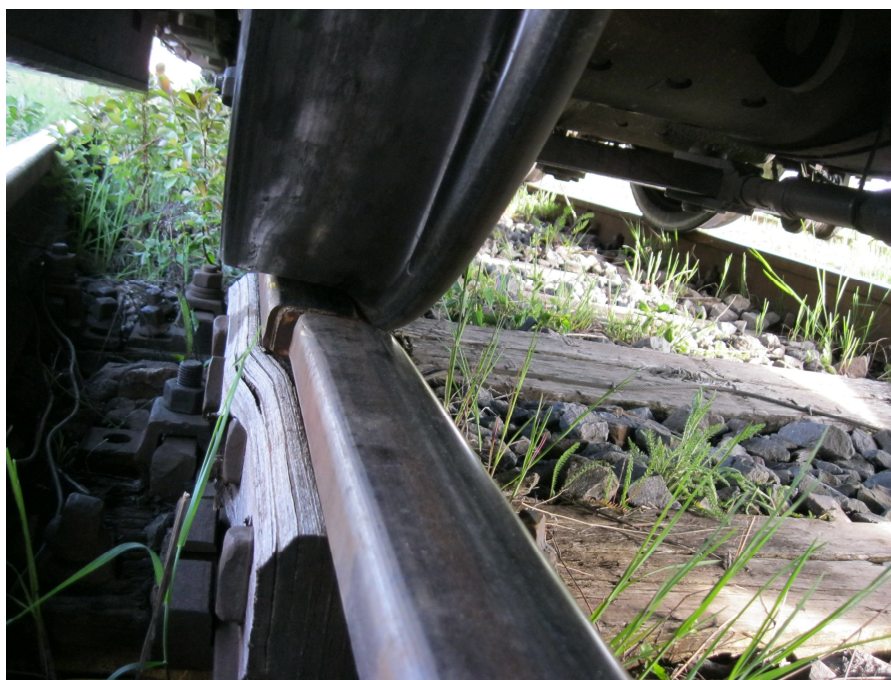
photo no. 2 – forming of the side threshold at the passing of the rolling stock

After the checks performed in static condition with the rail measuring pattern of the gauge and of the cross level on the two rails ends composing the heel joint of the crossing core of the switch no. 6 (the lignopholium joint), was found that between the gauge values was a difference of 8 mm, as consequence of the side threshold created.

This side threshold determined the escalation by the bandage rim of the wheel on the right of the first axle of the first bogie of the locomotive, of the rolling surface of the graft rail of the crossing core of the switch no. 6.

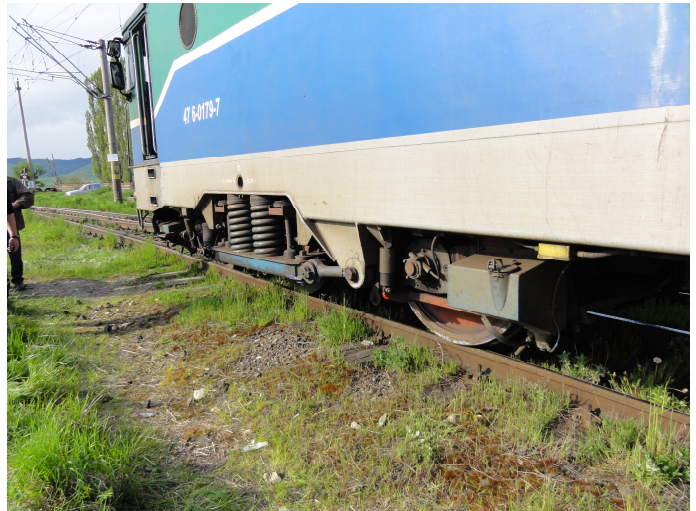
- the locomotive EA 179 was stopped on the diagonal 2-6 with the first axle of the first bogie derailed at about 1.8 m before the heel joint of the core of the switch no. 2, the other axles of the first bogie not being derailed.
- the sides of the wheels on the left of the axles no. 1 and no. 3 of the first bogie had friction signs.

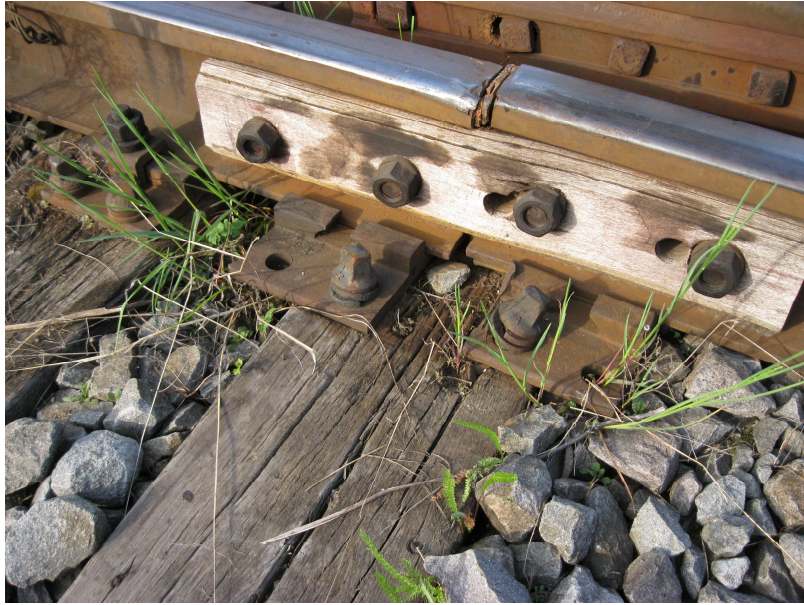
In the area of the heel joint of the core on the direct, on the right in the running direction of the locomotive the inappropriate technical condition of the sleepers and of the assembly “joint” was inappropriate, which favored the forming of a side threshold, escalation of the rolling surface of the core graft rail by the bandage rim of the wheel on the right of the first axle of the first bogie, its rolling to the top of the core, followed by its fall on the right of the side rail.

photo no. 5 - technical condition of the joint which favored the escalation of the rail by the bandage rim of the wheel on the right in the running direction of the locomotive

B.7.1. The direct cause of the occurrence of this accident was the side threshold created at the insulating joint (of polarity) near the expansion joint between the rail end on the right of the transition panel 49/60 and the rail end on the direct from the heel of the crossing core of the switch no. 6, which allowed the escalation of the rolling surface of the graft rail of the core by the wheel bandage rim on the right of the first axle of the first bogie of the locomotive, the rolling of the bandage rim of this wheel on the rail head to the top of the crossing core, followed by the fall of the wheel on the right of the side rail.

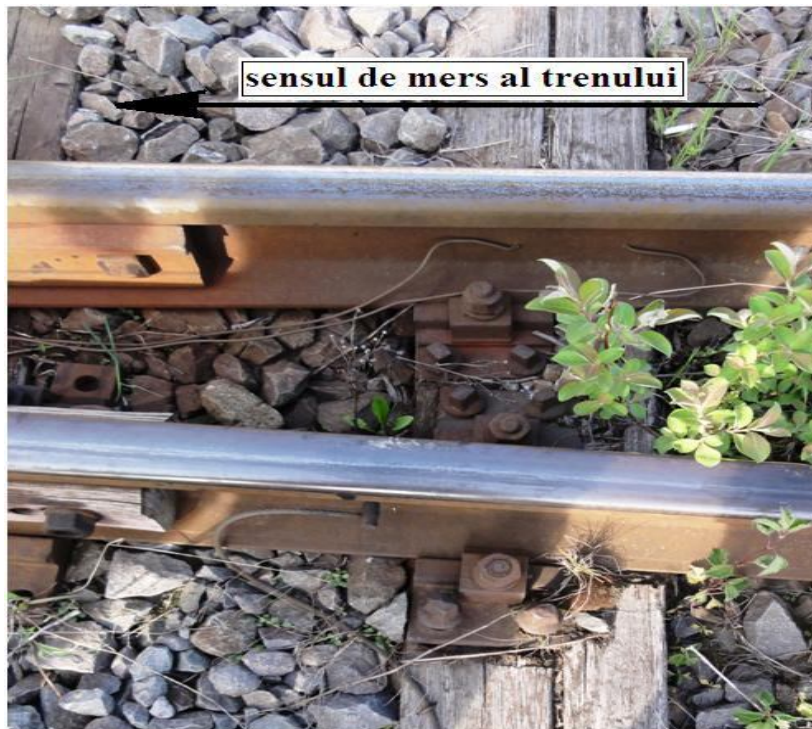
photo no. 6 - technical condition of the sleeper before the joint where the escalation occurred

- the mechanic wear of the top side of the sleeper next to the joint of the insulating joint and of the next sleeper on the transition coupon 60/49 from the switch no. 10;
- the untighten coach screws at the metallic plate on the right of the sleeper placed before the polarity joint;
- the horizontal screws from the polarity joint, which had the ends buried in the straps body on the right of the joint;
