ROMANIAN RAILWAY INVESTIGATING BODY

## INVESTIGATING REPORT

on the railway accident  
occurred on the 18<sup>th</sup> of April 2011 in the railway station CFR Jianca

Final edition  
The 15<sup>th</sup> of December 2011

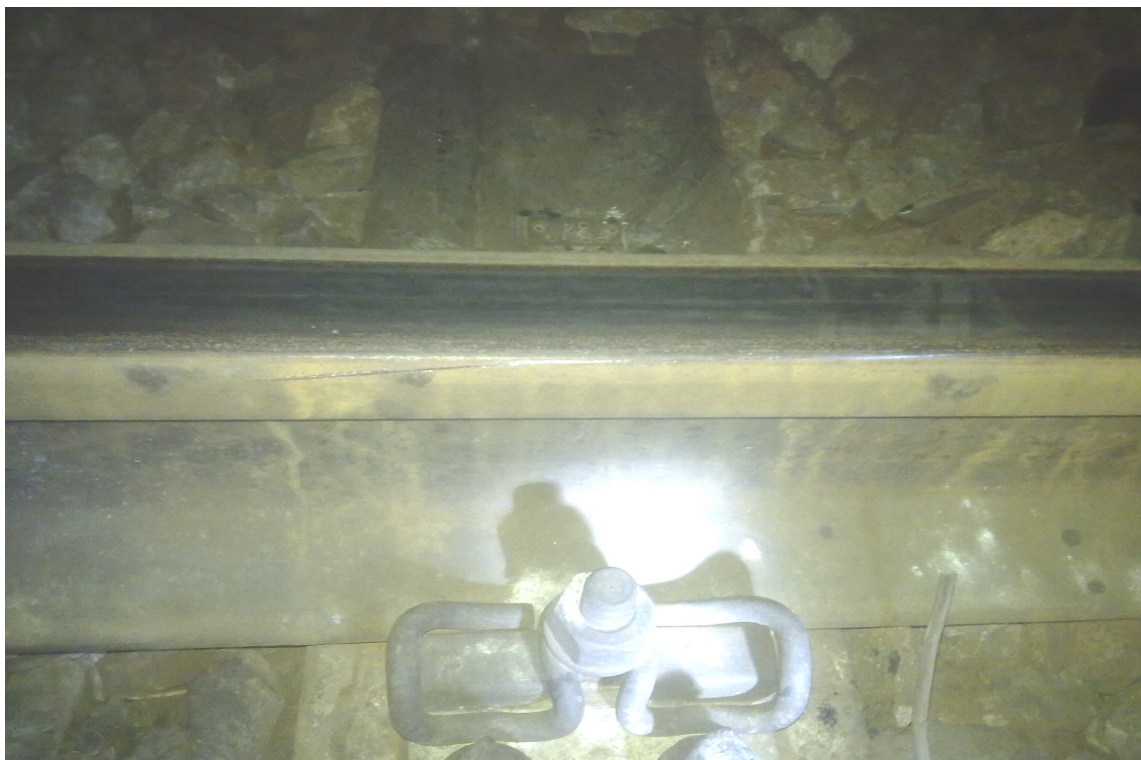
The point where occurred the escalation of the rail on the outer wire of the curve of the switch no. 7 by the wheel on the left of the first axle of the locomotive (in the running direction of the train) is located on the curve of this switch.
