INVESTIGATING REPORT

**to establish the conditions and determine the causes that led to breaking a large number of rails, during 2010-2011,
on the range of activity of C.F. Iasi Regional Branch – Section L4 Bacau, on the main line no. 500, on the lines I and II between the railway stations Adjud and Bacau**

*Final report
The 23rd of January 2012*

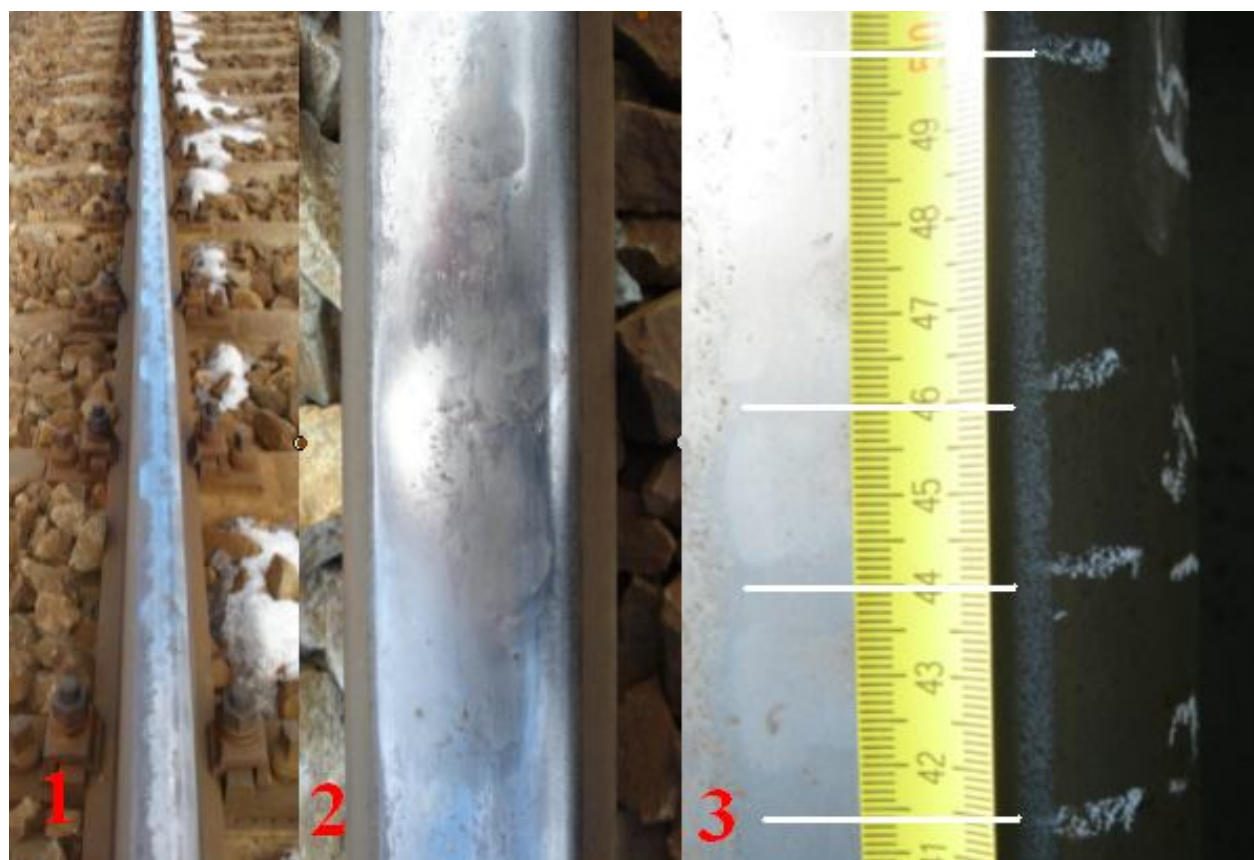
The defect corresponds to that identified with the symbol 49.2a of the Instruction to determine the rails failures and to check the rails in the path no. 306/1972 and is of category III.

photo no.1- ondulatory wear line II Km 248+335 the rail on the left

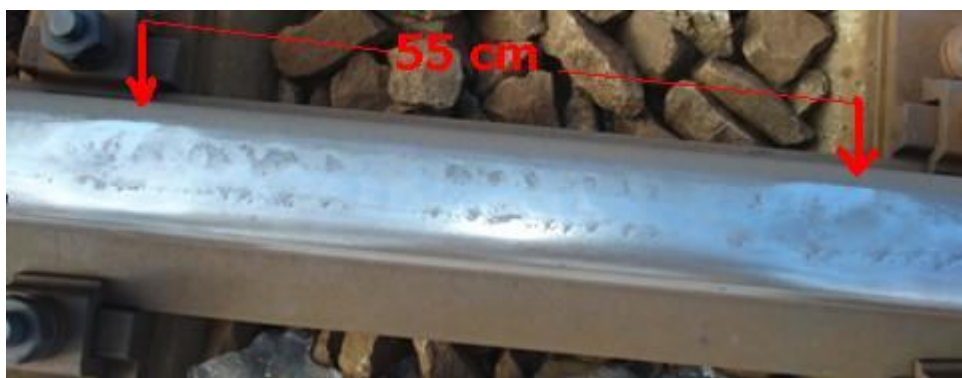
The concave parts of the ondulatory wear develop and occur more visibly on the lateral side along the rail, at the inner side of the line. The distance between the concavities is of 50-60 cm. In this stage the defect corresponds to that identified with the symbol 40.2a of the Instruction to determine the rails failures and to check the rails in the path no. 306/1972. If the concavity depth is lower than 2 mm the defect is of II category.

*photo no. 2- concavities arrangement line II Km 248+335
the rail on the left*

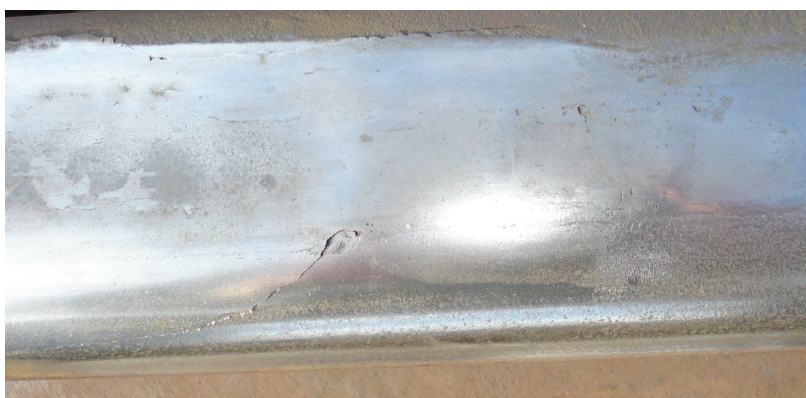
*photo no.3 – the occurrence of the cracks in concavity (type squats)
line II Km 248+080 the rail on the left*

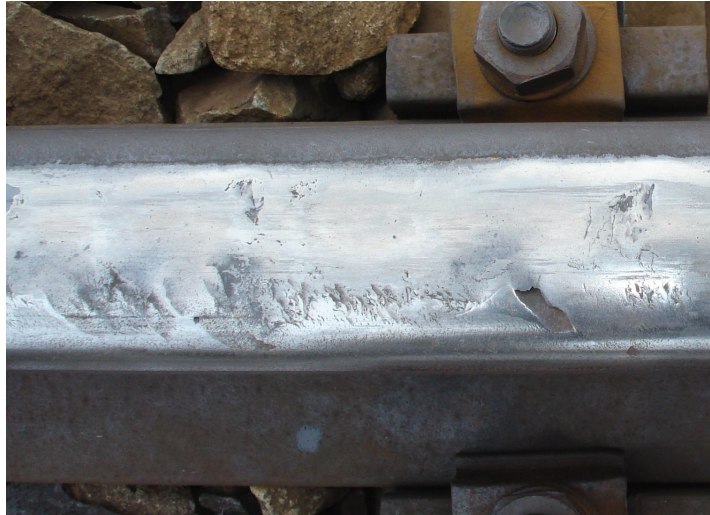
These cracks grow and develop more and more gaining the appearance of inclined cracks type “head checks”.

*photo no.4 – the occurrence of the inclined cracks (type head checks)
line I Km 248+080 the rail on the right*

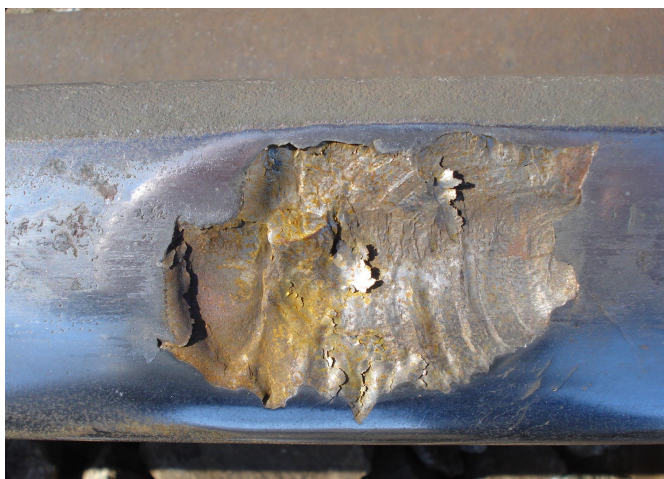
The holes in the rolling surface of the rail, corresponding to the concave areas of the ondulatory wear, develop by crack propagation and material exfoliation from the rolling surface. The size of the hole can progress reaching 3-4 mm - photo no. 6.

*photo no. 6 – the vertical expansion of the cracked concave areas
line II Km 256+670
the rail on the left*

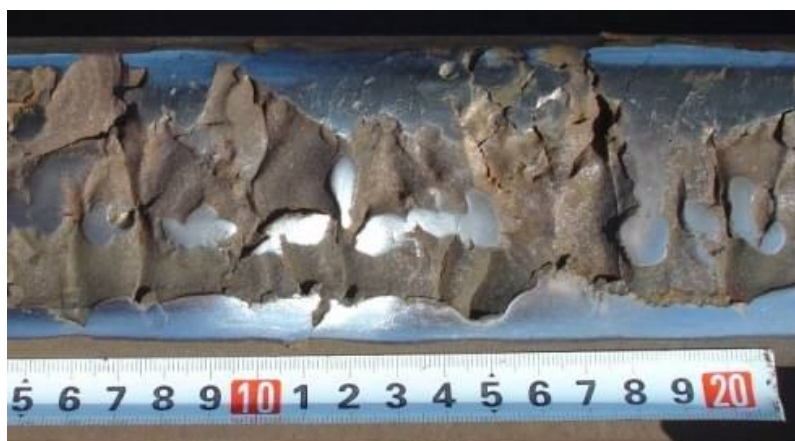
In these stages the defects corresponds to that identified with the symbol 40.2c of the Instruction to determine the rails failures and to check the rails in the path no. 306/1972 and corresponds to a defect of category I - photo no. 7.

*photo no.7- the horizontal expansion of the length of the cracked concave areas
line II Km 256+200
the rail on the right*

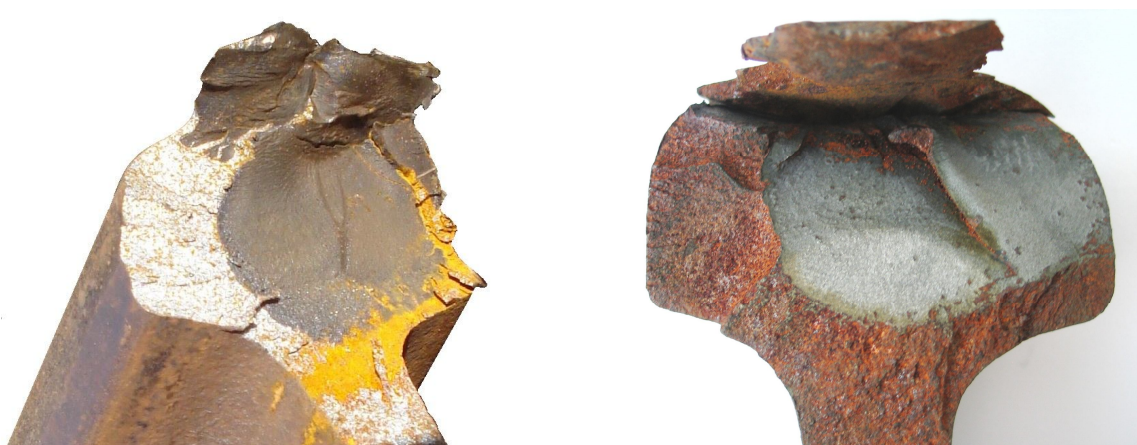
- a layer of 2-5 mm where developed the cracks, situated on a well defined boundary glossy and ribbed at the bottom;
- the existence of a black spot (of oxidation) or a silver one at the top of the breaking section; - photo no. 8

photo no.8 – breaking cross sections

It is observed the crack start area, the crack propagation area with smooth glossy aspect and the final breaking area with granular crystalline aspect.

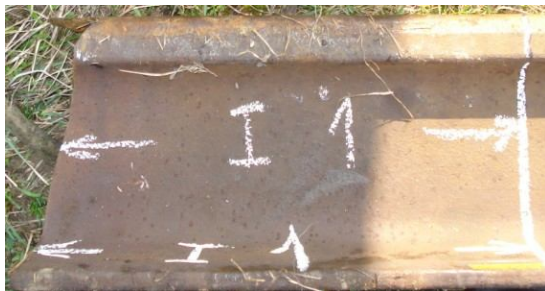
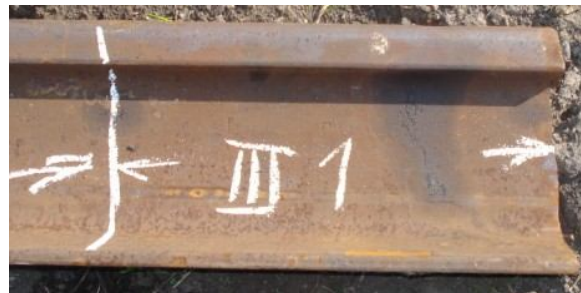
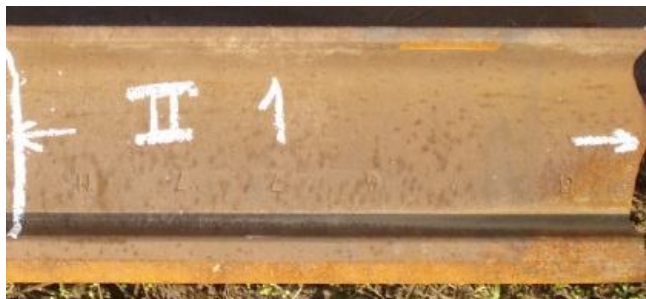
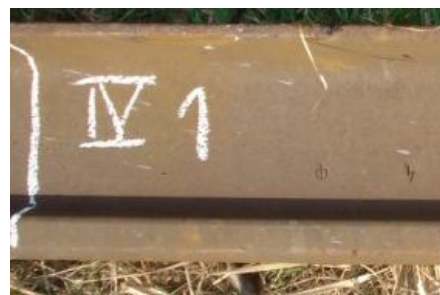
Photo no.10 – rail coupons that have the defect included

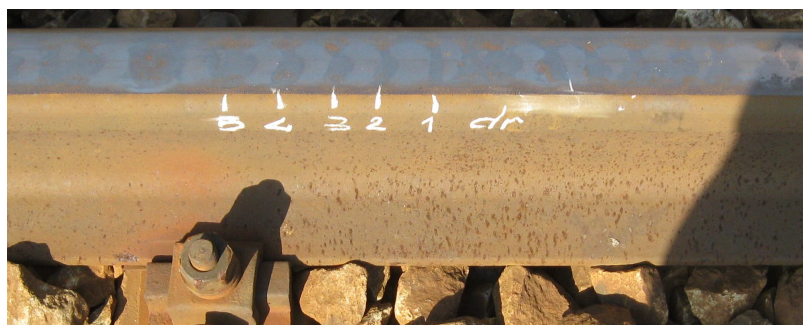
photo no. 11- km 248+340 wire II rail on the right

In figures 11 and 12 is shown the area measured on the right wire of the current line wire II between the railway stations CFR Adjud-Sascut from the km 248+340 - photo no. 11

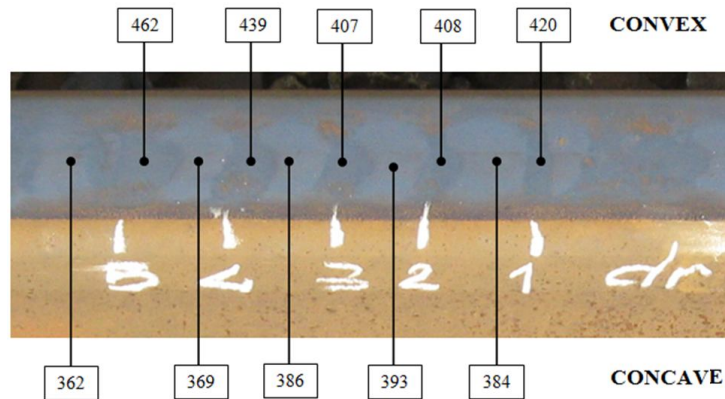
photo no.12 - km 348+340 rail on the right

The hardness on the running surface of the rail was measured in the elevated points (convex) and in the fallen ones (concave) of the deformed surface - photo no.12.

The measured values confirm that the convex points have higher values than the ones measured in the concave points.

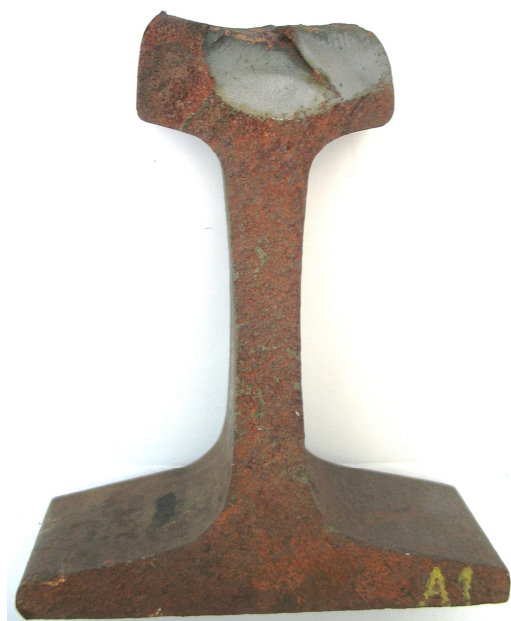
photo no. 21. – Sample coupon A1

In the rail-head associated to sample A1 it is noticed an area of **breaking at fatigue** (with fine granulation, in two shades of gray) on about 20% of the breaking surface. The last portion of the breaking, with large granulation, is characteristic to a sudden breaking.

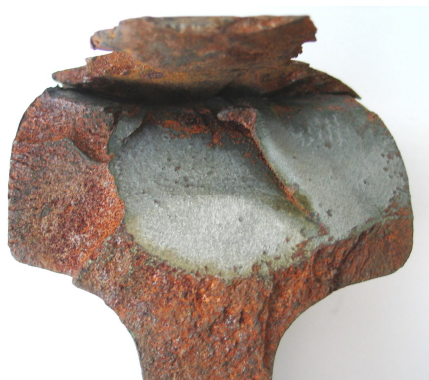
photo no. 22. – breaking outbreak at fatigue sample A1

The breaking outbreaks at fatigue consisted of cracks started and developed from the running surface.

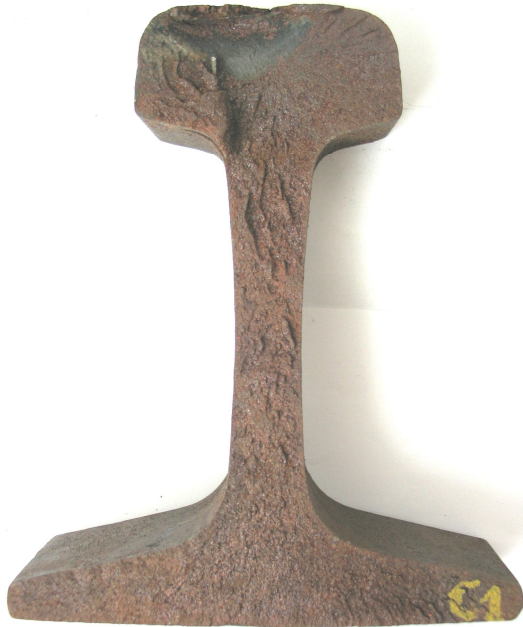
photo no. 23. Sample coupon C1

In the rail-head associated to sample C1 it is noticed an area of breaking at fatigue (smooth) on about 12% of the breaking surface. The last portion of the breaking, with coarse granulation and material bond, is characteristic to a sudden breaking.

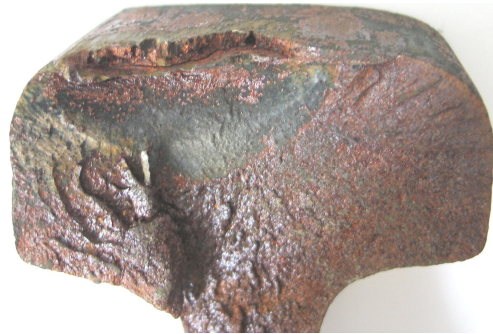
*photo no. 24. – Breaking outbreak
at fatigue sample C1*

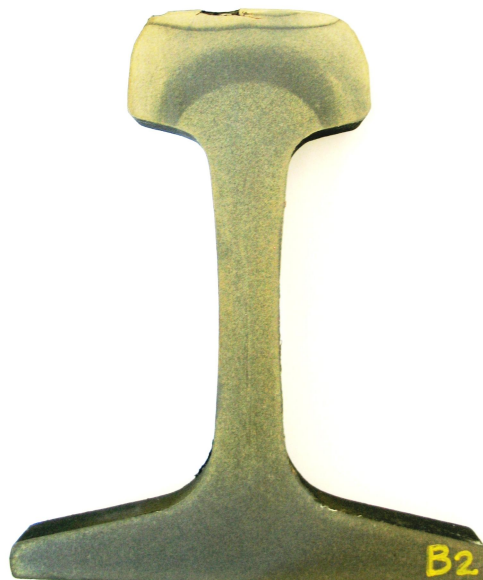
photo no.25. – sample coupon B2

For the samples taken from the body of the 7 coupons it was highlighted an area with thermal treatment applied at the upper half of the rail-head highlighted through a concave dark color band of about 7...10 mm thickness.

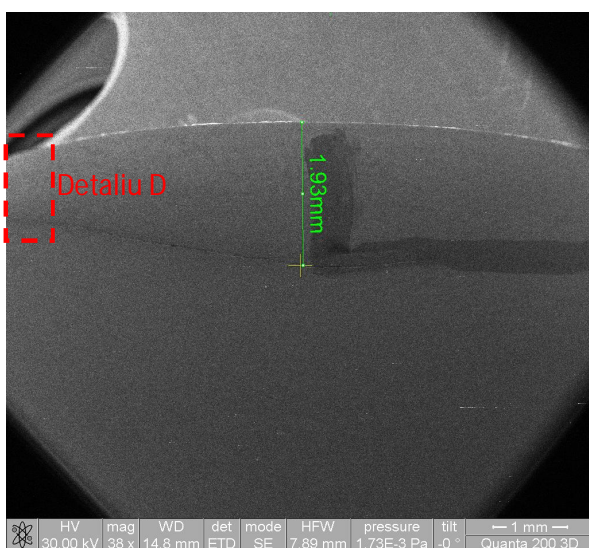
photo no. 61. Area C. Aspect of the crack placed at 1-2 mm from the rolling surface (38x)

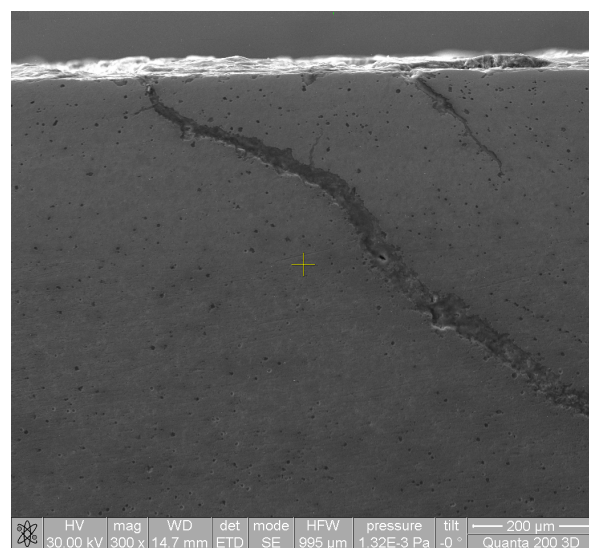
photo no. 62. Detail D – fig. 10. Aspect of the crack (300x)

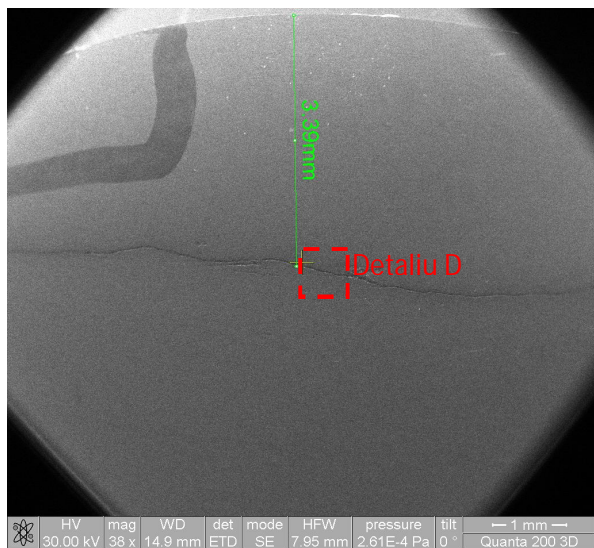
photo no.73. Area C. Aspect of the crack placed at 3-4 mm from the rolling surface (38x)

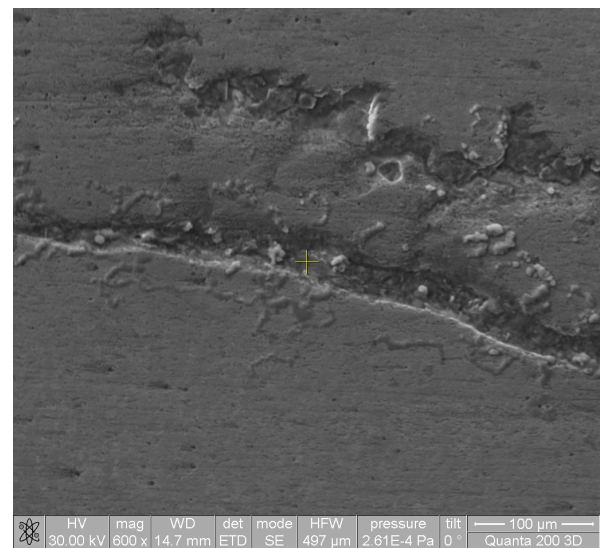
photo no. 74. Detail D – fig. 21. Aspect of the crack (600x)

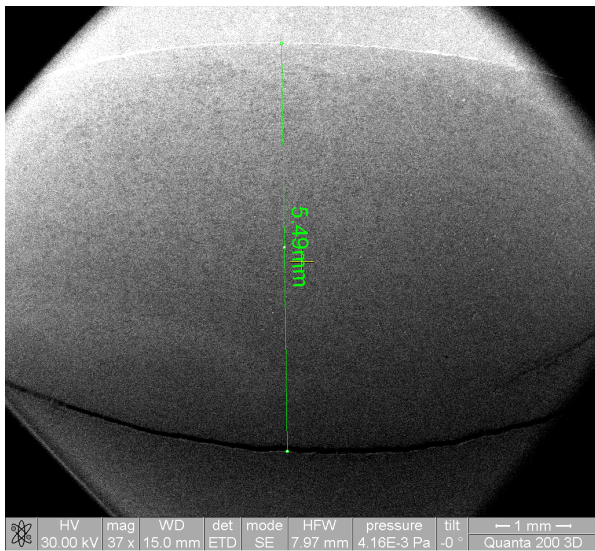
photo no. 80 Area C. Aspect of the crack (24x)

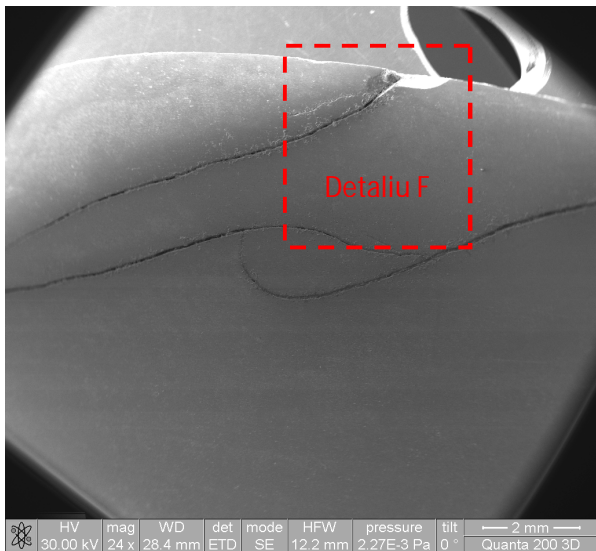
photo no. 81. Area D. Aspect of the crack (24x)

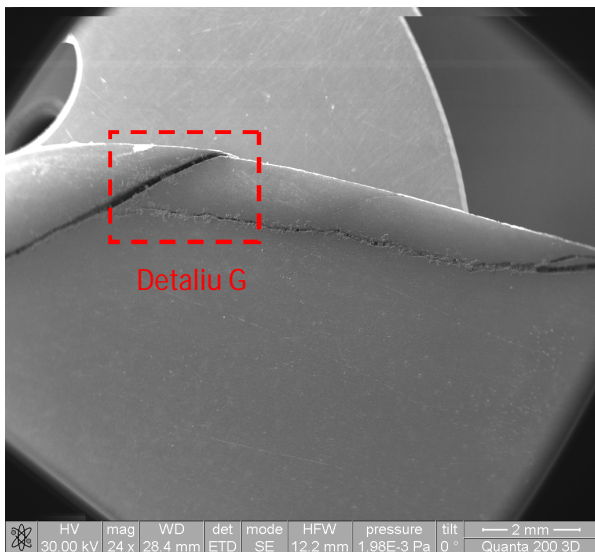
photo no. 82. Area E. Aspect of the crack (24x)

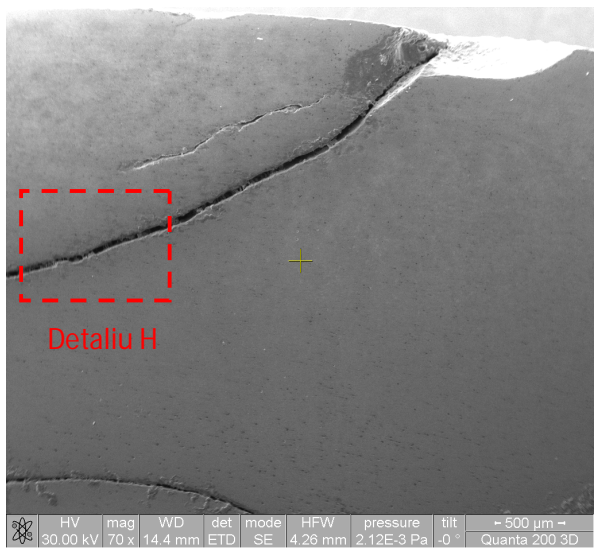
photo no. 83. Detail F – fig. 81. Aspect of the crack (70x)

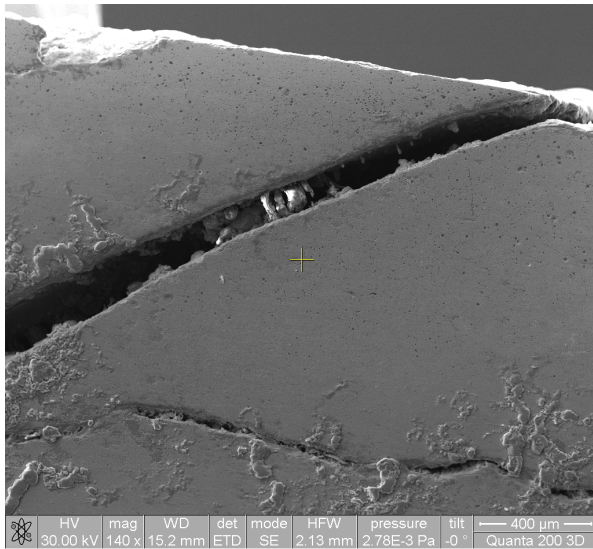
photo no. 84. Detail G – fig.82. Aspect of the crack (140x)

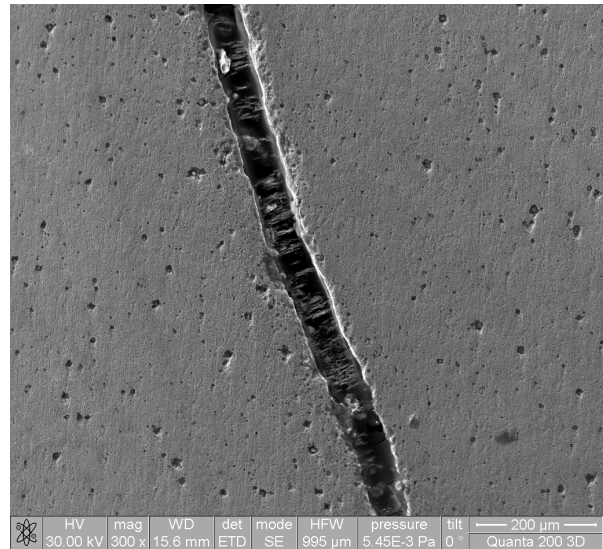
photo no. 85. Detail H – fig. 83. Aspect of the crack (300x)
