MINISTRY OF TRANSPORTS AND INFRASTRUCTURE  
ROMANIAN RAILWAY AUTHORITY - AFER

ROMANIAN RAILWAY INVESTIGATING BODY

## INVESTIGATING REPORT

of the railway accident  
occurred on the 30<sup>th</sup> of August 2010 at the entry to the railway station CFR Livezeni

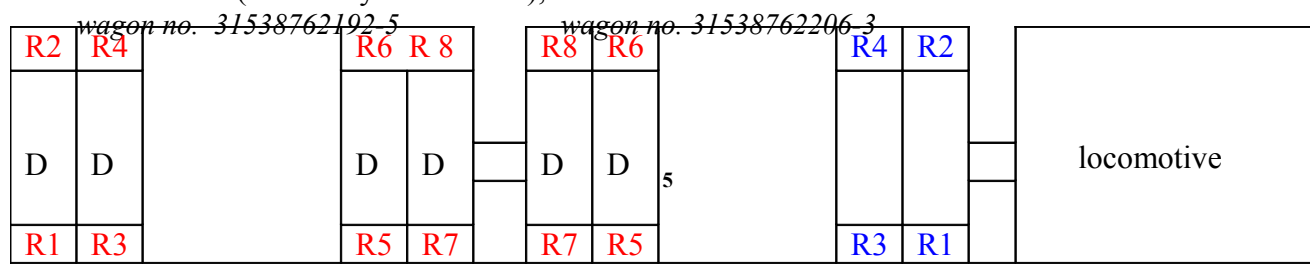
At the train crossing over the diagonal 10-18, at about 60 m before the joints of the switch no. 18 in direct position, occurred the derailment of the wagon no.31538762206-3 (first by locomotive) from the second bogie in the running direction and the derailment by both bogies of the wagon no. 31538762192-5 (second by locomotive), as illustrated below:

*note: D = derailed axles*

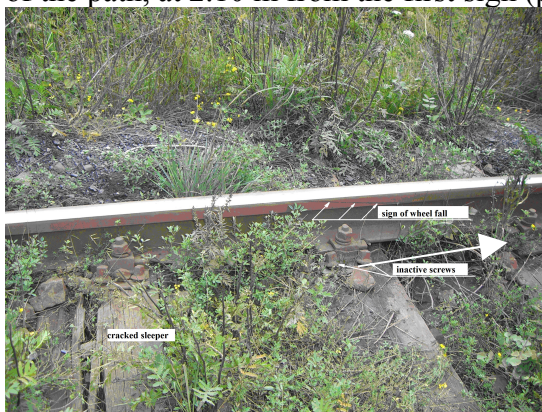
point 1

The first sign of derailment (fall of the wheel 5 within the path - point 1) was observed on the left rail wire path in the running direction of the train, at km 83 + 520 (to the end of the circular curve). The second sign of derailment (in fact fall of the wheel 6 on the upper side of the rail and not escalating the rail - point 0) was observed on the rail wire on the right side of the path, at 2.10 m from the first sign (point 1) in the running direction.

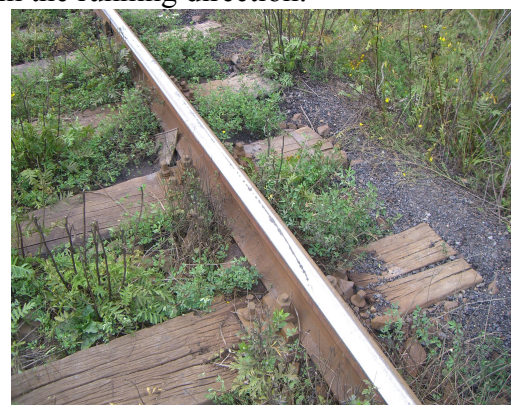
point 0

- joints made of beams 6 and 7 is muddy with water stagnation in the ballast prism
- measurement from point 0, point situated at 2.10 m from point 1, where the wheel 6 felt on the upper side of the rail, was made on the 31<sup>st</sup> of August 2010 in the presence of the main investigator and the OTF delegate.

- on the 31<sup>st</sup> of August 2010, on the distance of 2.10 m between points 1 and 0 has been established that there aren't lateral movements on the sleepers of the whole rail / mounting plate, even if the coach screws are inclined. Under the metal plate are mechanical wear of the sleeper with plates embedded in the sleeper up to 7-8 mm (see photo above).

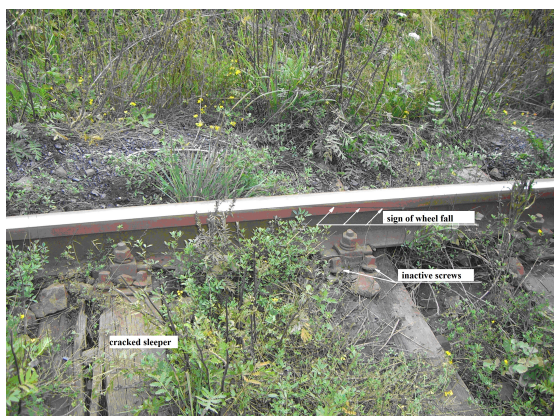
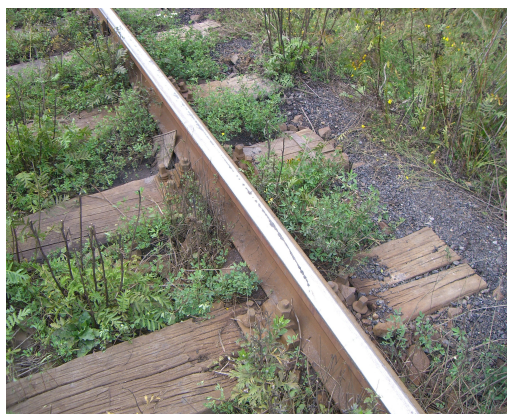
At the request of the railway undertaking there was made a further examination of the gauge and of the cross level on the derailed area at the point "0" at a distance of 2.10 m after point "1". From this point begin visible traces of fall on the rail upper side of the right side wheel.

On the areas between the measurement points no. 1-2 and no. 3-4 were found were found by 3 consecutive improper sleepers.

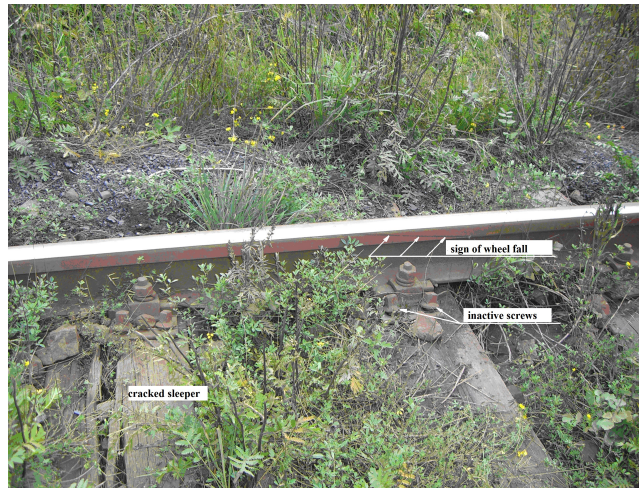
*clogged area with inappropriate sleepers and fastening*

- between the measurement points 3 and 4 is a muddy area with water stagnation in the ballast prism;
- between the measurement points 1 and 2 the wooden sleepers 2, 3 and 4 were inadequate, clamping plate sleeper being ensured with at least 2 coach screws;

- between the measurement points 3 and 4 the wooden sleepers 11, 12 and 13 were inadequate, clamping plate sleeper being ensured with at least 2 coach screws;

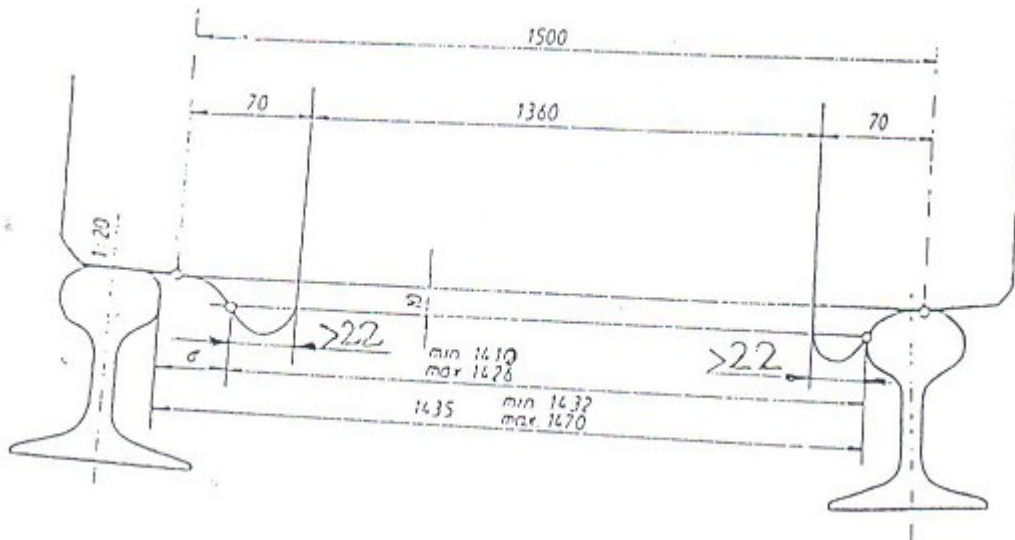
drawing no.1

In terms of guidance, putting the vehicle with the wheels rims between the two wires of the rail is ensured by the width of the guidance channel, that is by the existence of the total stroke  $\sigma$  between the wheel rim and the inner side of the rail, defined as the difference between the rail gauge and the axle gauge, as in drawing no.1.

The **minimum** admitted stroke of the axle in rail, corresponding to the situation when the rail gauge is of 1435 mm and the distance between the outer sides of the wheels rims is of maximum 1426 mm (rail and wheels with the running profile unused) is:  $\sigma = 1435 - 1426 = 9$  mm, plus the value of the rail over-enlarging in curves. For constructive reasons for this stroke is taken the value of **10 mm**.

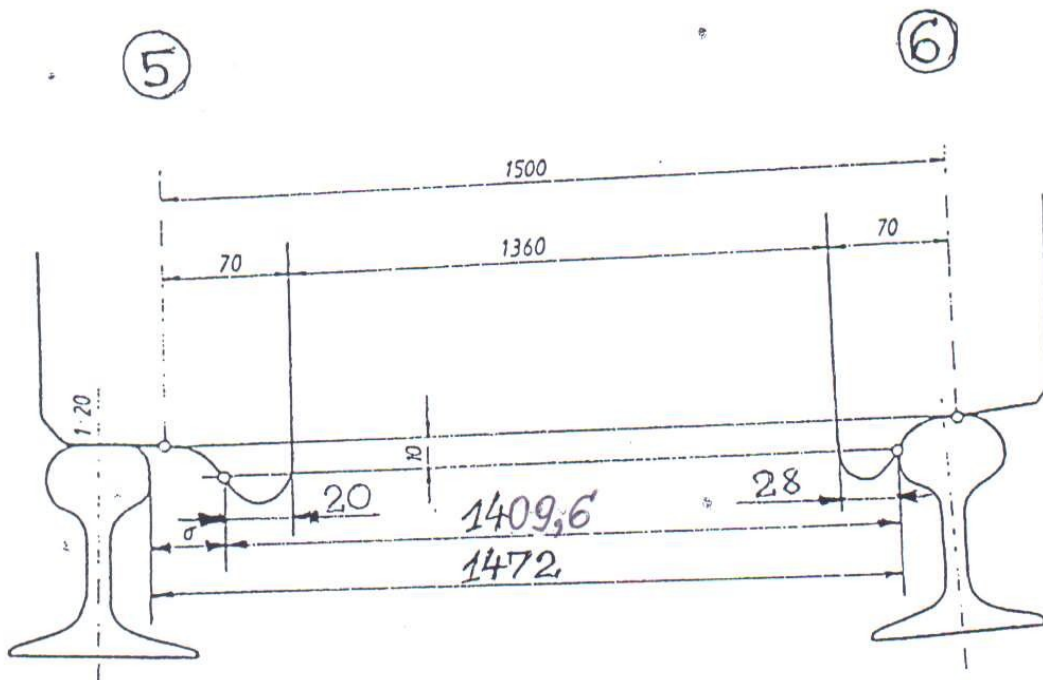
drawing no.2

Reducing the dimension of the axle gauge previously calculated with the value of the rail gauge measured with the rail measuring pattern, results that the axle with the wheels no.5-6, crossing over the point no. 1, had a total stroke in rail  $\sigma = 1472 - 1409.6 = 62.4 \text{ mm}$ , stroke due to the serious wear of the outside active flank of the rim of the appeal wheel no. 5 (groove tore of the rim of the appeal wheel no.5) and to the gauge in this point, according to drawing no.2.

In this case, the consumption of this total rail stroke of the axle – result of the inherent flexuosity movement of the axle while running led to a monocontact between the inner flank of the upper side of the rail on the left in the running direction and the wheel no. 6, on the one hand and a bicontact (situation characterized by the existence, in addition to the contact point on the running surface, of a contact point on the rim) between the inner flank of the upper side of the rail on the right in the running direction and the appeal wheel no. 5, on the other hand, as in the drawing no. 2, which made that the wheel no. 6 run on the surface on the outer running profile, characterized by maximum taper ( $< 1:15$ ).

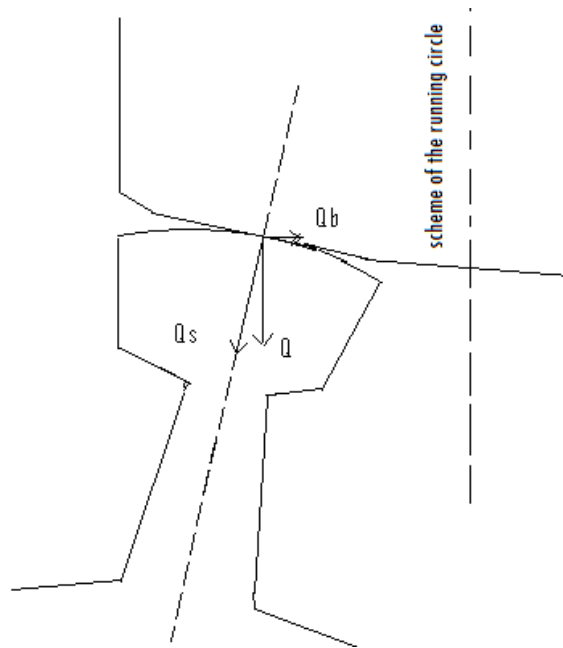
*drawing no. 3*

The running of the wheel no. 6 on the maximum taper surface of the running profile – possible due to the conjugated wears of the wheel rim and of the rail gauge – allowed the development of the horizontal force Qb at a level that exceeded the guidance capacity of the rail on the right in the running direction, practically canceling the recovery tendency of the axle in the rail and so causing the slip of the wheel no.6 from the rail on the left in the running direction, concluded by its fall in the inside of the path.

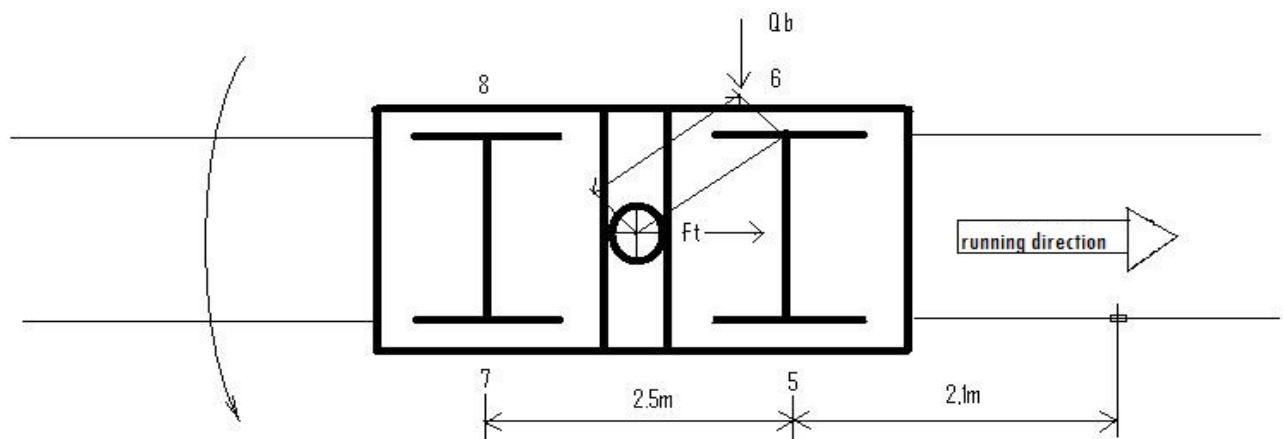
*drawing no.4*

Because the wheel no. 6 lost the contact with the rail and it came into contact with the sleepers, running over these, it put a strong resistance to forward, currently playing as a fix point, around which the traction force  $F_t$  transmitted through the pallet bolt created a pivoting moment, giving to the bogie a counterclockwise rotation movement, according to the drawing no.4

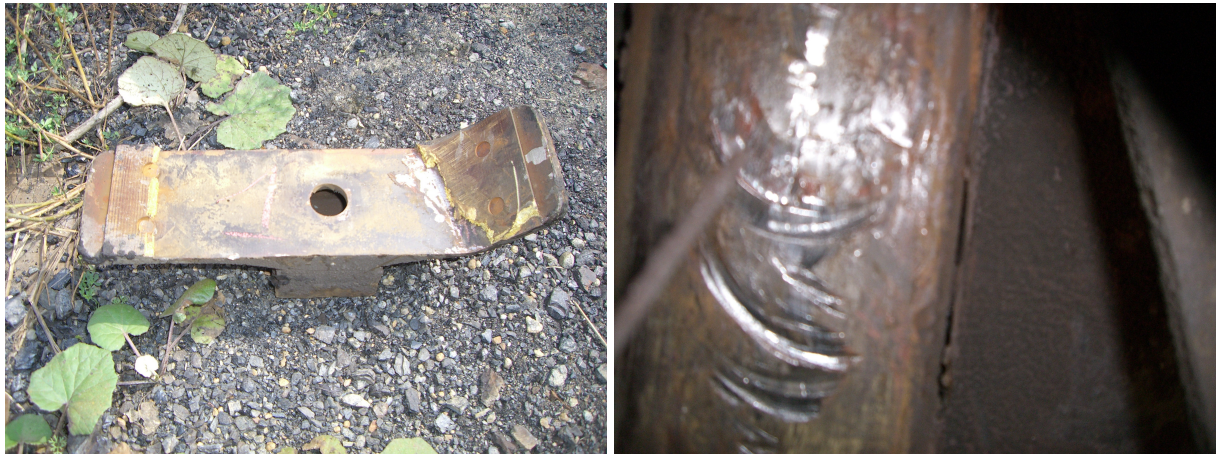
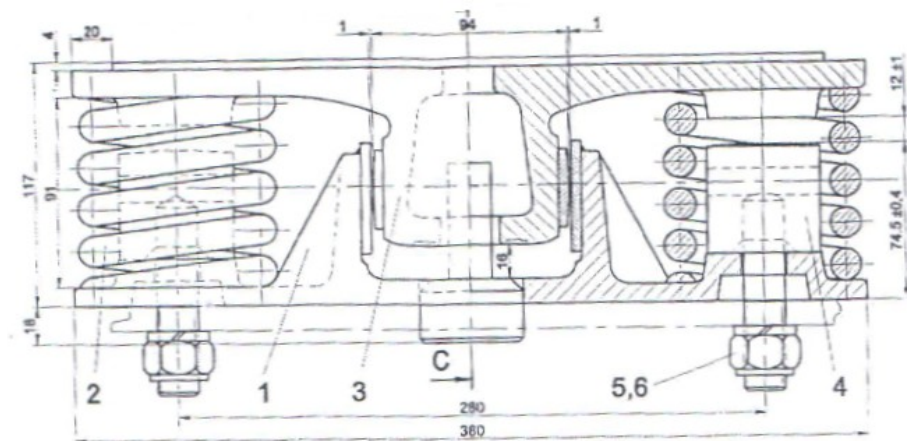
*drawing no. 5*

When the wheel no. 6 fell from the rail, the steady state of the bogie was damaged suddenly, from its four boundary points on the rail (materialized by the contact points with the rail of the wheels 5, 6, 7 and 8) remaining only 3 (the appeal wheel no.5 that was running with the bandage rim on the rail and the wheels no. 7 and 8), that determined a down movement of the bogie next to the disappeared support point (wheel no.6) which made that the slide holder on the bogie frame also move down and so to allow the upper slide holder to come out of its slot and the two springs to

In this case the upper slide holder, being out of the slot, is subjected to a crush between the pallet cross on the wagon chassis and the bogie frame, which creates a strong vertical deformation thereof and the spring located to the end of the wagon is bent by the rubbing stone on the chassis, causing a distortion of it in the running direction and the printing of the circular traces left by the top of this spring on the rubbing stone of the pallet cross of the chassis, as attached photos taken in the spot and the drawing no. 5.
