## INVESTIGATING REPORT

on the fire occurred on the 11<sup>th</sup> of May 2011 on the range of activity of CF Timisoara Regional Branch, in current line wire II (double line electrified), between hm Merisor and the railway station Banita km. 66+500 at the locomotive EA 40-0791-0 (belonging to SC CARGO TRANS VAGON SA Bucharest) hauling the freight train no. 20936.

Final edition

The 16<sup>th</sup> of December 2011

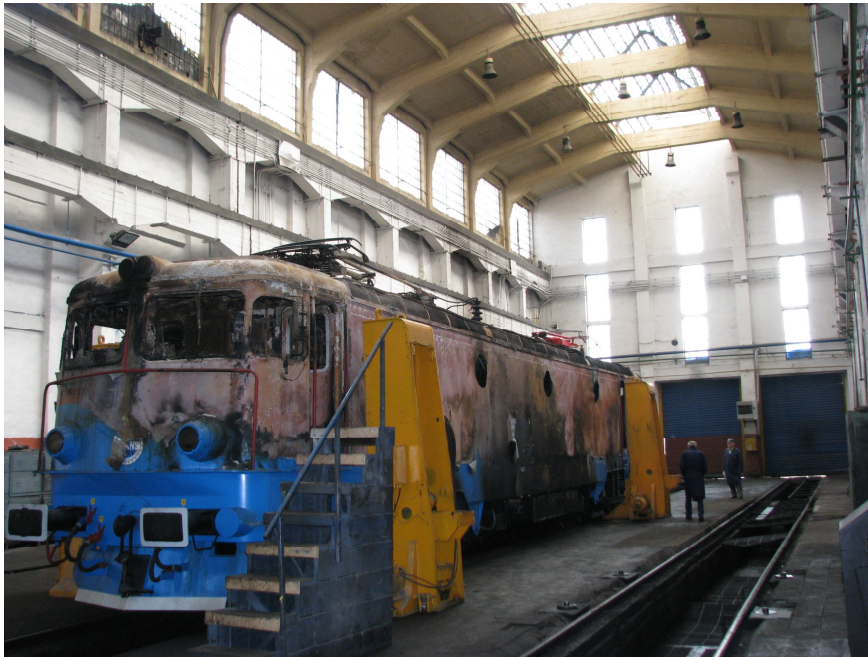
- the front side corresponding to the driving stations on the upper half has the paint burnt and the sheet thermally deformed and the windows glass broken; (Photo 1)
- on the side, the box is thermally affected from the chassis upwards, with the paint burnt and the sheet deformed;
- the most thermally affected side area of the locomotive box (on the left and on the right of the locomotive) is placed towards the station 2, above MET 4;

- at the upper side, the roof is thermally affected, the pantograph 1 strongly thermally affected and the pantograph 2 less thermally affected;

Photo 1 – Locomotive box on the outside

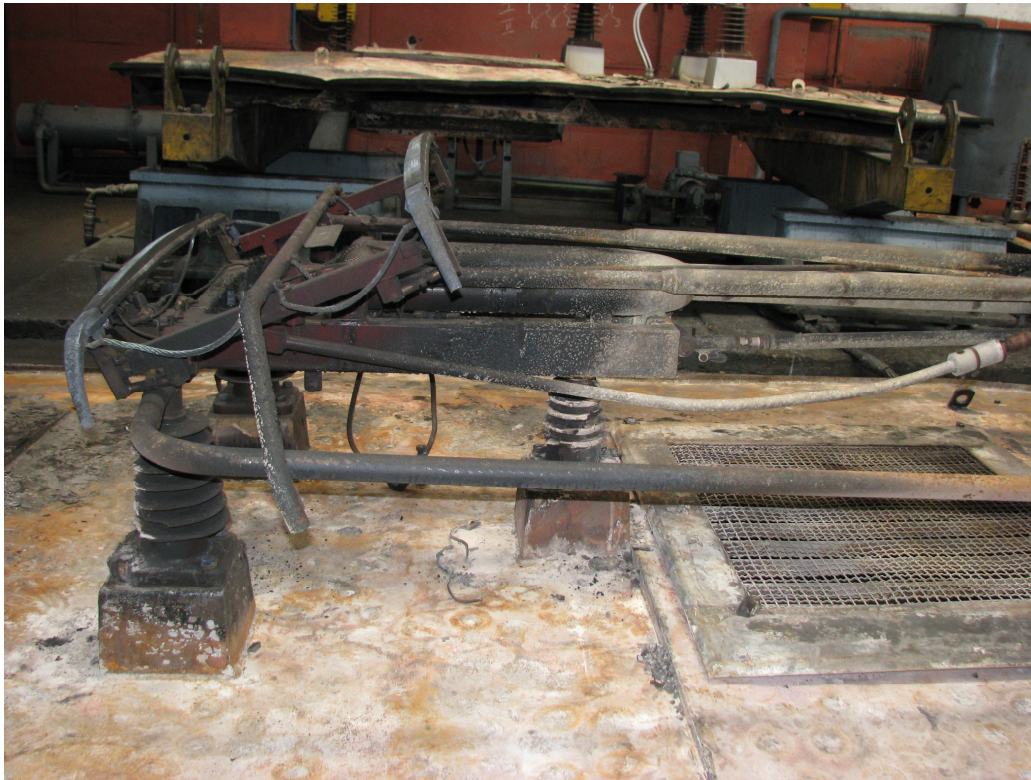
- pantograph no.1 is thermally affected, useless; (Photo 2)
- pantograph no.2 and the support insulators are in proper condition;
- the circuit breaker thermally affected at the control part;
- the discharger, by appearance, corresponds;
- the rods are appropriate;
- the overload measuring transformer 25 KV with the housing melted, useless;
- the bushing broken;
- the roof separators are appropriate;
- the support insulators of pantograph no. 1 damaged;
- the bar support insulators damaged;
- the sheet on the roof and on the side walls thermally affected and deformed.

Photo 2 - Pantograph no. 1

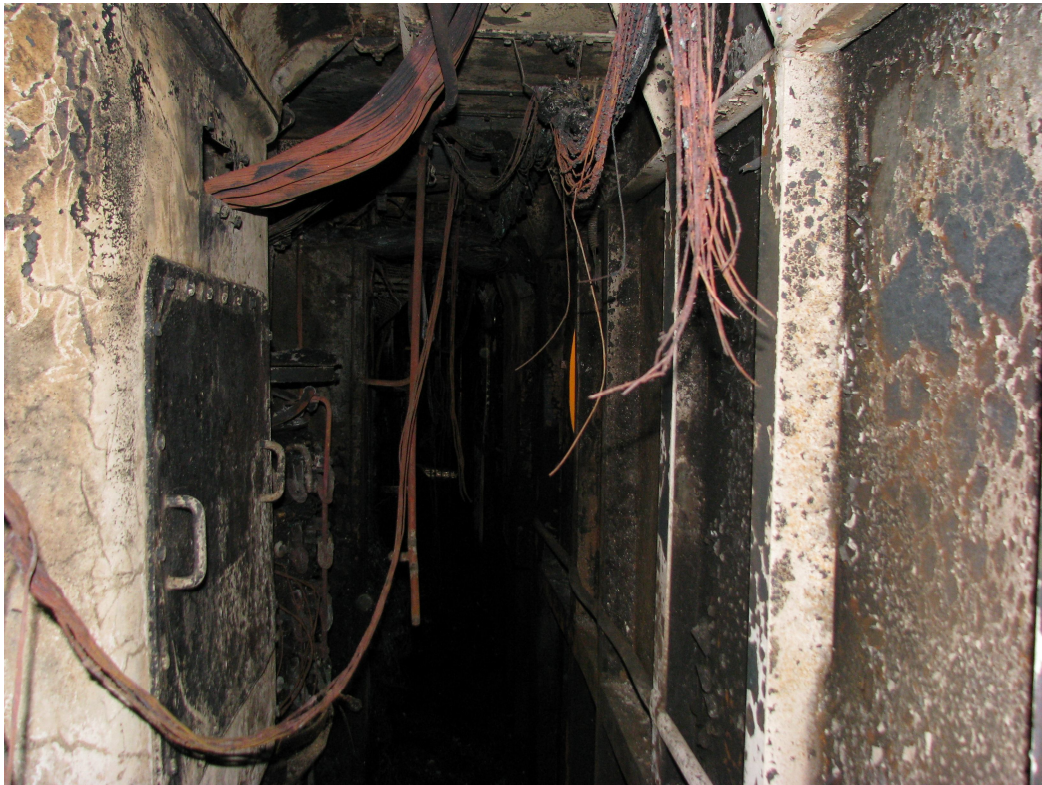
- all wires (of power. Auxiliary and command) have burned insulation; (Photo 3)
- the driving stations have the floor, the walls, the roof, the devices and the wires thermally affected; (Photo 4)
- the driving stations with all the components and cables in their equipment totally burnt;
- inside the engines box all the equipments, the floor, the walls and the roof are thermally affected;
- the blocks S1....S10, have all the cables and components thermally affected (burnt) totally, useless. (Photo 5)

Photo 3 – Wiring with burnt insulation

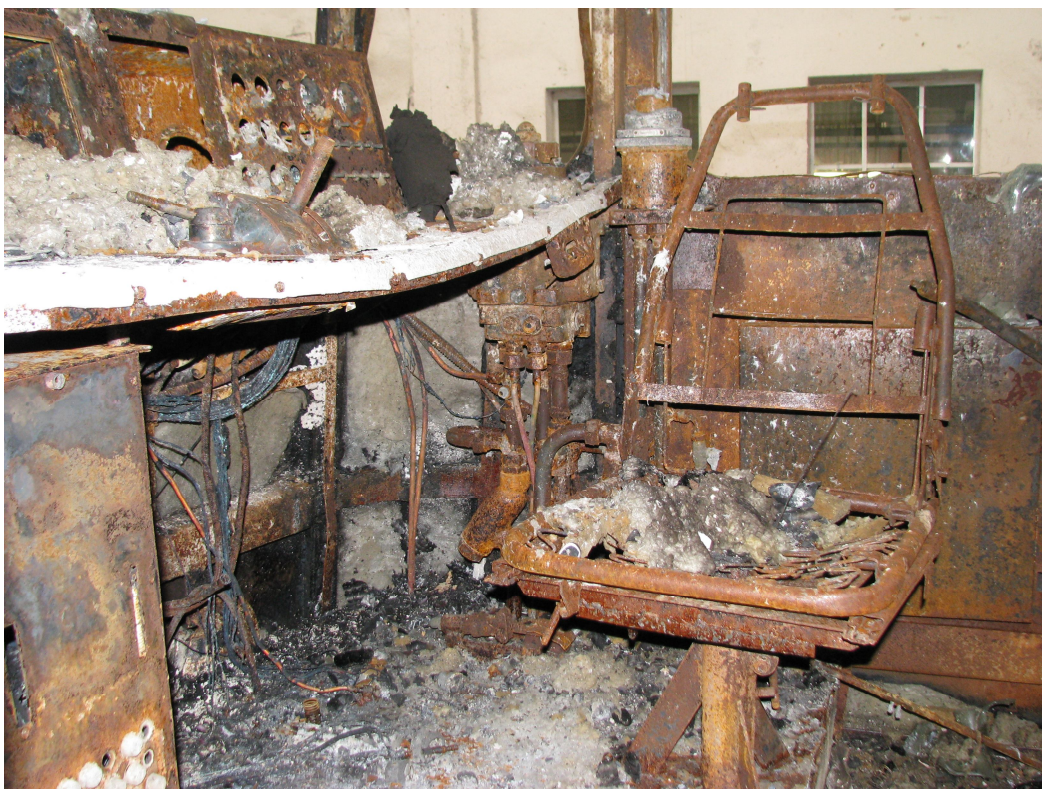
Photo 4 – driving station

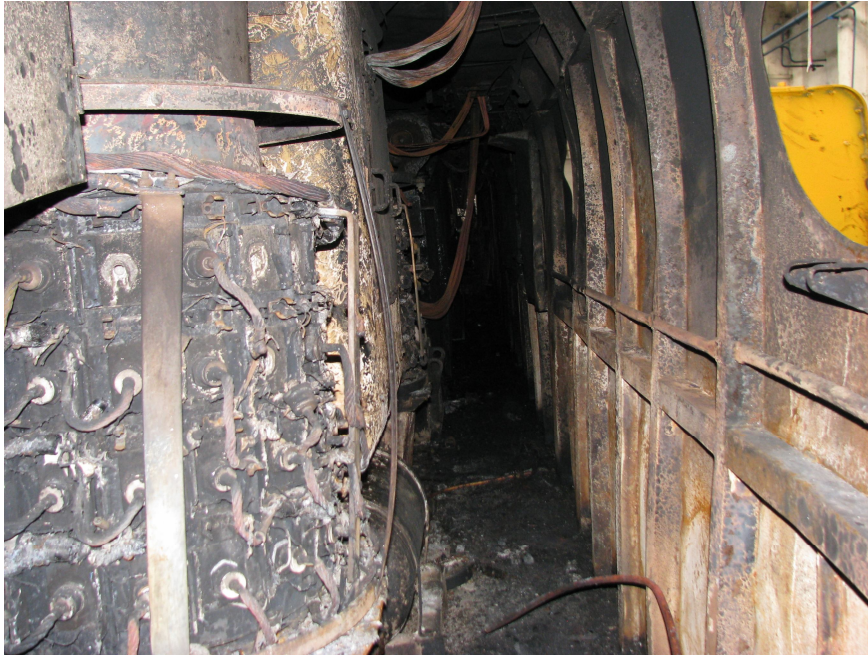
Photo 5 - Blocks S1- S10 burnt

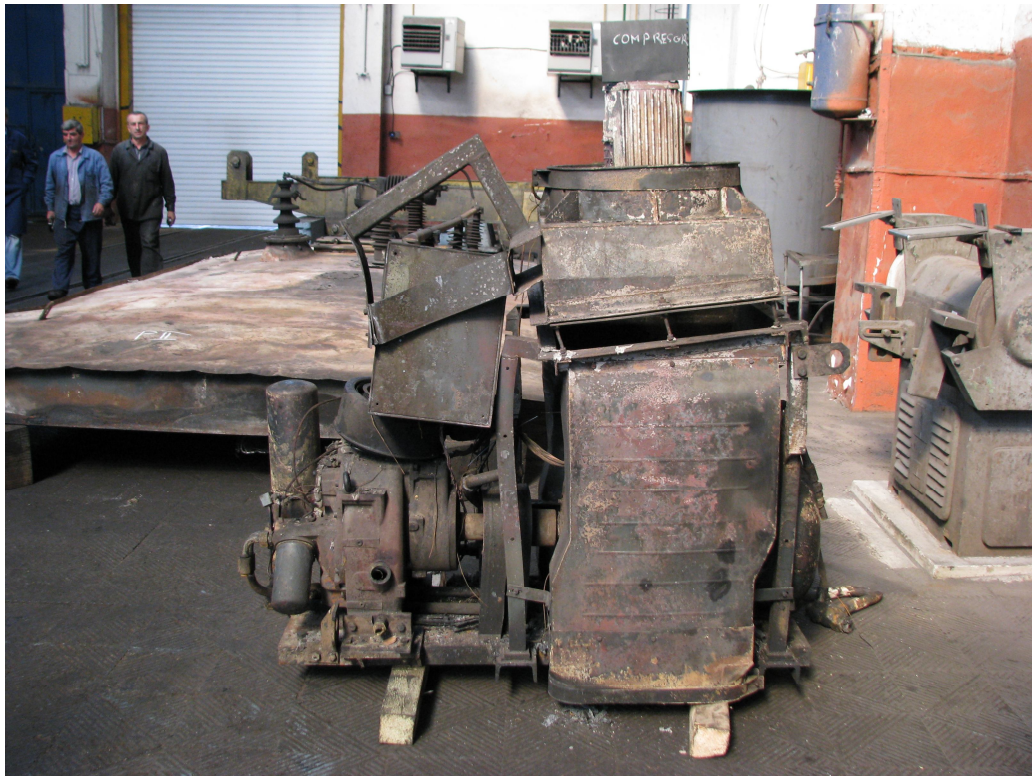
#### **The main air compressor (Photo 6)**

- the housing of the compressor is overheated and with signs of rust inside;
- the command block had all the components burnt and damaged;
- the devices corresponding to its operation and protection (filters, valves, pressure switch, combistat, etc.) completely damaged, most of them being burnt;
- helical rotors (the snails) of the compressor have signs of overheating and rust;
- the helical rotor bearings thermally affected because of the fire, one having signs of overheating being bluish (NSK HM 88649 JAPAN), the other having signs of rust and a tendency to lock (SKF M 8454842 MEXICO) and one being blocked on the axis (it could not be dismantled);
- the bearings housings overheated and without signs of friction or treads.

- the terminal board is completely burnt;
- the insulation on the cables of the terminal board is completely burnt;
- the rotor bearings thermally affected by the fire;
- stator winding insulation burnt;

- at the electric motor dismantlement the stator remained blocked on the rotor;

- the rotor overheated, having the aluminum bars melted and the aluminum leaked to the bottom of the engine (in the shield from the fan);
- the plastic fan blades missing due to their full melting;
- the stator winding insulation burnt;
- the bearings on the rotor axis thermally affected by the fire, one being blocked (NSK 6206 Z POLAND).

Photo 6 – The screw electro-compressor ECE 3.5 LE

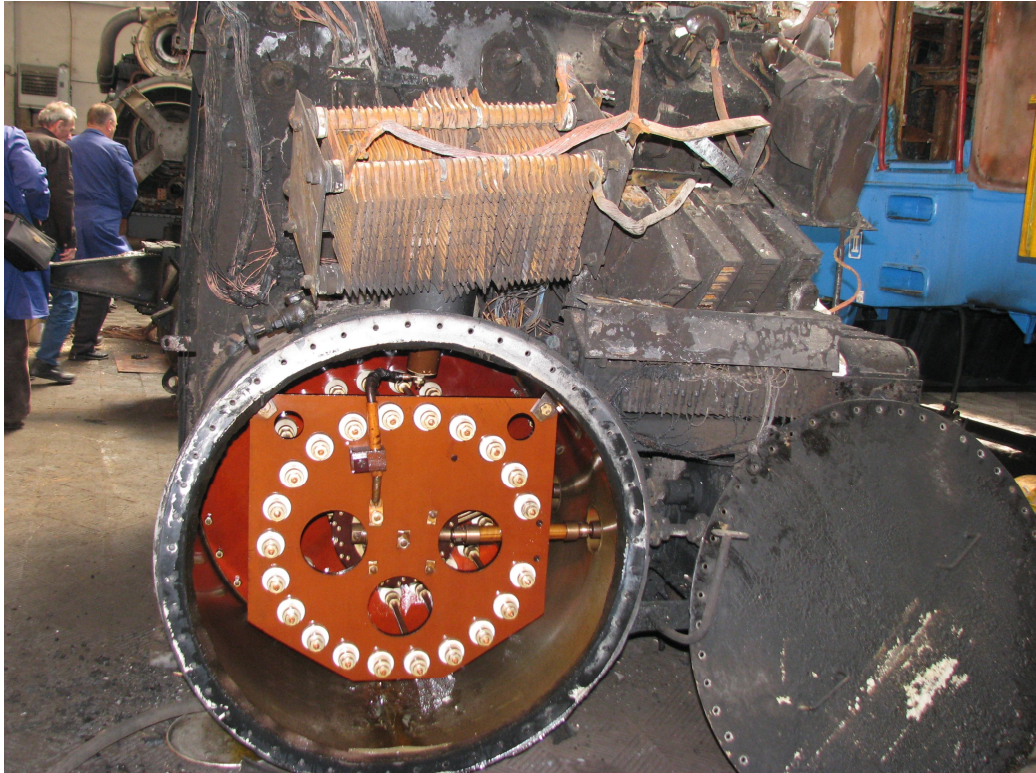
### **The main transformer (Photo 7)**

- TP was found with oil up to the level of the upper valve;
- on the outside it has the wiring completely burnt and the pipelines thermally affected;
- the output insulator broken do to overheating;
- the contactors K1...K4 thermally affected and the extinguishing rooms completely burnt;
- the switching resistance T4.1 thermally affected;
- the substation oil cooling hood thermally affected (checked by dismantlement);
- the selector on the inside does not have signs of abnormal operation;
- the main transformer winding does not have signs of overheating (check made through the access cover);
- the flattening safe id thermally affected, with the connection plates removed due to the fire (checked by dismantlement);
- the motors for the cooling fans: AMV 1.1, AMV 1.2, AMV 1.3 are thermally affected.

AMV 1.1 was dismantled and there were not found signs of abnormal operation.

Photo 7 - The main transformer

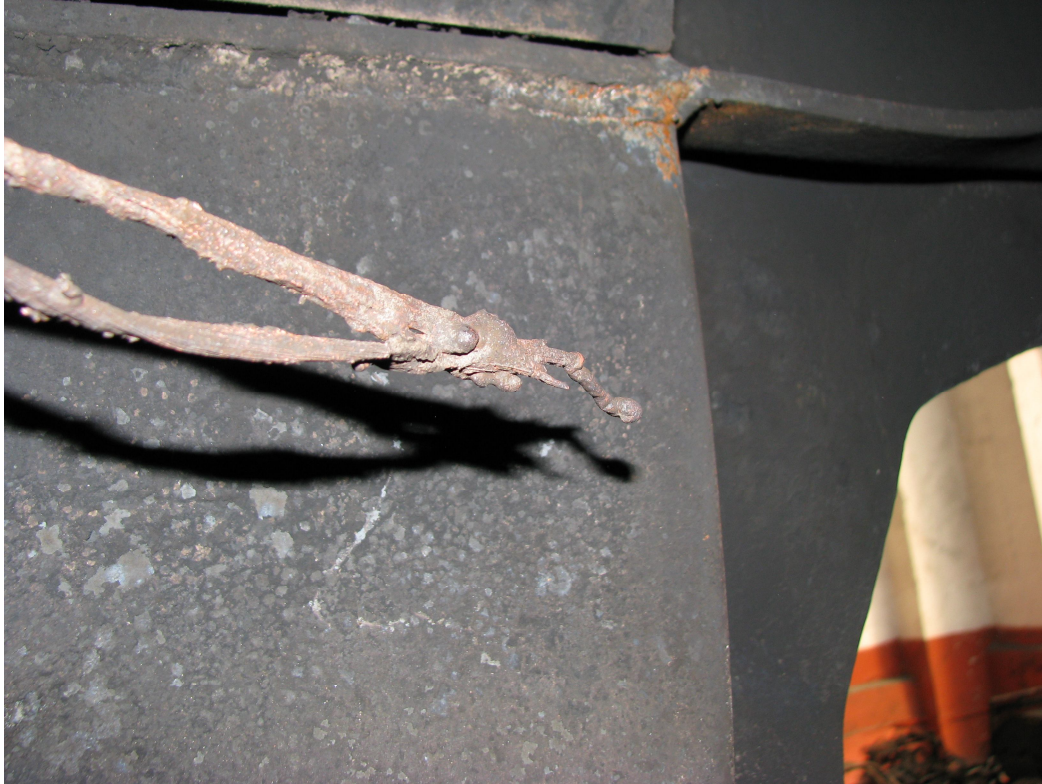
The stranded copper wiring of section  $16 \text{ mm}^2$  with the numbers 2061, 2062, 2063 in the wiring diagram, cables that supply the electric motor activating the main compressor have the insulation burnt at 100%. The mentioned wiring is connected to the terminal block of connections from the block S8, browse the wiring channel placed above the access lane on the right of the locomotive, up to near the compressor, where they are interrupted. In this interruption point the mentioned cables have copper melt accumulated in drops and two are welded together (Photo 8). The portion between the wiring channel and the silica battery is missing on an estimated length between 7 cm and 15 cm and continues on the silica battery where it has on the first part the same copper melt accumulated in drops (Photo 9). The wiring continues to the output of the silica battery where it is interrupted again and has copper melt accumulated in drops. Checking the supply cables of the ventilation electric motor of the compressor with the numbers 2051, 2052 and 2053, with the section of  $4 \text{ mm}^2$  and the cables from the panel monitoring the operation of the compressor with the section of  $1.5 \text{ mm}^2$ , it is found that above the silica battery they are interrupted in 7 points with copper melt accumulated in drops.

The melting phenomenon of the cables and accumulating in drops of the melted copper comes most probably from the occurrence of an electric arc.

Photo 8 – The cables of the electric motor activating the compressor – welded over the access lane

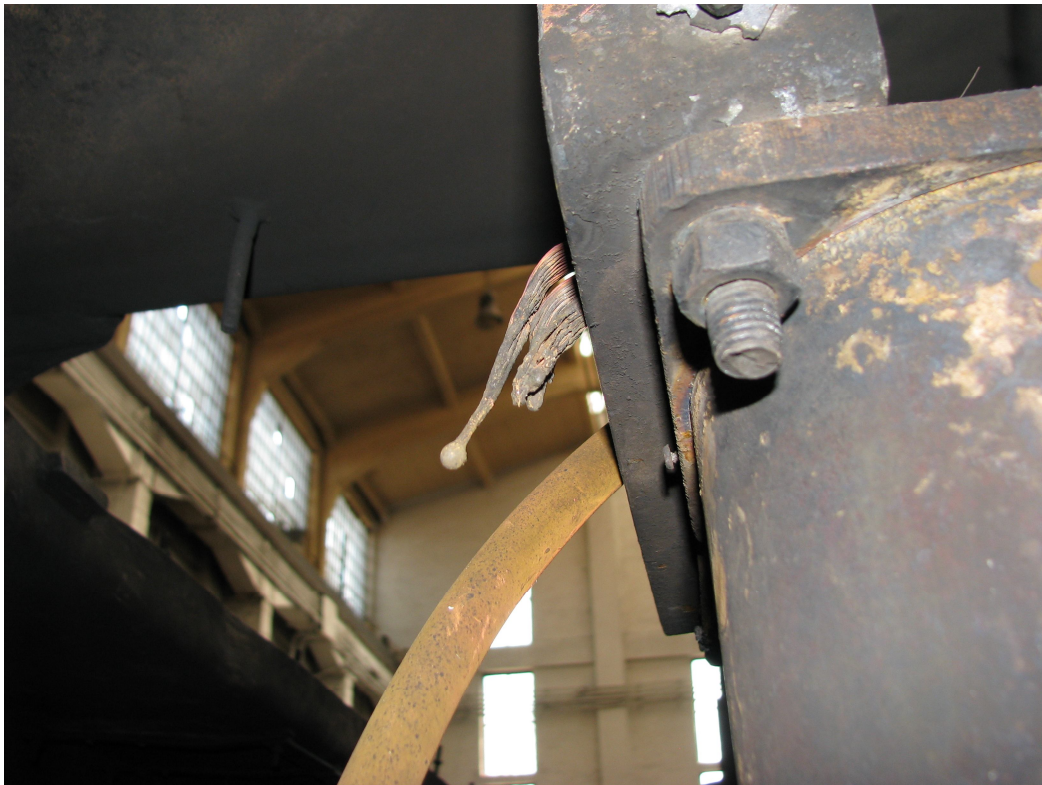
Photo 9 – The cables of the electric motor activating the compressor – placed above the silica battery – have copper melt

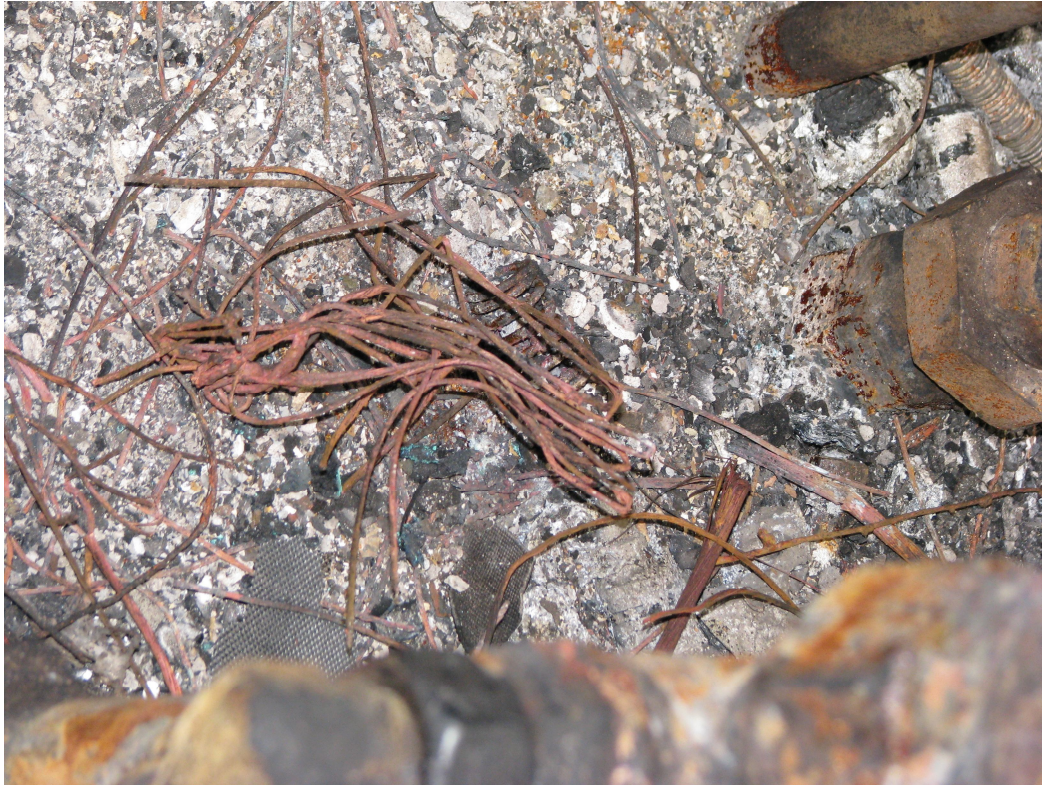
Photo 10 – Bundle of wires from the supply circuit of the ventilation electric motor of the compressor and the monitoring circuit of the compressor operation, melted and welded together by the melted copper

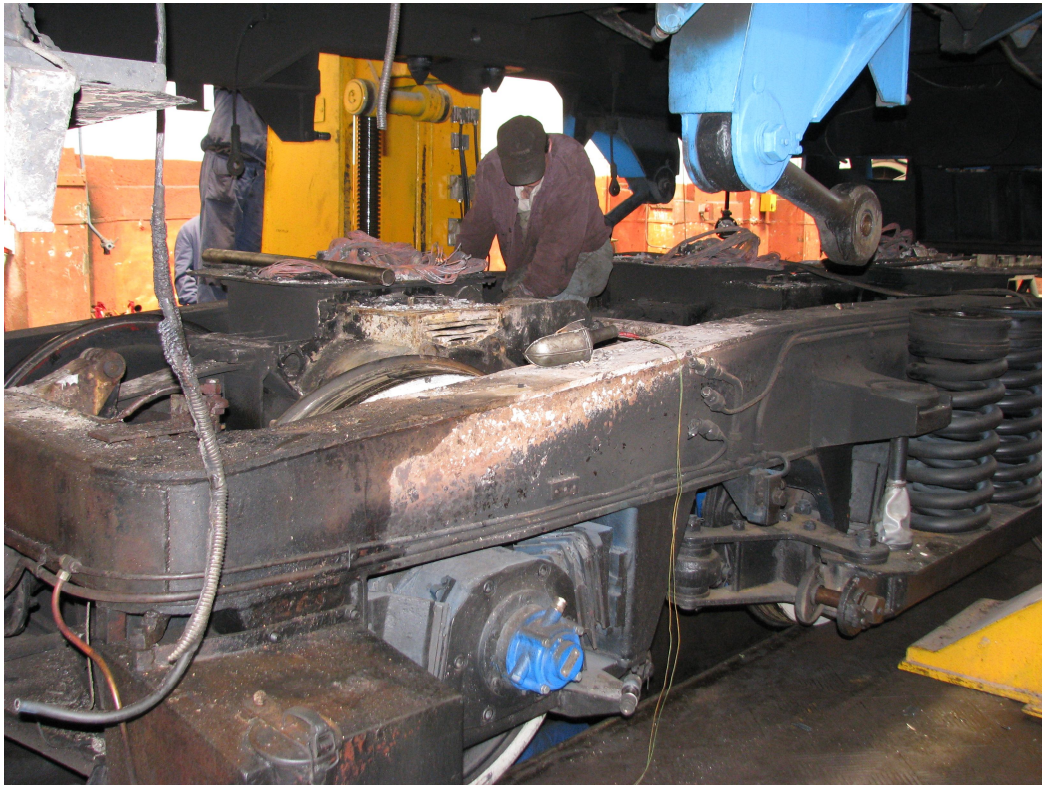
- the brake wheelhouse and the rolling part do not show signs of abnormal heating;
- the frame of the bogie II has signs of burning on the upper side in the area MET 4 (Photo 11);
- the bandages from the wheels of the axles 3 and 4 have signs of smoke (Photo 12);

Photo 11 – frame of the bogie II has signs of burning on the upper side, in the area MET 4

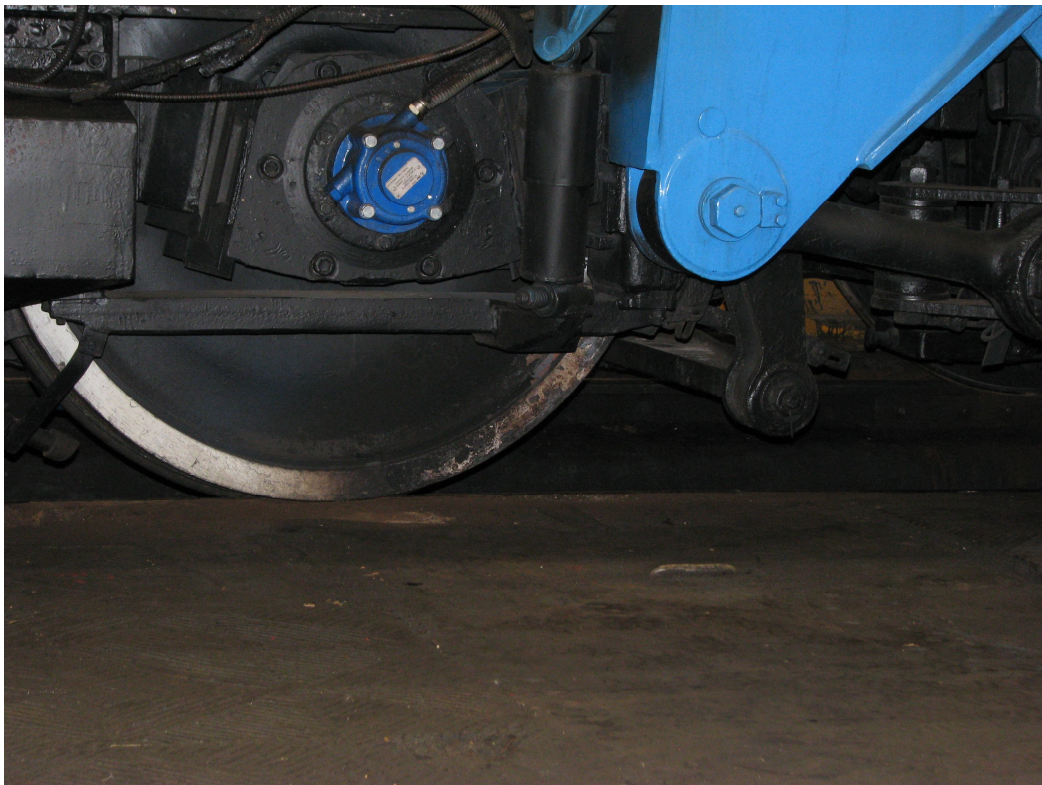
Photo 12 – the bandages from the wheels of the axles 3 and 4 have signs of smoke

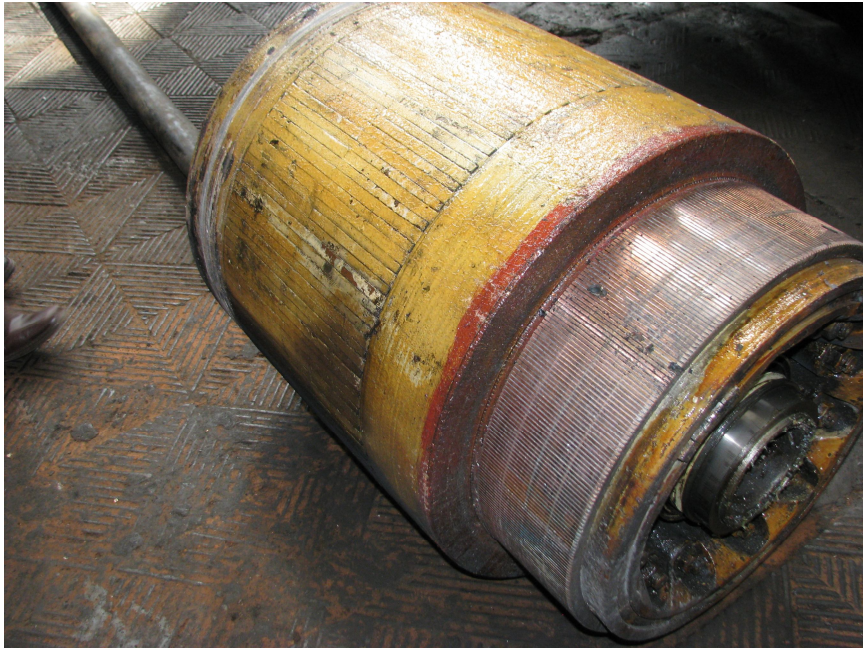
Photo 13 – Rotor from the traction engine

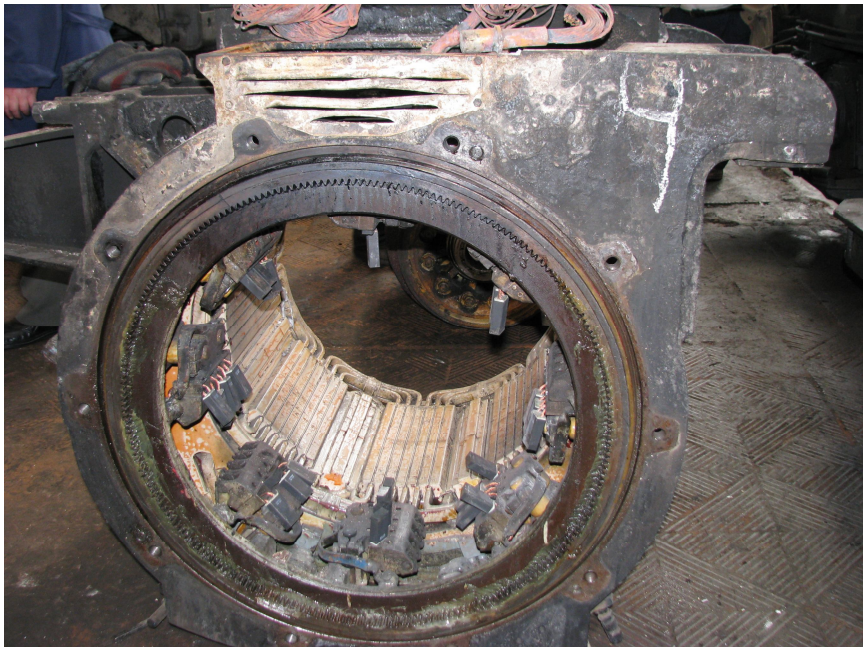
The housings from the MT3 and MT4, on the upper side, have a stronger heating due to the temperature existing in the engines box (Photo 14).

Photo 14 - stator from the traction engine

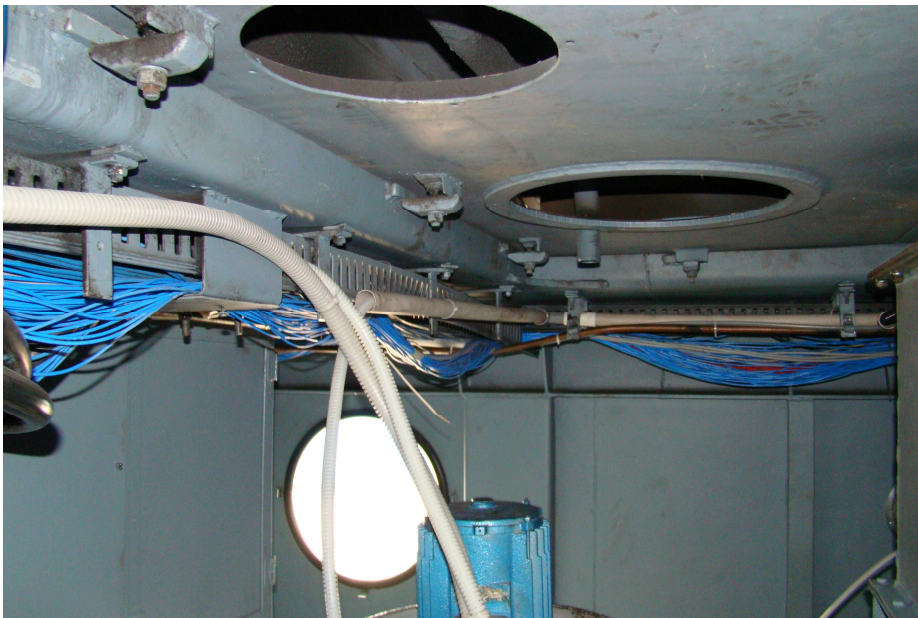
The electric cables of power and command of the electro-compressor were drawn together, through a duct (Photo 15).

Photo 15 - The electric cables were drawn together, through a duct (Photo taken during the mounting of the electro-compressor).

Given the use in cable shafts with insufficient cooling of the stranded tinned copper conductors insulated in PVC, the current density is 1...2 A/mm<sup>2</sup> with the condition that the maximum operation temperature do not be exceeded (cf. pg. 5 of the Tests report 3052-040 from the 14<sup>th</sup> of September

- Checking the heating temperature of the electric circuits of the locomotives by the thermo-vision procedure, at the final tests after the planned repairs;
- Checking the work of the protections for the electric circuits of the locomotives at the final tests after the planned repairs;
- In the technical specifications on the construction or modernization of the rolling stock to be contained the standard SR EN 50343:2006 *Railway applications. Rolling stock. Rules for the installation of cables.*
