INVESTIGATING REPORT

on the railway accident occurred on the 27th of September 2010 on the range of activity of CF
Brasov Regional Branch between the railway station CFR Miercurea Ciuc – Hm CFR Sanraieni

FINAL EDITION
Date: the 4th of February 2011

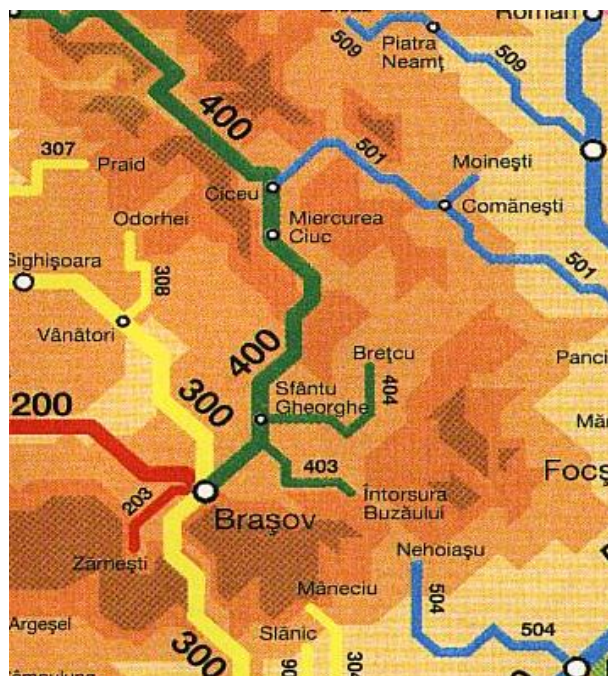
The railway accident occurred as a consequence of the collision between the isolated locomotive EA 40-0919-7 and the last coach of the passenger train no. 4504, that was stopped in current line. The consequences of the collision consisted of:

- injury of the guard of the passenger train no. 4504;
- damage of the locomotive aid running isolated;
- damage of the last coach in the composition of the passenger train no. 4504;

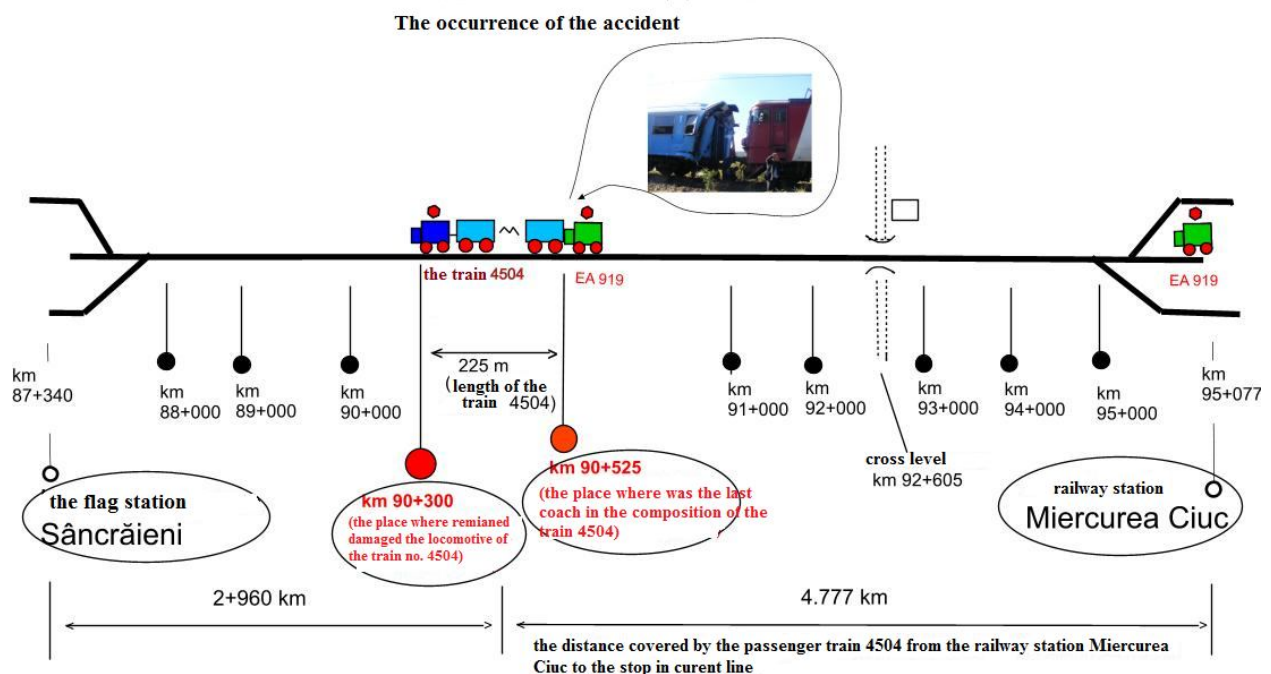
The locomotive aid EA 40-0919-7 ran between the railway station CFR Miercurea Ciuc and the place where was stopped in current line the passenger train no. 4504, with speeds within 17 and 40 km/h, and around 7:44'02" a.m., at a speed of 23 km/h collided the last coach in the composition of the train no. 4504.

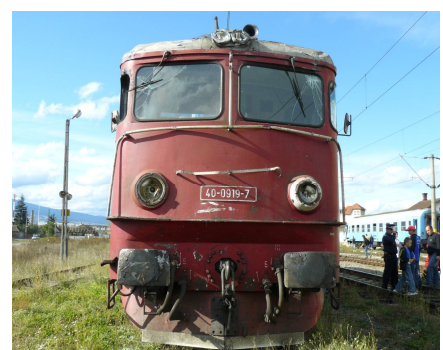
- injury of the guard of the passenger train no. 4504;
- damage of the locomotive EA 40-0919-7, damages to the driving station I:

- the pads had the front plates slightly deformed;
 - corner windows broken;
 - central headlights broken;
 - front protection bar deformed.
- damage of the coach no. 50531957073-3, the last in the composition of the passenger train no. 4504:
 - front sleeper (head of handbrake) displaced to inside of the coach;
 - the pivot of the pallet from the bogie with R1-4 (handbrake) broken and the bogie displaced to the center of the coach;
 - the upper side of the coach box deformed and displaced to the center of the coach;
 - the traction, collision and linking devices, deformed and broken;
 - the front platform deformed to inside the coach;
 - the toilet cabin and the compartment 1 deformed;
 - the backbone of the chassis and of the coach box compromised.
