MINISTRY OF TRANSPORTS AND INFRASTRUCTURE
ROMANIAN RAILWAY AUTHORITY - AFER

ROMANIAN RAILWAY INVESTIGATING BODY

INVESTIGATING REPORT

on the fire occurred on the 25th of May 2011, on the range of CF Constanta Regional Branch, between the railway stations CFR Navodari – Constanta Marfuri, at the locomotive DA 60 – 1528 (belonging to SC Grup Feroviar Roman SA Bucharest) in the composition of the train no. 79156

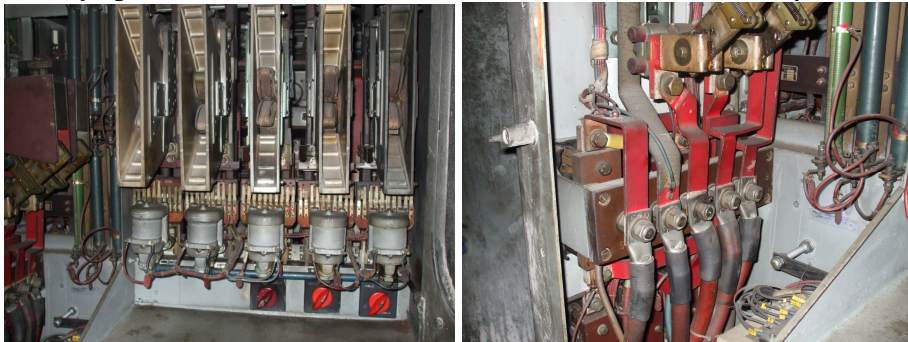
- relays panel, the automatic fuses block, unaffected thermally, have only deposits of soot;

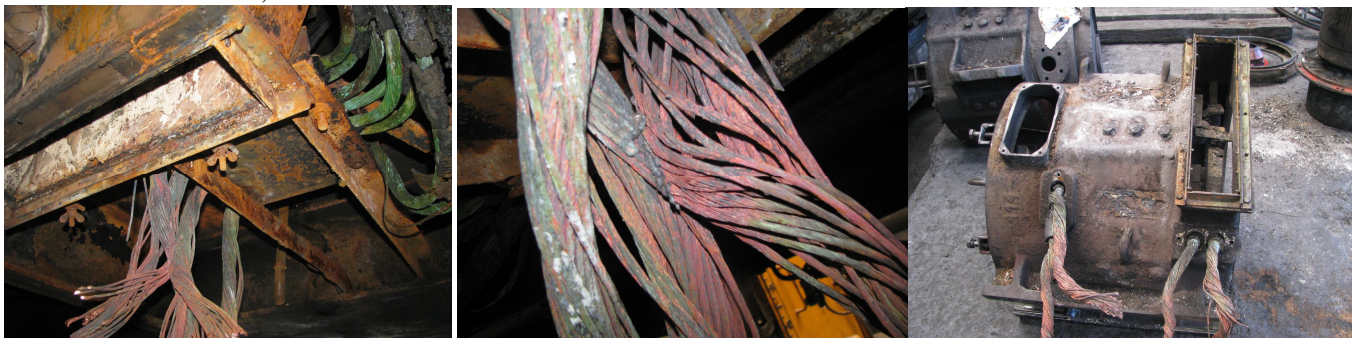
Occurrence of a short-circuit between the supply cables A and E of the traction engine no. 3 as a consequence of piercing the insulation in the contact area between the two cables, which led to the appearance of a top of intensity of the supply current of the engine, followed by the welding of the metallic part of the two cables and the ignition of the insulation of the other cables associated to the electric traction engine no. 3 and by influence of the supply cables of the electric traction engine no. 2.

Piercing of the insulation occurred as consequence of the mechanic wear in the contact area of the supply cables insulation of the electric traction engine A (rotor connection) and E (stator connection).

- supply cables had the insulation completely charred and completely displaced from the engine housing to the terminals box;

- cables A (rotor connection) and E (stator connection), welded at a distance of about 400-500 mm from the terminals box of the traction engine no. 3;

Following the occurrence of eventual wears in the contact area of the power wiring insulation of the electric traction engine A (rotor connection) and E (stator connection), and also the fund of eventual aging effect in time of these cables insulation, occurred the piercing of the insulation and a short-circuit between the two electric cables, which led to the ignition of the cables insulation associated to the electric traction engine no. 3, and also to the welding of the cables metallic part in an area placed at a distance of about 400-500 mm from the terminals box of the traction engine no. 3.

1. Identifying and implementing solutions to ensure protection of the supply cables of the electric engines against the mechanic wears in the contact area between them.

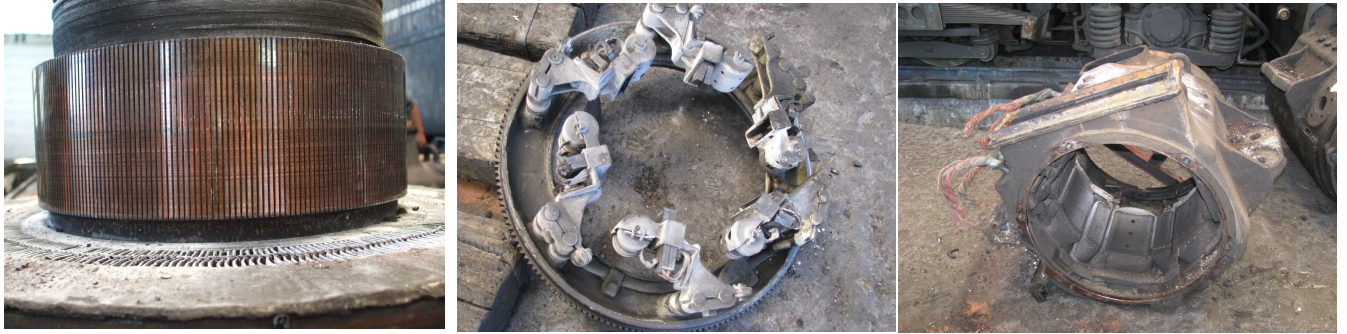
- bellows of the ventilation channel, completely burnt;

- winding rotor, stator and brush-holder crown in normal condition;
- stator and rotor insulation resistances of the electric traction engine no. 3, appropriate (100 Mohm).

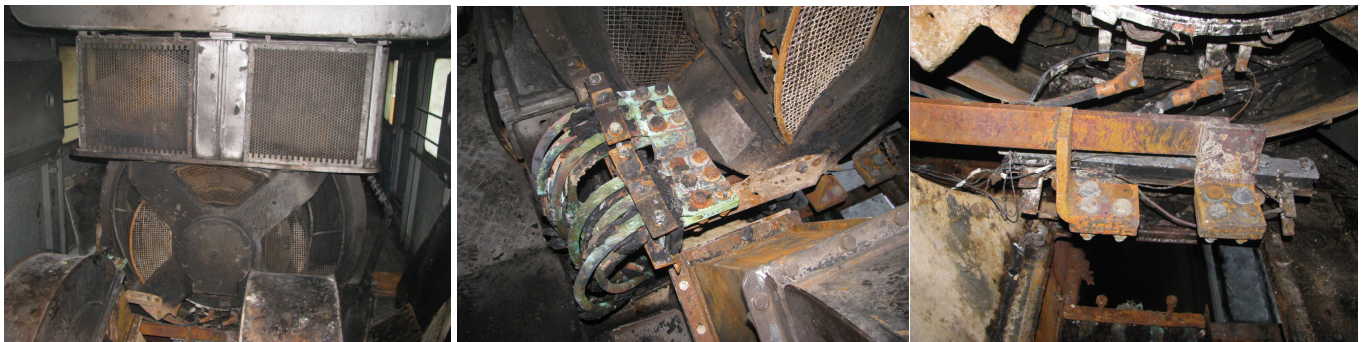
- the bottom area of the brush-holder crown, thermally affected;
- stator coils insulation, thermally affected;
- the power wiring insulation charred on a distance of about 400 mm on the area between the generator terminals and the entry in the wiring channel.

By burning of the serial registration cables of the electric traction engine no. 3 by influence were thermally affected the wiring insulation of the electric traction engine no. 2 and also the brush-holder crown (in the bottom area) and the stator coils insulation of the auxiliary generator.

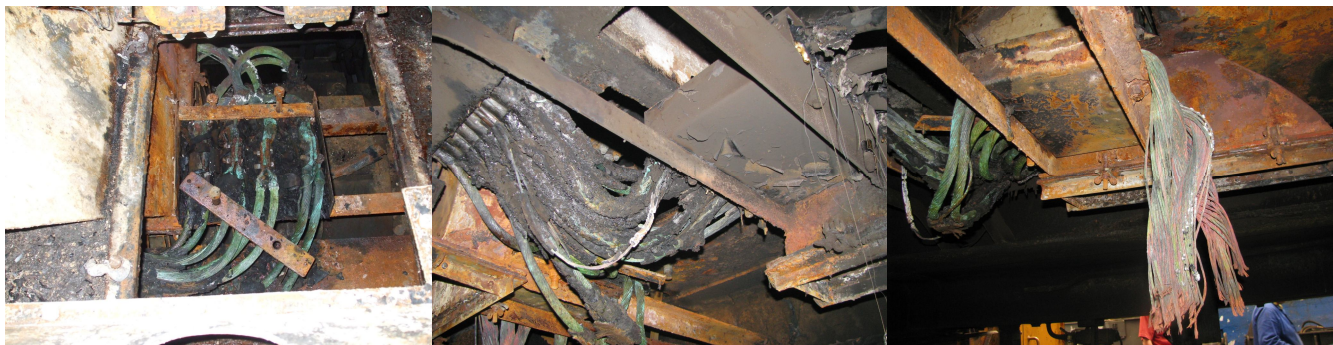
- serial registration cables of the traction engine no. 1, in normal condition, unaffected thermally;
- serial registration cables of the traction engine no. 2, with the insulation partially charred on a distance of about 400-500 mm in the fixing area on the terminals board;
- serial registration cables of the traction engine no. 3, charred and completely displaced from the engine housing to the terminals box and the cables A (rotor connection) and E (stator connection), welded at a distance of about 400-500 mm from the terminals box of the traction engine no.3;
