## INVESTIGATING REPORT

on the fire occurred at the locomotive DHC 80-0172-9  
belonging to SNTFC “CFR Calatori” SA,  
in the running of the train no. 17360 on the 8<sup>th</sup> of September 2010,  
on the non-interoperable running section Oravita – Berzovia (km. 45+700)

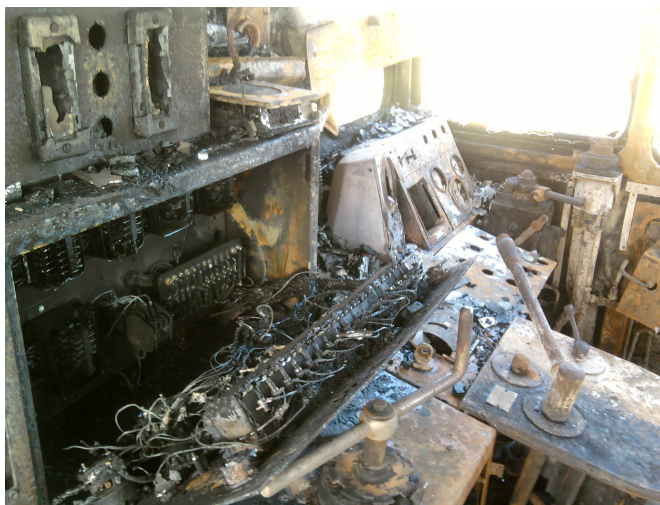
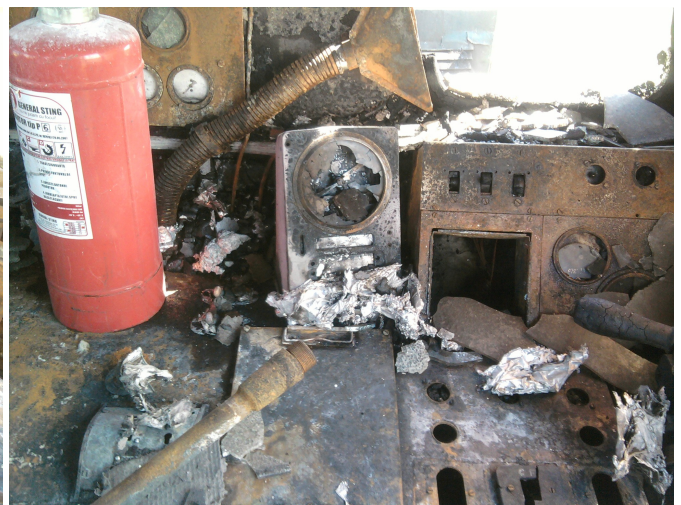
Effects of the fire on the equipment of control, indication and protection from the driving cab

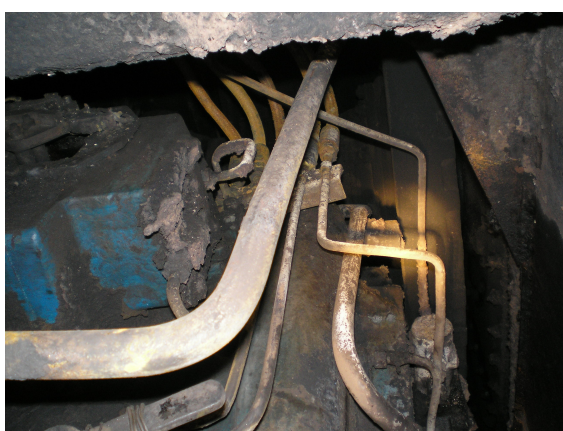
on the covers of the hydraulic transmission, reversing gear, axle attacks 1-4, on the cardan axes were not found signs of thermal damage; on their external sides were found deposits of dirt and oil; at the control valves of the hydraulic transmission was found the thermal damage of the terminal plates, of the coils and related wires, of the air pipes from the pneumatic set and of the Argus tubes that make the connection with the valves S4-S8;

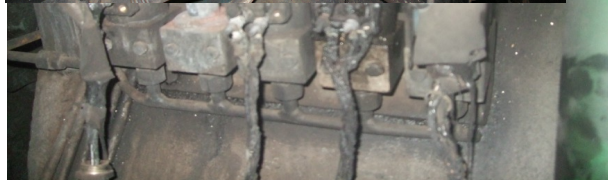
there was missing the coil corresponding to the valve S5 (operation heavy regime), power and control wires hanging on the outer side surface of the transmission and the insulation of the wires and terminals board casing had signs of thermal damage; there were not found specific signs of a short-circuit occurrence;

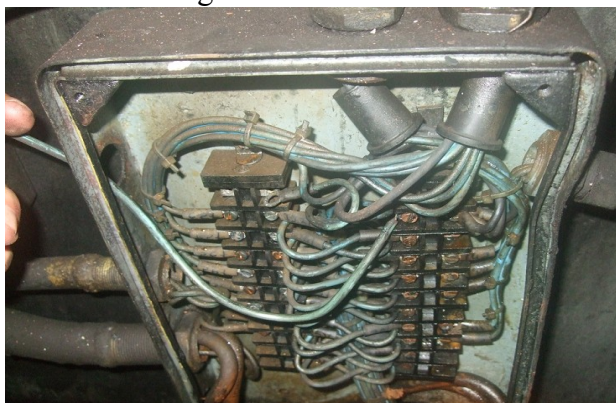
- between the engine electric dose and the TH dose was found an electric conductor 31 insuring the electric connection (minus) between them and which was mounted outside the electrical wiring tubes, over the hydraulic transmission housing; this had the insulation burnt, excepting portions near and inside the doses;

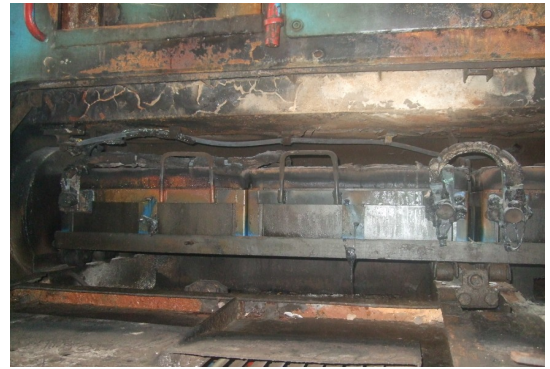
- the accumulators batteries from the niche on the right of the locomotive (boxes 5-8) thermally damaged on the upper side, the serial registration flexible connections between the batteries with the insulation thermally damaged, the connection cable between the niche no. 1 and the niche no. 2 with the insulation thermally damaged only on the area located in the niche on the right, melt H

type connections between the elements, the upper seals of the batteries completely burnt;

- there were not found specific signs of the electric short-circuit to the batteries 5-8 from the niche on the right;

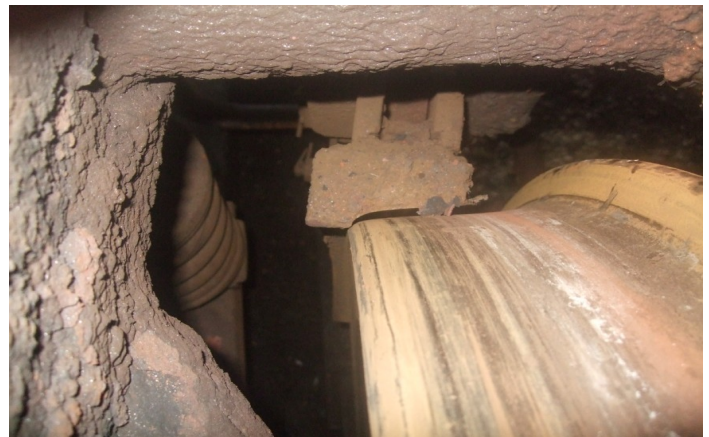
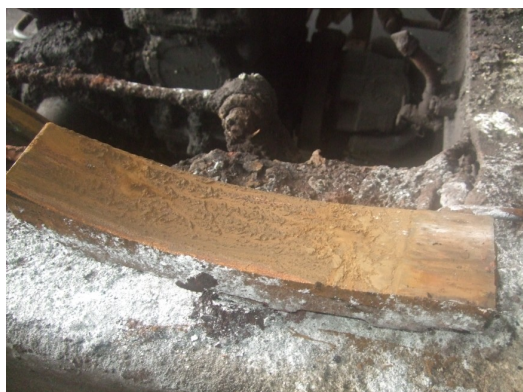
- at the shoe on the back of the axle 2 (the right side) was found the formation of a shoulder with height of about 5 mm and width between 15 mm (in the middle of the shoe) and 25 mm (in the end of the shoe), as a result of the shoe placement to the outside of the bandage tread; also were found on the active surface of the shoe material gaps with depths of maximum 1 mm and the diameter between 5-20 mm, the shoe width (measured on its lateral side from the bandage rim) was of 30-35 mm;

- the eccentric position of the shoe from the back of the wheel on the right of the axle no. 2 was as a result of the wears in the braking wheelhouse joints; also were found eccentric positions of the shoes to the rolling surface of the wheels and at the wheels on the left axle 3 and axle 4 right side;

- on the edge between the active surface and the lateral surface of the shoe were found small burrs (max. 1.5 mm);

- at the shoe in front of the wheel on the right of the axle no. 2 was found that the active contact surface (of rubbing with the wheel) had been only 20 % of the active surface of the shoe, the rest of 80% of the surface being covered with oxide mixed with dust; the last intervention at the brake shoes was made during 02-03 of August 2010 at the R2 type revision, some shoes being replaced.

- 1 Compliance with the deadlines to put in planned repairs the locomotives;
- 2 Regular cleaning of the fuel residues accumulations from the areas inclined to accidental ignition of the locomotive, tasks to be included in the technological processes of the periodic inspections;
- 3 Checking the brake wheelhouse at the hydraulic diesel locomotives to detect wears in joints and take control measures at technical planned revisions.

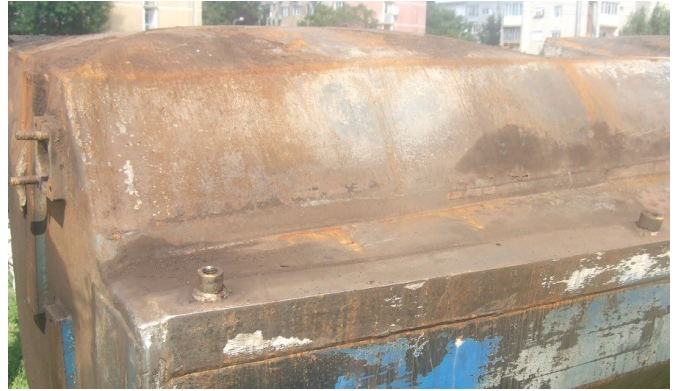
- the auxiliary tank and associated pipe work, free from recent intervention and free of thermal damage, except the oil supply pipe of the unit GAT 08S2 which is affected in the area under the locomotive chassis;
- the main tank on the left shows overpressure characteristic deformations, being also broken two mounting screws of the tank on the main outer strut (to the axle 3);
- the tank on the left was dismantled from the locomotive in Oravita shed to move the locomotive in safe conditions to Timisoara Depot;
- the tank on the left shows three cracks in the joint areas of the tank sides, as a result of the overpressure created by the fire, two on the top side of the tank and one on its bottom side, which led to the entire quantity of diesel leaking from the inside;
- upper level indicators were thermally damaged, at the both tanks;

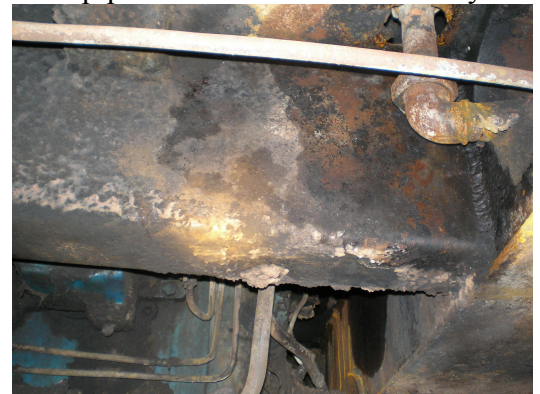
- in the lower area of the big hood, on the right, the air and fuel pipes in the channel formed by the locomotive chassis, the main outside strut on the right and the inside strut on the right under the locomotive are thermally damaged, have signs of burning of the existing deposits, on the entire distance between the pivot sleeper of the bogie 1 (including the area with the collector bags) to the pivot sleeper of the bogie 2;

- the inner sides of the channel formed by the inner and outer struts on the right with the locomotive chassis, have signs of thermal damage with color change and also remains of the burnt deposits on these elements;

- in the area between the top side of the tank on the right and the bottom side of the chassis were found signs of thermal influence and also the damage of the paint on the front and top side of the main tank on the right (in the area of the power mouth);

- on the left of the locomotive, in the area between the top side of the locomotive main fuel tank and the locomotive chassis, up to the area of axle 3 were found signs of thermal damage and burning of the existing deposits ( with color change of all the metallic elements);

- signs of thermal influence on the inner surfaces of the channel formed by the locomotive chassis with the main outer strut on the left and the inner strut on the left up to the area of the pivot sleeper of the bogie 1;
