MINISTRY OF TRANSPORTS AND INFRASTRUCTURE
ROMANIAN RAILWAY AUTHORITY - AFER

ROMANIAN RAILWAY INVESTIGATING BODY

INVESTIGATING **R**EPORT

On the fire occurred at the locomotive DA 60-1361-9
owned by SNTFM “CFR Marfa” SA, circulating as locomotive pushing the train
no. 53598, in range of the Regional Branch CF Constanta,
between h.m. Borcea Branch and railway station Ovidiu

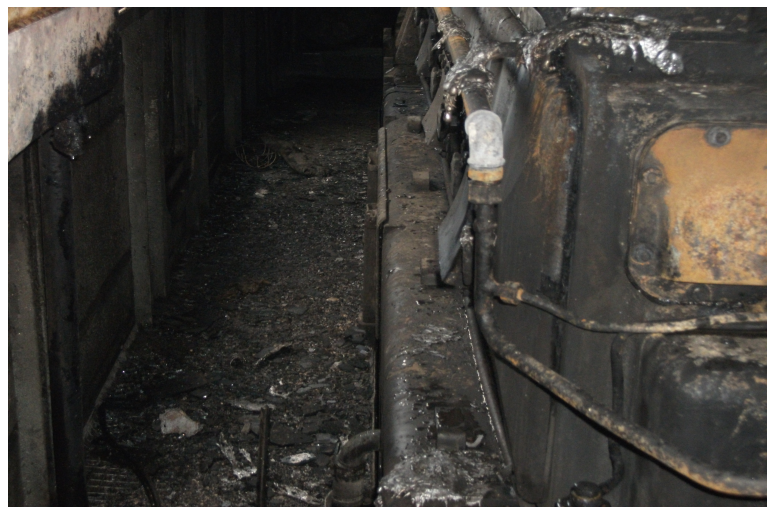
Effects of the fire on the equipment in the engine box on the right side of the locomotive.

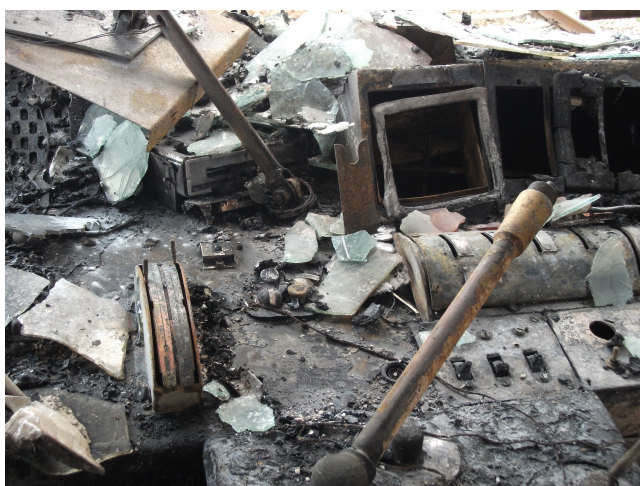
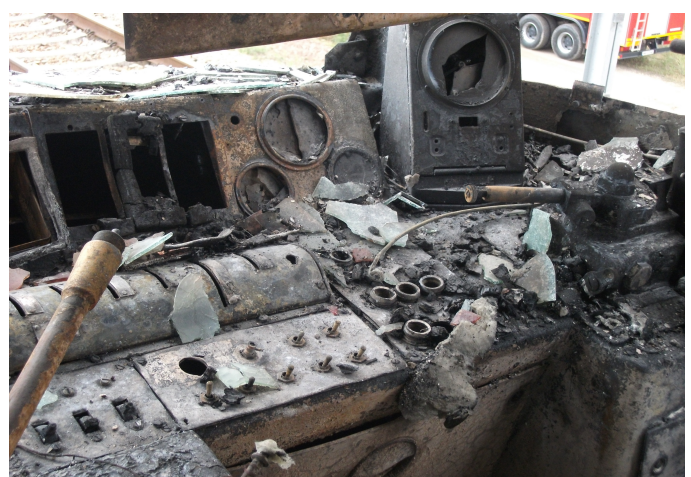
Effects of the fire on the equipment of command, indication and protection, in the cabins.

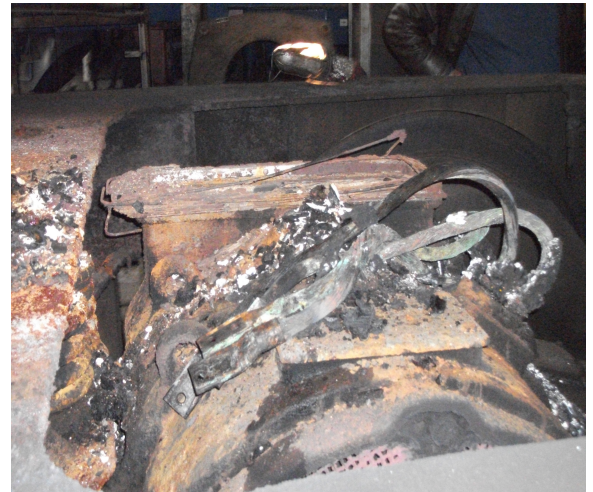
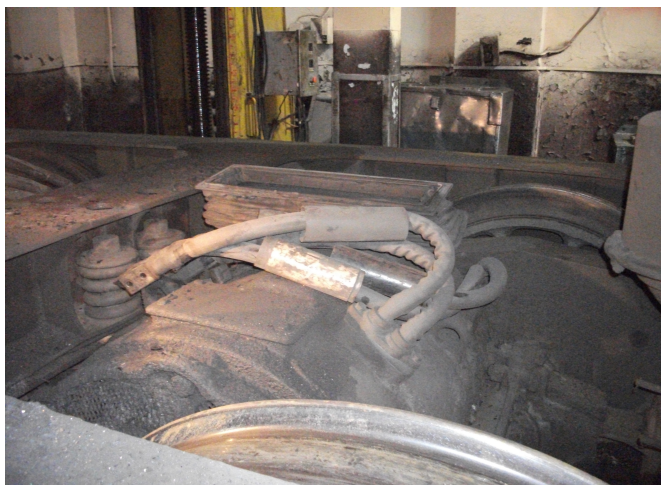
The electric traction engines no. 4 and 5 had the supply wiring thermally affected.

Inside, there was no sign of short circuit, flashover of insulators or insulation penetrations;

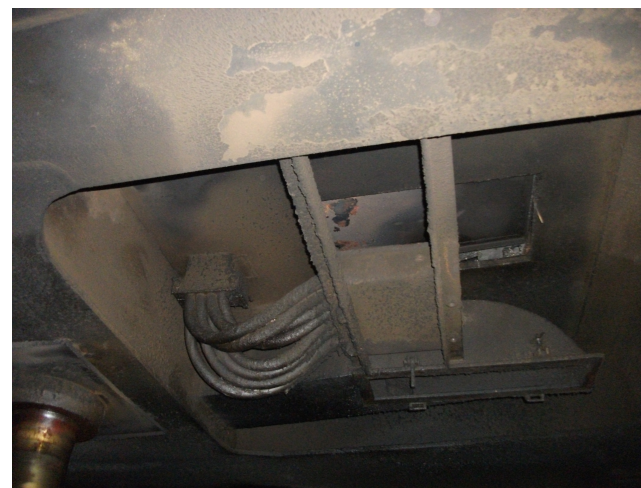
On the frames of bogie no. 1 and on the thermal unaffected side of bogie no. 2 and bottom of the locomotive chassis, the power wiring, at the findings after lifting winches, there were deposits of dust mixed with petroleum products.

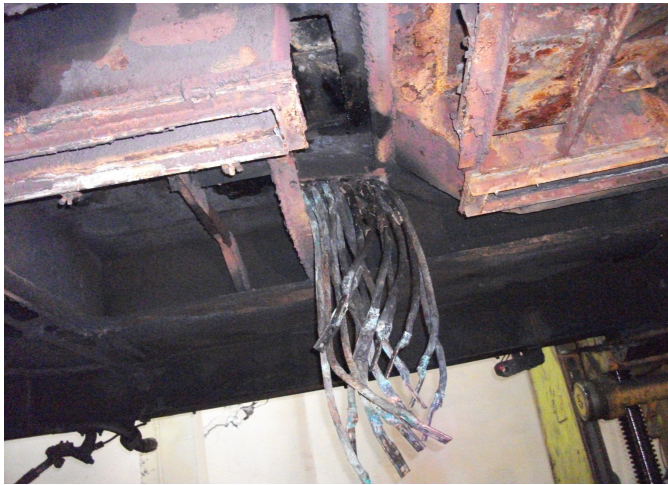
- wiring of series marking and power of the traction engines no. 4 and 5, had burned insulation between doses fixing slippers and clamps for fixing at the entry into the cable channel
- there were no traces of short circuit, cuts in slippers areas at all the power cables.

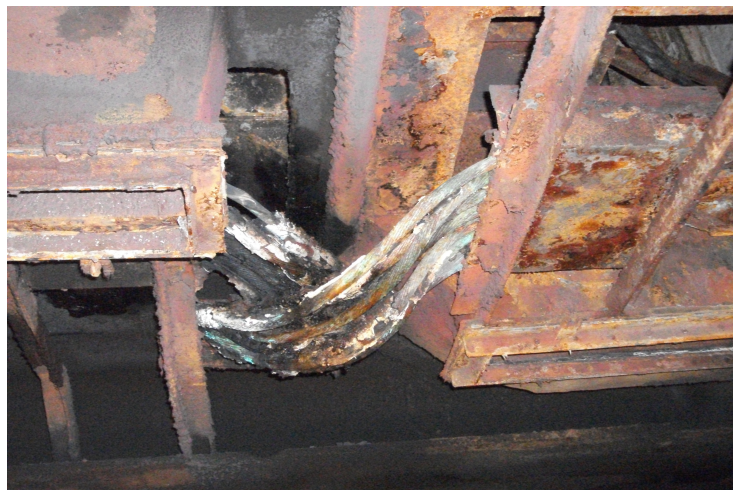
The condition of power cables from the output of the channel to the log dose of the traction engines no. 4-6 after the fire.
