## INVESTIGATING REPORT

on the railway accident occurred in the flag station Pajura,  
on the 7<sup>th</sup> of January 2011

Final edition  
The 11<sup>th</sup> of April 2011

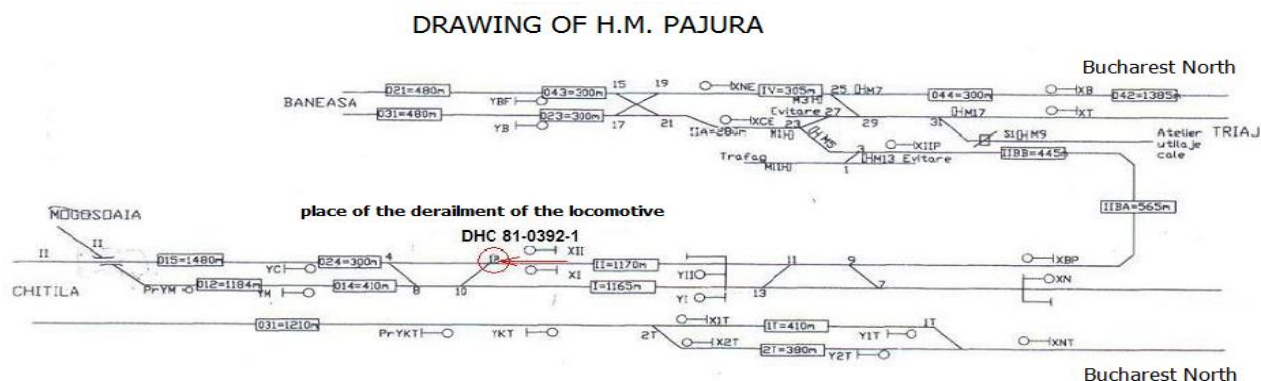
After the entry of the first bogie and of the first axle of the second bogie of the locomotive DHC 81-0392-1 (in the running direction of the locomotive) on the elements of the switch no. 12 (handles in the output path to the railway station CFR Chitila, placed with access towards the switch no. 4), after handling of the switch no. 12 from the position “+” on the position “-” occurred the derailment of the second axle from the second bogie of the locomotive DHC 81-0392-1 (the last in the running direction of the locomotive), the wheel on the right (in the running direction) being placed on the counter-rail and the wheel on the left being suspended without contact with the construction elements of the switch no. 12.

At 6:20 a.m. the movement inspector provider PCCE-2 recorded in RRLISC that the switch 12 had remained without control on the monitor as consequence of the derailment of the last axle of the locomotive DHC 81-0392-1 running isolated.

There were no deaths or injuries.

There were no damages at the lines, installations or environment.
