MINISTRY OF TRANSPORTS AND INFRASTRUCTURE
ROMANIAN RAILWAY AUTHORITY - AFER

ROMANIAN RAILWAY INVESTIGATING BODY

INVESTIGATING REPORT

on the technical failure of the structural subsystem infrastructure
occurred on the line Babeni – Alunu on the 15th and 24th of October 2010

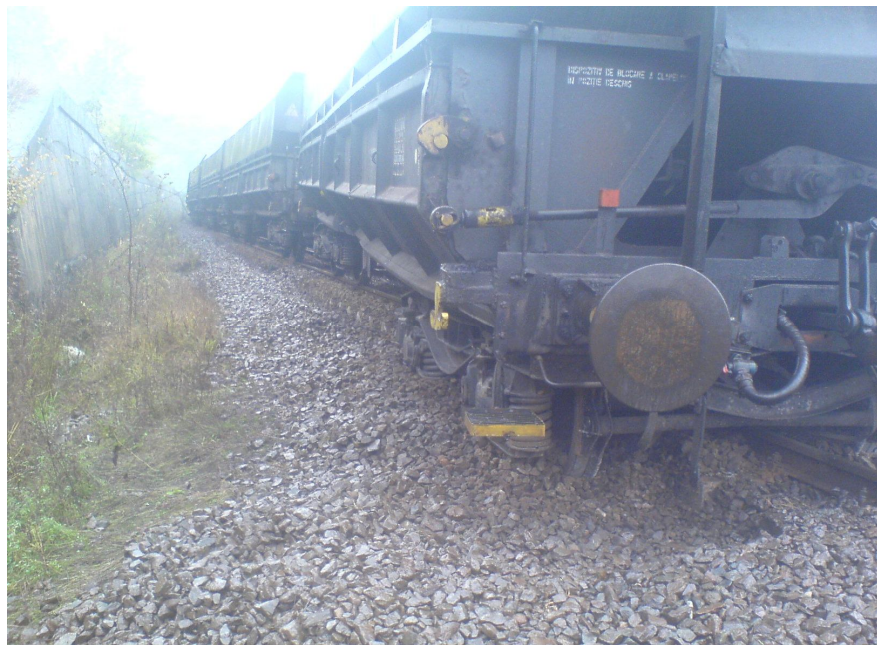
photo no.1

In horizontal plane the area where occurred the embankment compaction and respectively the derailment of the 10th wagon by locomotive is on the curve km 18+886-19+295 on the surface of the parabolic curve of connection between the circular curve with $R=535$ m and the adjacent alignment. In this area the transverse profile of the rail is mixed and in the profile along the area is in ramp of 9.31‰.

The prism of broken stone was unclogged and unconsolidated. On the 15th of October 2010 were performed works of mechanical sifting, stuffing and shifting with railway heavy machineries on the area km 18+800 - 19+250 km. Stuffing and shifting I on this area was performed in two stages on the 29th of October 2010 and the 3rd of November 2010.

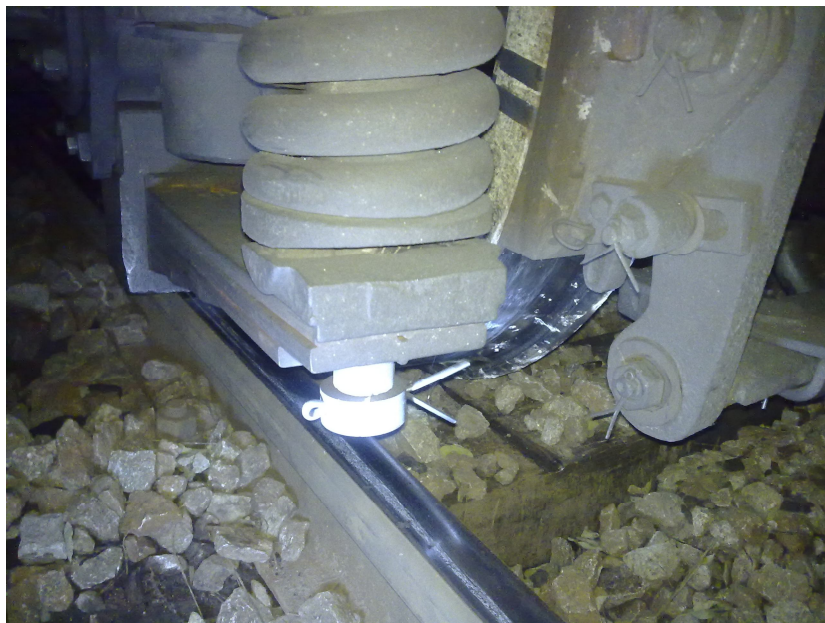
photo no.2

In the area of the derailment the line is in curve with the radius $R=300$ m, the over-elevation $h=70$ mm, over-enlargement $s=15$ mm, the transverse profile is mixed, in ramp of 14.66‰ (on the area of km 21+775 - km 22+225).

The prism of broken stone was unclogged, unconsolidated. On the 11th of October 2010 were performed works of mechanical sifting, stuffing and shifting with railway heavy machineries on the area of km 21+700 - km 22+300, distance on which was performed the stuffing I on the 18th of October 2010.

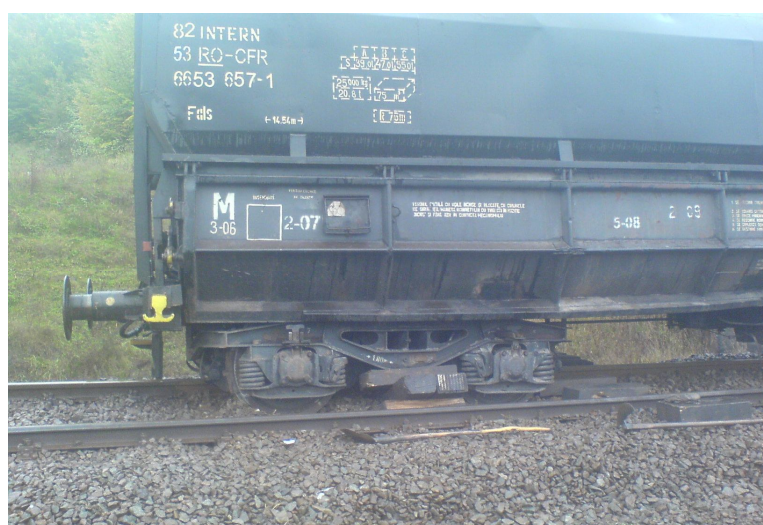
photo no.3

The sifting was performed without addition of new broken stone, which resulted of decreasing the height of broken stone layer from under the sleeper sole.

The technological stuffing, intermediate and stuffing I, were performed without addition of broken stone, on the prism remained at the sizes after the sifting

The prism after the stuffing was complete from the point of view of the outer sizes which led to the conclusion that values of the outer sizes could have been obtained only by decreasing of the height of broken stone layer from under the sleeper sole.

The decrease of the width of broken stone layer led to an increase of the loads on the embankment platform surface from under the line by decreasing the coefficient of bed of the system between the sleeper sole and the embankment platform.

The water runoff is not provided from the level of the rail platform by cutting of the banquets or performing some end drains.

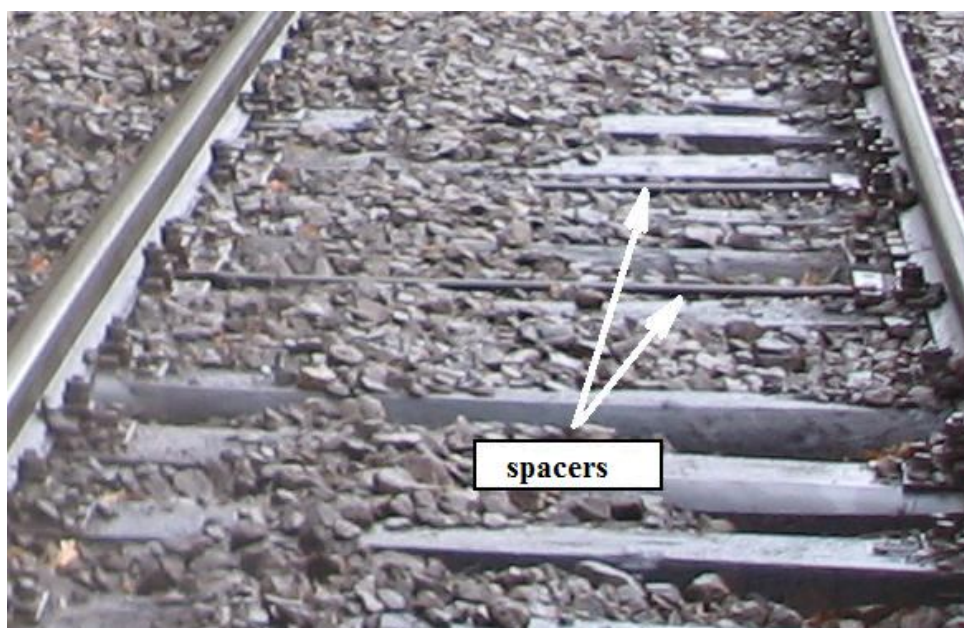
photo no.5 – fixing consolidated with spacers at km 21+900

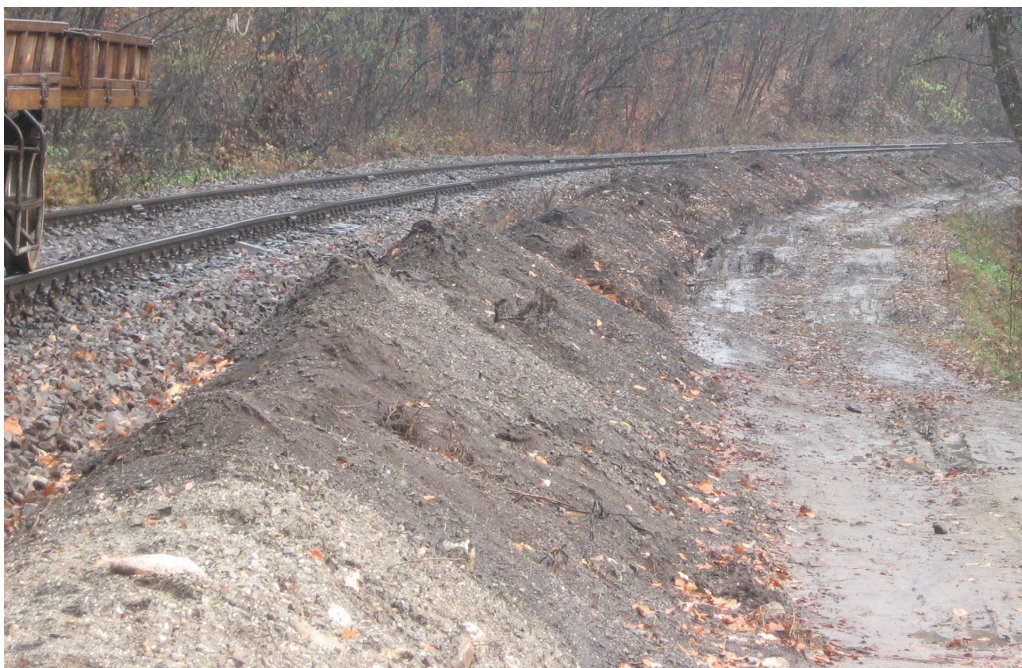
photo no.6

The sifting was performed without addition of new broken stone, which resulted of decreasing the height of broken stone layer from under the sleeper sole.

The technological stuffing, intermediate and stuffing I, were performed without addition of broken stone, on the prism remained at the sizes after the sifting.

After the technological stuffing the prism of broken stone had provided the instructional width but given the deficit of broken stone it can be provided only by decreasing the height of the broken stone layer under the sleeper sole.

The decrease of the width of broken stone layer led to an increase of the loads on the embankment platform surface from under the line by decreasing the coefficient of bed of the system between the sleeper sole and the embankment platform.

The water runoff is not provided from the level of the rail platform by cutting of the banquetts or performing some end drains.

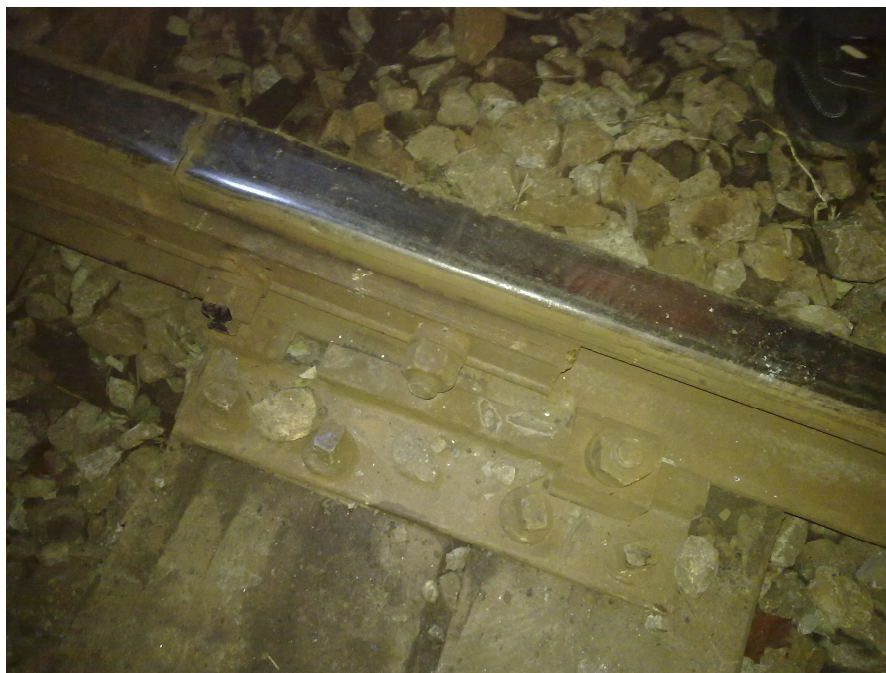
photo no.7

Vertical fixings with high degree of wear that led to the introduction of some metal spacers to keep the gauge in tolerances.

Due to rails reversals in curve performed over time, the gaps moved, some joints becoming suspended.

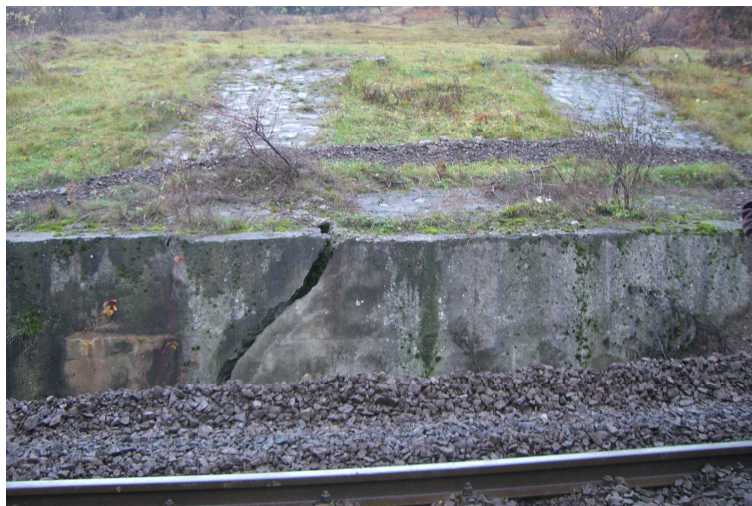
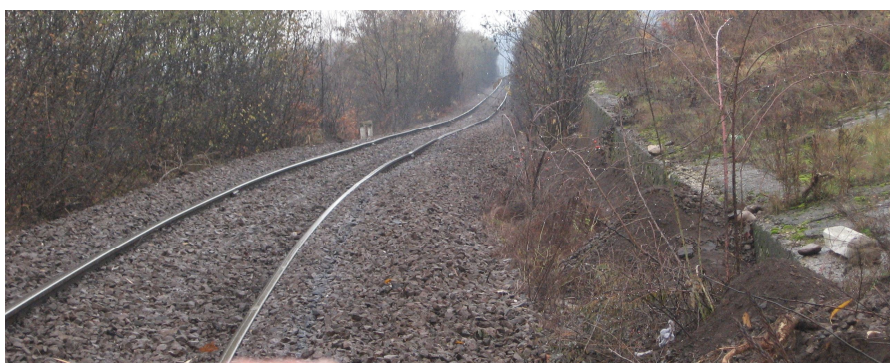
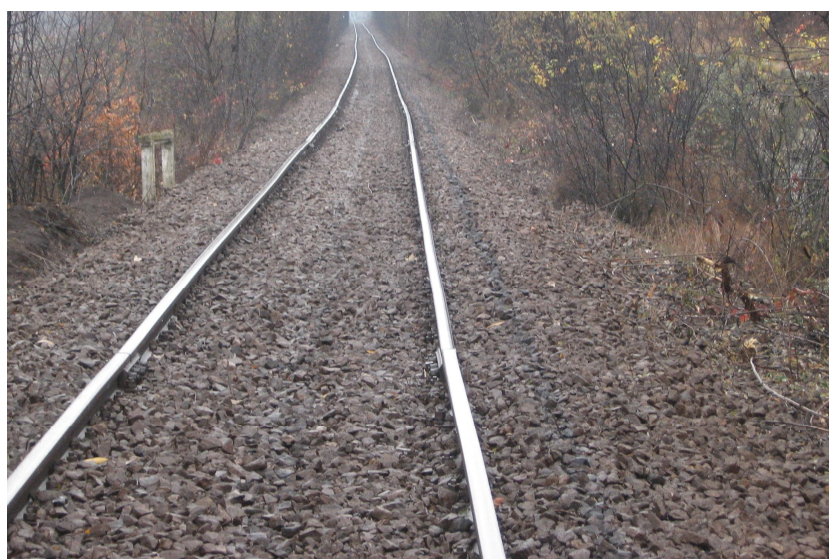
- area from km 18+150 to km 18+450 where the line is affected by sliding of the slope on the left of the rail that led to the braking and deformation of the support wall, of the reinforced trench and the deformation of the direction and of the profile along of the line on a distance of about 300 meters. To improve the quality of this area is prepared a technical documentation no. 8-263-99 by ISPCF Bucharest since 1999, but the work to date has not been executed.

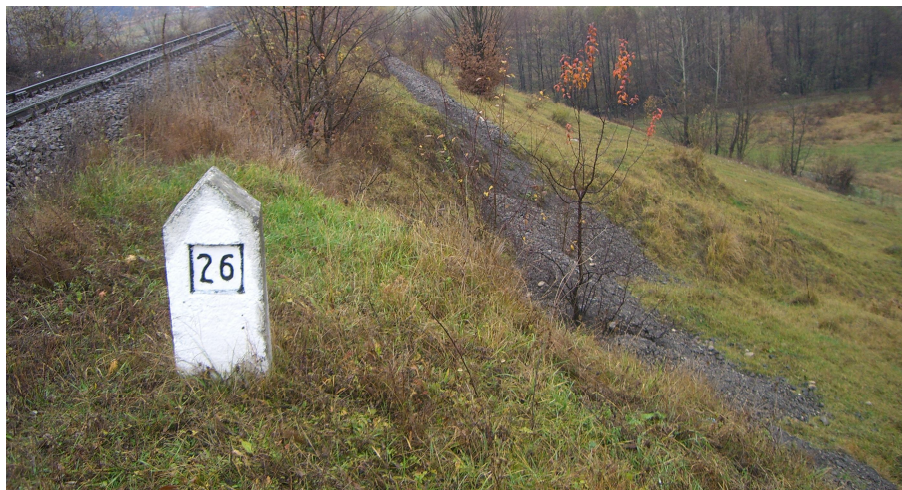
photo no.12

- area from km 26+000 to km 26+015 where the line is affected by the sliding of a part of the slope on the right of the embankment and by a landslide on a length of 10 m.

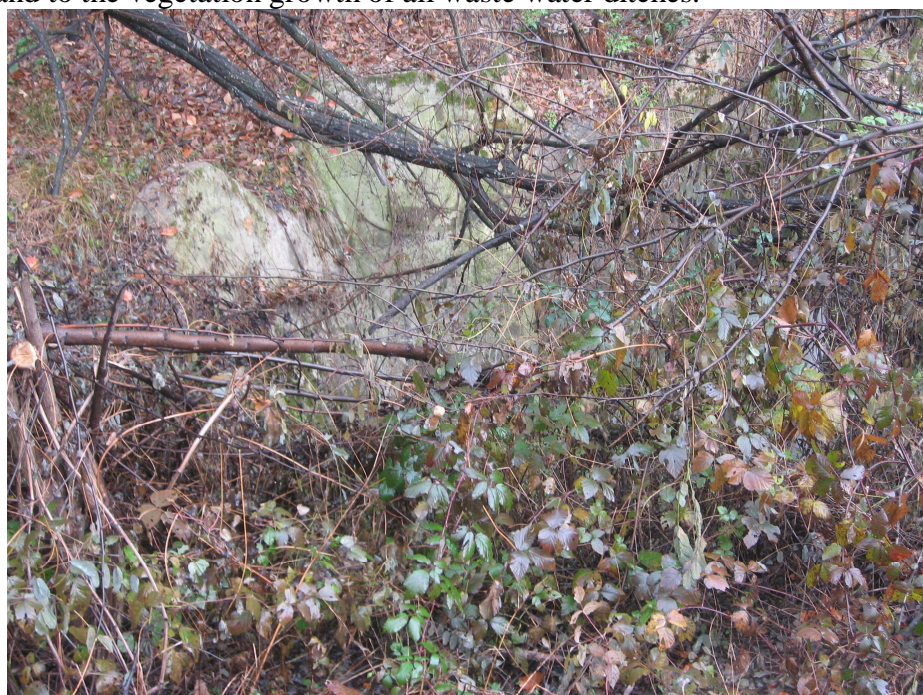
photo no. 13 - km 21+900

It was also found the obstruction of the waters access to the fall chambers of the footbridges due to the clogging and to the vegetation growth of all waste water ditches.

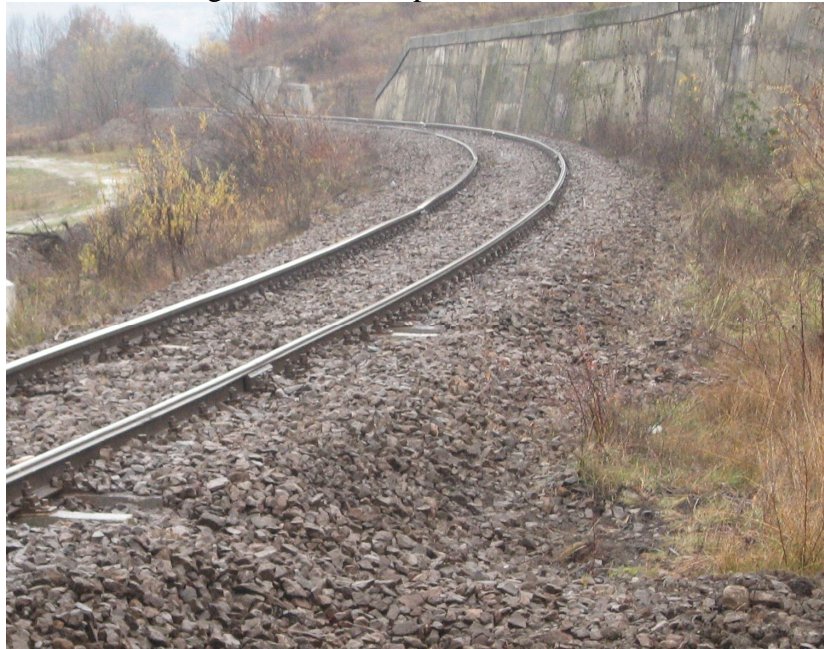
photo no.15

area of km 18+890

- width of the prism of broken stone was provided, but the broken stone was not compacted and reinforced and the clogged banquet and the sterile resulted from the sifting process were impeding the waters discharge from the rail platform.

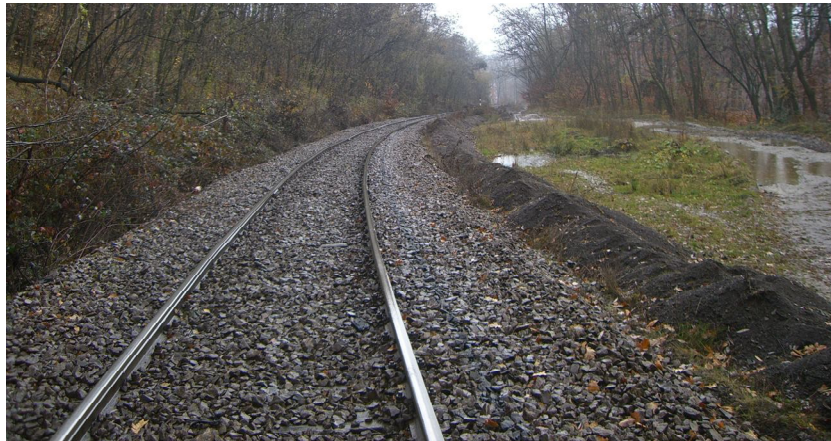
photo no.16

area of km 21+900

- width of the prism of broken stone was provided, but the broken stone was not compacted and reinforced and the clogged banquet and the sterile resulted from the sifting process were impeding the waters discharge from the rail platform;
- rail banquet towards the drainage ditch on the right clogged and the drainage ditch was full of vegetation.
