## **INVESTIGATING REPORT**

on the railway accident occurred on the 9<sup>th</sup> of July 2011,  
on the range of activity of CF Iasi Regional Branch  
between the railway station Podu Iloaie and the flag station Sarca

Final EDITION  
*The 5<sup>th</sup> of September 2011*

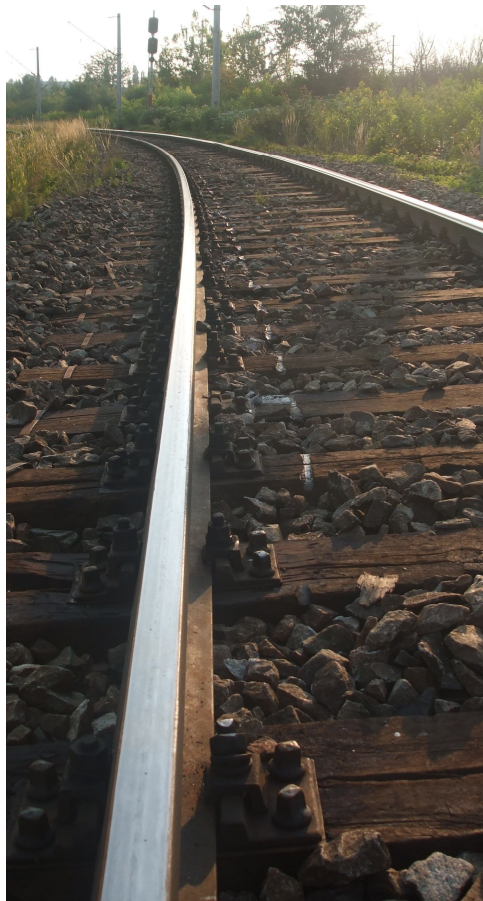
Km 42+620

The wheels on the right of the bogie (in the running direction) ran outside the path on the sleepers end to the limit of the metallic clamping plates and the wheels on the left ran between the path wires from the limit of the metallic clamping plates to the path axis.

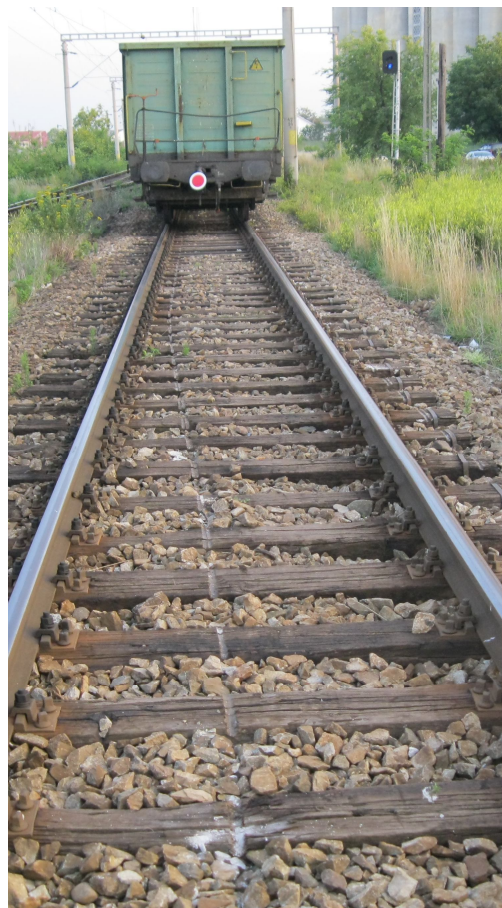
Km 42+210

The derailed bogie was stopped at the km 42+210, at 2 m from the shunting signal M 3 of hm Sarca and at 10 m from the first joint of the double-junction crossing 5/7 from the X end of the flag station.

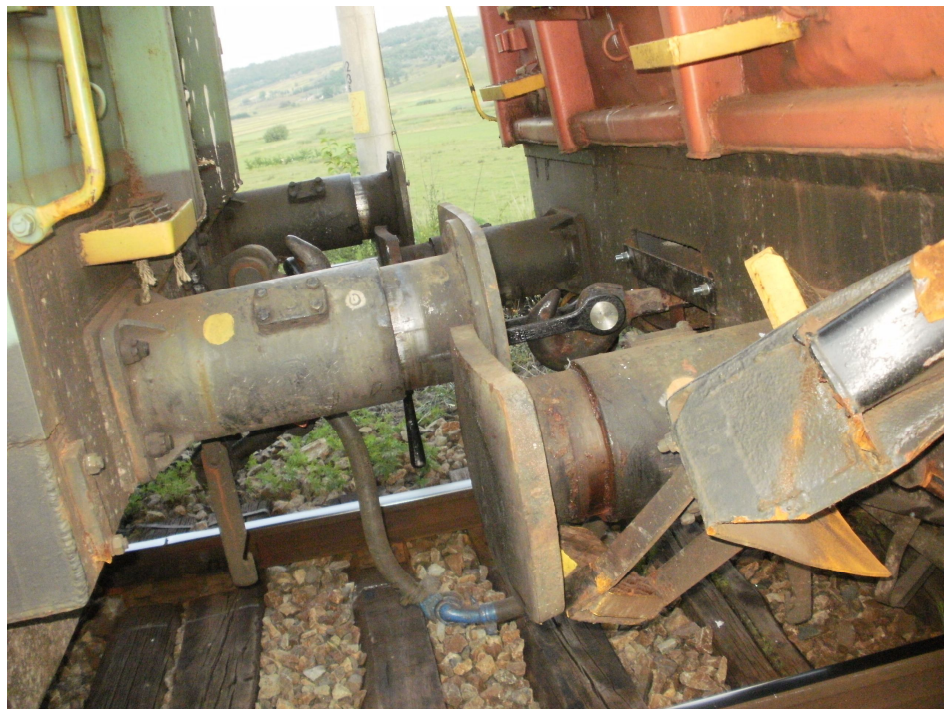
The wagon with the derailed bogie ran to the km 42+210. On the distance of 410 m the wheels on the right of the derailed bogie ran on the end of the sleepers distance from the outside rail of the curve being within 20 and 50 cm and the wheels on the right of the bogie ran on sleepers, between the path wires. On this distance occurred also the overlap (jamming) of the pads plates of the last but one wagon (derailed) with the ones of the last wagon.

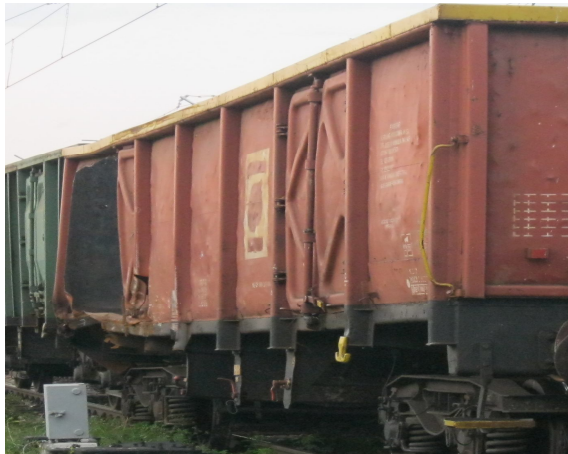
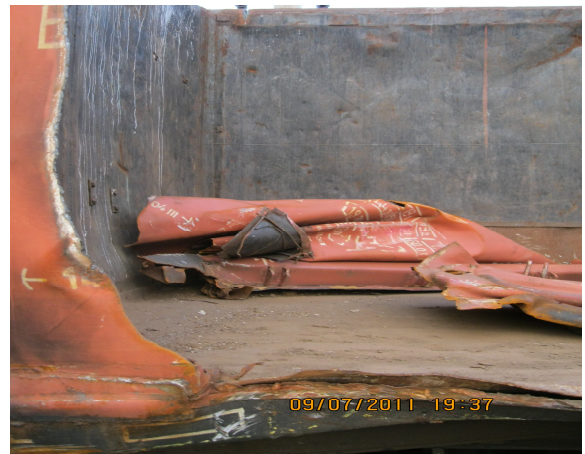
- \* the right side wall (in the running direction) of the wagon box was cut on a length of 2.70 m and was deposited on the wagon floor, on which was fixed by welding;

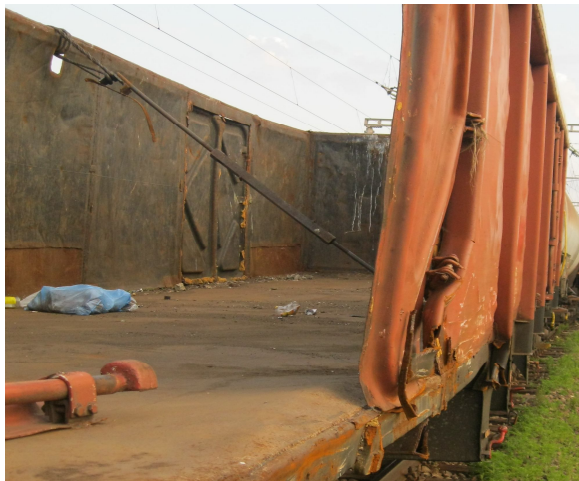
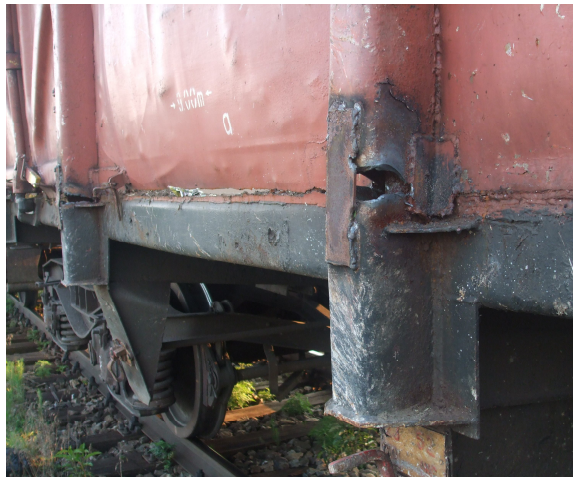
- \* The wagon box was temporary reinforced through inside by a metallic rod linked on the wall on the left (in the running direction) and welded on the wagon floor and on the broken or cracked areas of the wagon walls the reinforcement was insured through outside by welded metallic plates;

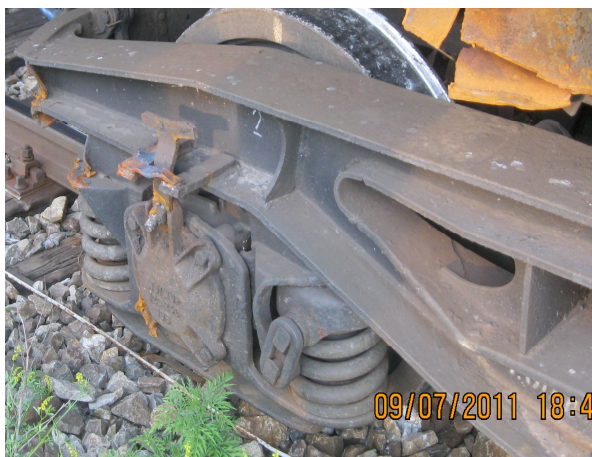
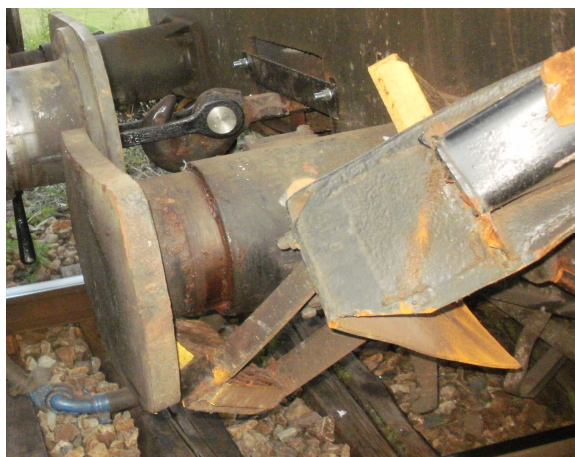
- \* The bogie frame Ycs 25, no. 07202 (derailed) had the limiter type T and a broken screw, next to the wheel 2, temporary repaired by welding;

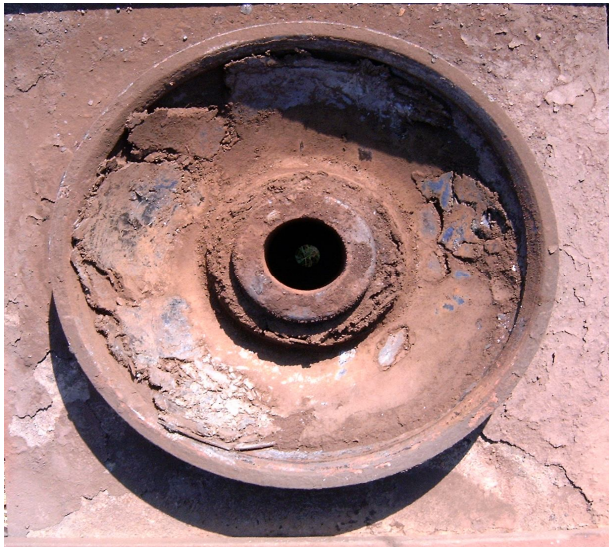
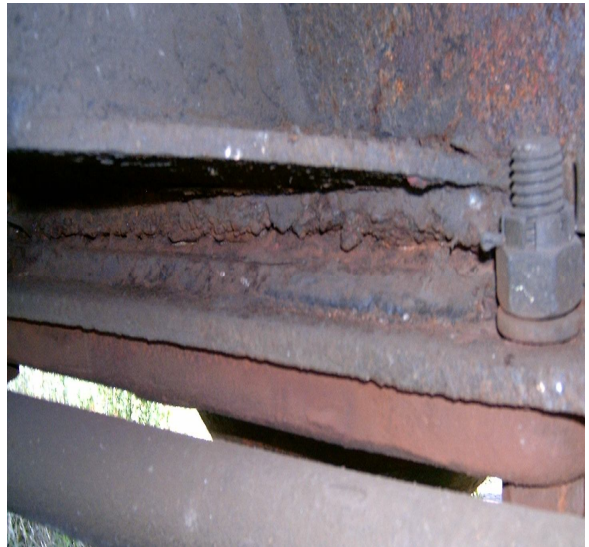
- at the semispherical pallet of the derailed wagon the wear plate type “Railko” was destroyed in proportion of 80%;

The increase of the resistance at rotation of the pivot in the pallet was due to the increase of the friction coefficient because of the destruction of the wear plate type “Railko”, of formaldehyde resin.

The destruction of the wear plate occurred at the inclination of the loaded wagon at shunting in the railway station CFR Cristesti Jijia, at the railway incident occurred on the 21<sup>st</sup> of June 2011.

- 80% destruction of the wear plate type "Railko" from the hemispherical pallet of the bogie derailed from soliciting and tilting of the wagon in an incident occurred on the 21<sup>st</sup> of June 2011, which made difficult the entry of the bogie in the curve;

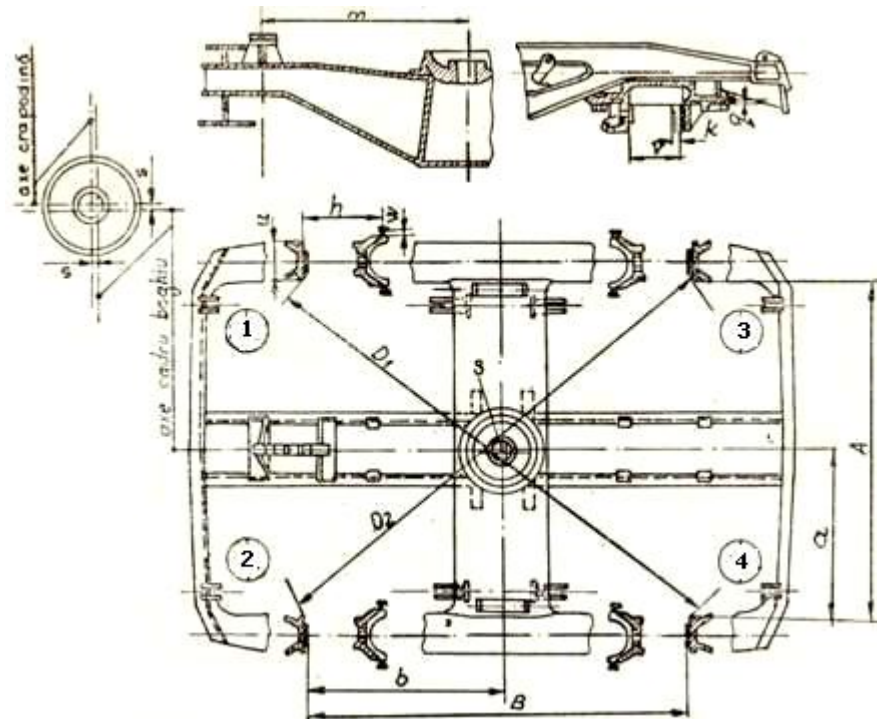
The values of the measurements of the bogie frame show its deformation over the admitted limits.

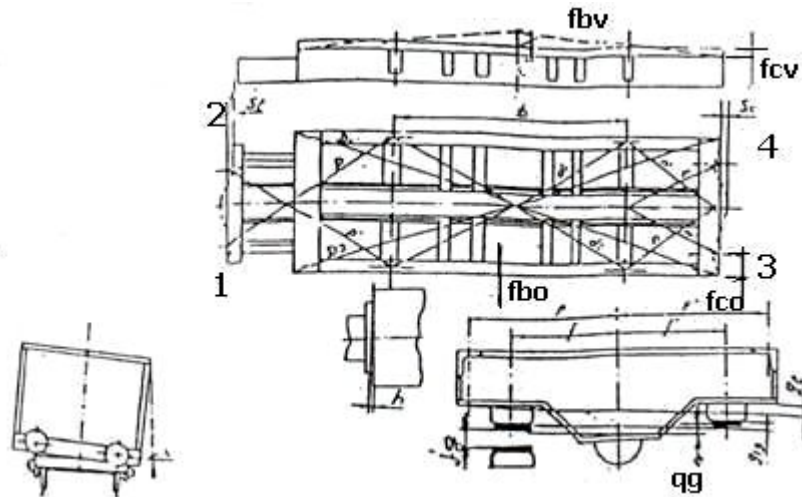
The values of the measurements at the wagon chassis show its deformation over the admitted tolerances.

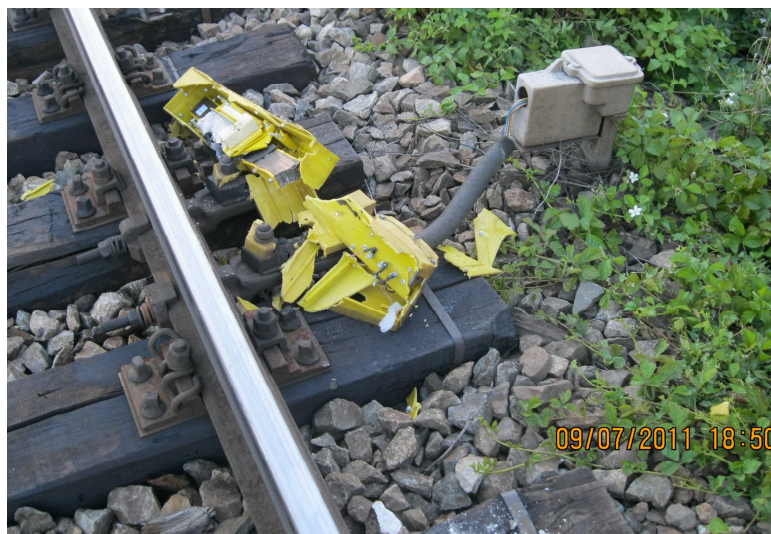
*The inducer of 1000/2000Hz of the signal X*

After the derailment the inducer of 1000/2000 Hz placed next to the input signal X was destroyed by the derailed wheels of the bogie.
