MINISTRY OF TRANSPORTS AND INFRASTRUCTURE
ROMANIAN RAILWAY AUTHORITY - AFER

ROMANIAN RAILWAY INVESTIGATING BODY

INVESTIGATING REPORT

on the railway accident
occurred on the 31st of December 2010 in the railway station CFR Sinaia

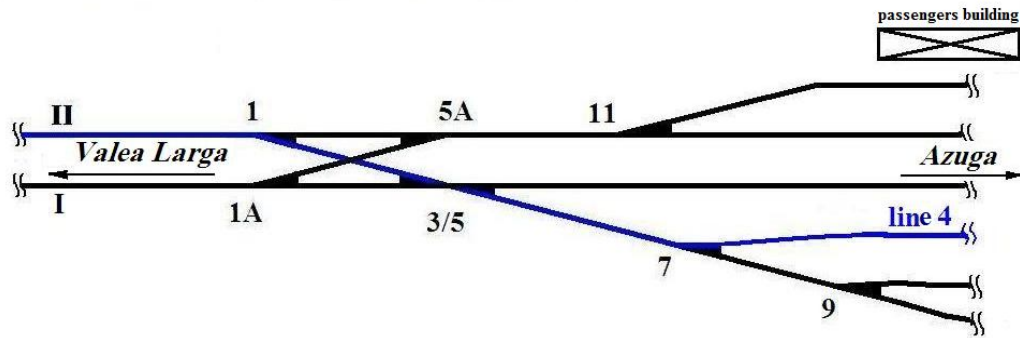
The railway station CFR Sinaia X end

The switches no. 7 and no. 1 were attacked from the heel and the TDJ no. 3/5 was attacked on the direction II-IV

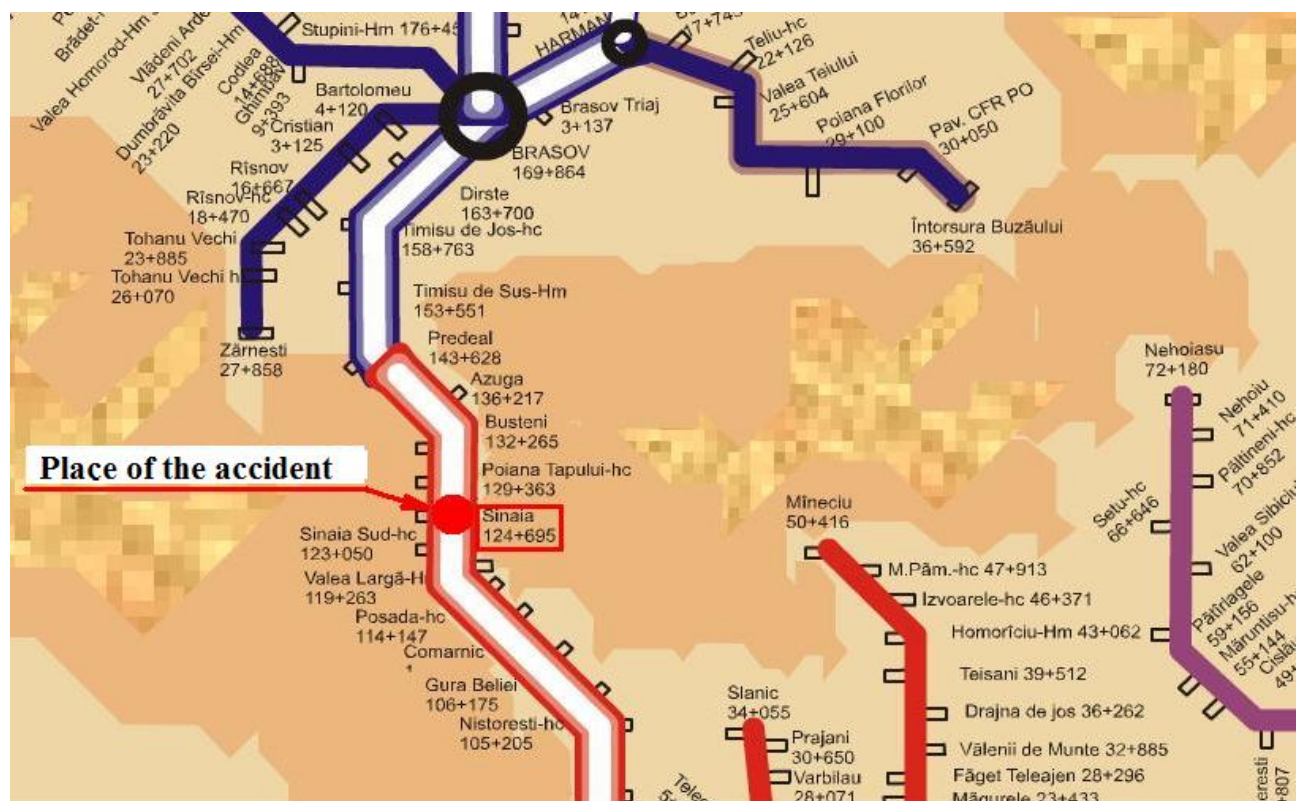
When the train stopped the locomotive EA40-0622-7 was on the direct of the leg 1-3/5-1A-3A corresponding to the running wire I Valea Larga – Sinaia and the secondary locomotive DA 60-1006-0 was accordingly to the train path, respectively on the diagonal 5/3-1 from the leg with access to the running wire II Sinaia-Valea Larga having all the wheels on the rails.

The wagons in the composition of the train did not derail.

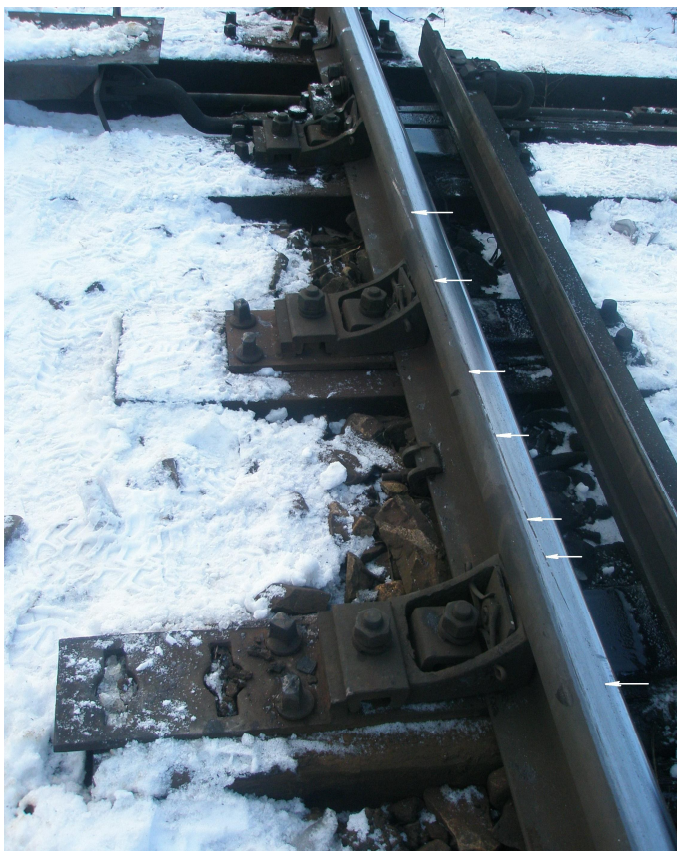
The first sign of leave of the rolling surface of the rail head was found on the connection rail corresponding to the outer wire of the curve of the switch no. 5 at a distance of 1020 mm after the top joint on the left (in the running direction of the train). Starting from this point on the rolling surface of the rail head was found a sign left by the bandage rim of the wheel on the left of the first axle of the locomotive. This sign is on a length of 1170 mm then the wheel on the left derailed and fell outside this rail and the wheel on the right between the railway wires near the rail head of connection on the right.

The locomotive ran derailed by the first axle, its wheels rolling with the bandages rims on the rods ends of the vertical screws and on the beams between the counter-needles and the needles.

In the area of the 3rd sliding (counted from the top of the needles towards their heel) on the right counter-needle was found a sign of rolling of the bandage on its head on a length of 1100 mm.

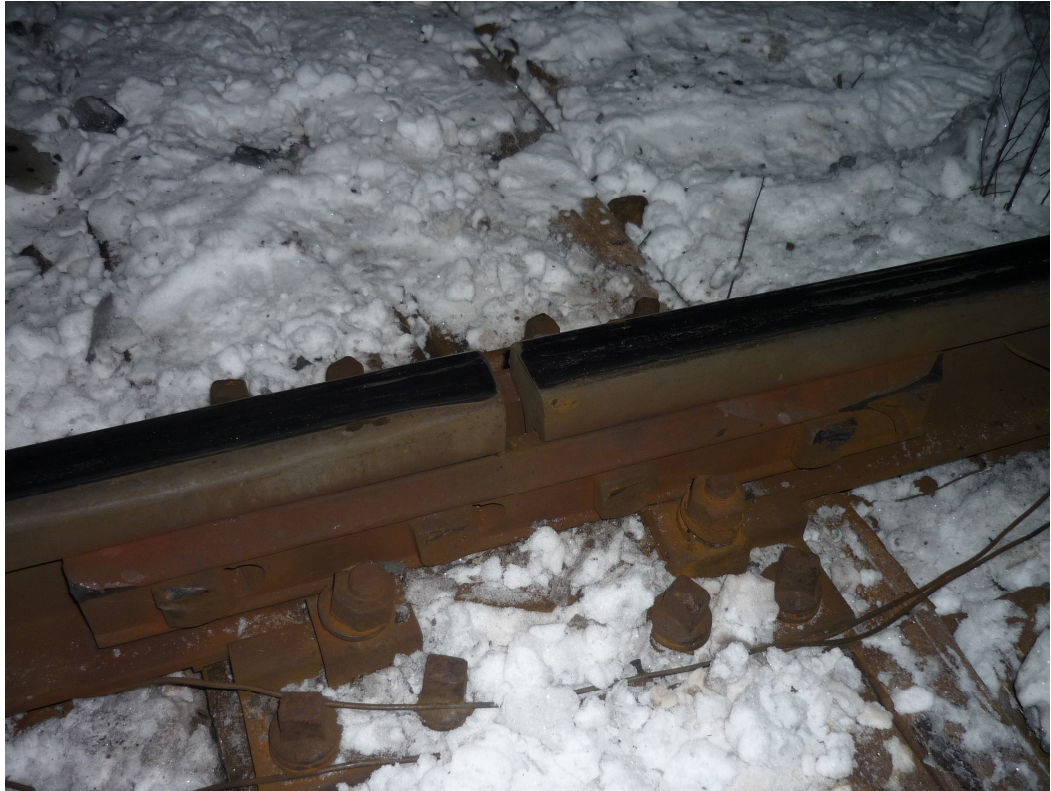
b) the diagonal between the switch no. 7 and the cross with double junction TJD no.3/5

On this line portion on the top ends of the rods of the vertical screws on the left of the left rail and on the left of the right rail were found rolling signs of the bandages rims.

Also were found slight signs of grinding of the edge of the metallic cover plates and of the ends of their horizontal screws.

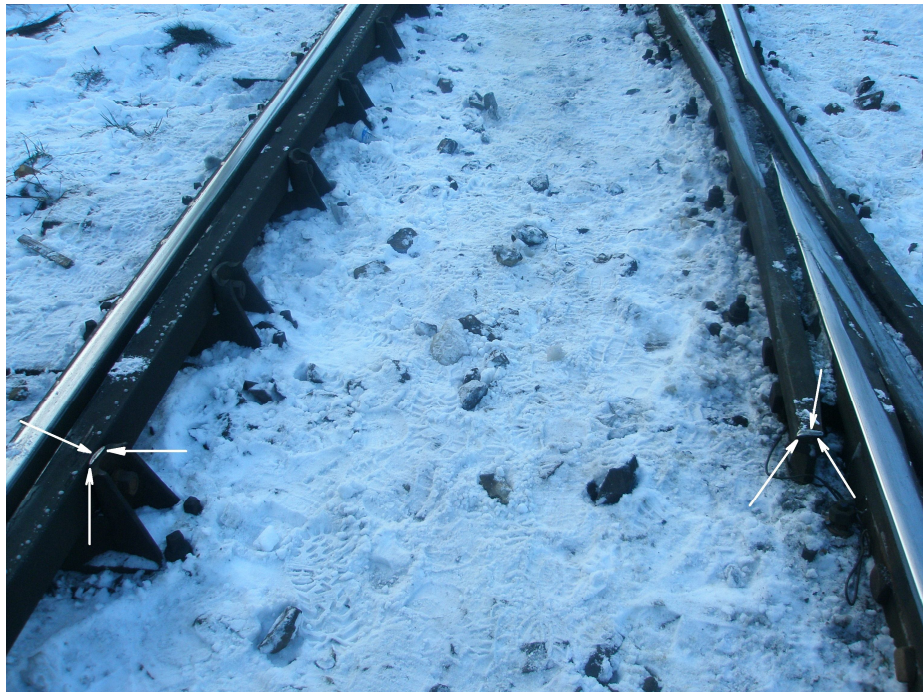
c) *the cross with double junction TJD no. 3/5*

On the metallic parts of the TJD no. 3/5 were found several signs of hit, escalation and fall. The first signs were found on the direction IV, at the simple core of the switch no. 5 in the composition of the cross with double junction, on the top side of the 2nd support from the checkrail near the core and at the end of the elbow rail from the switch no. 7.

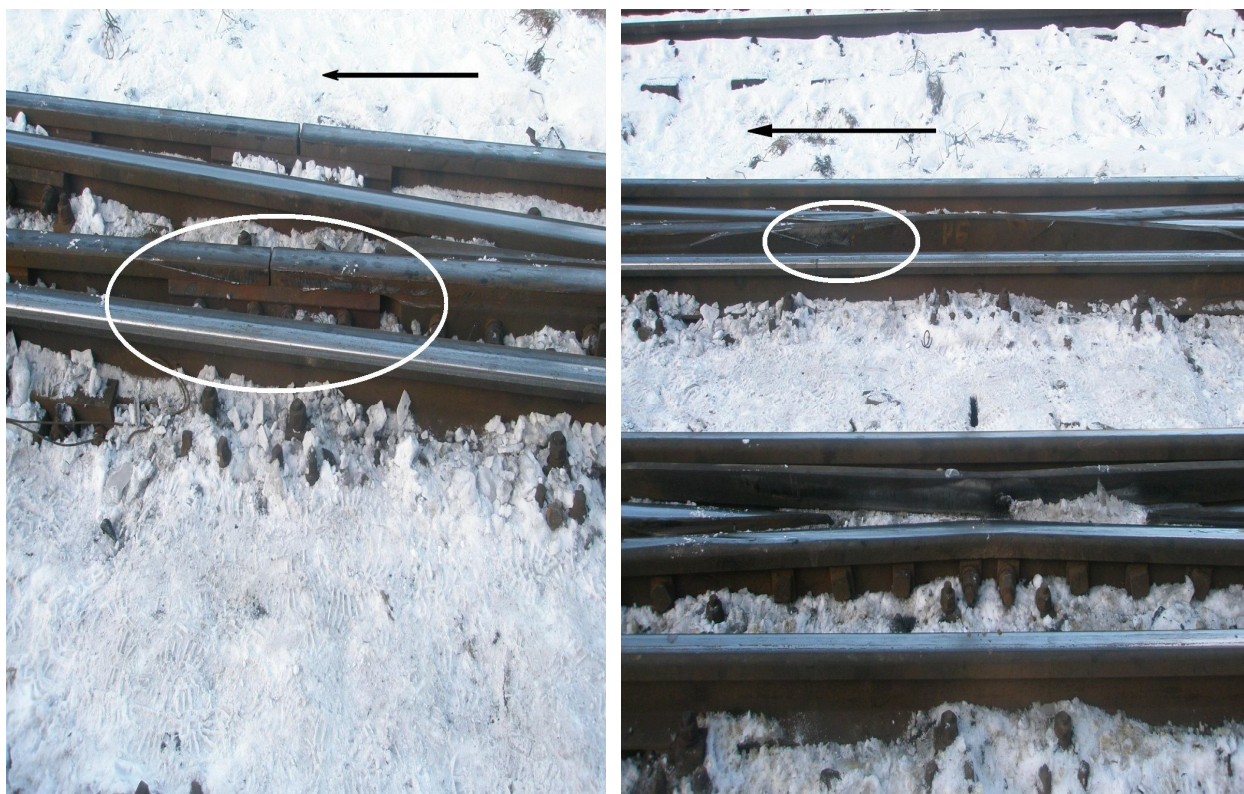
On the rolling surface of this crossing core were found also signs of rolling of the bandage rim of the wheel on the right.

Near the top joint of this core, which is also top joint for the top of the needles were found signs of rolling of the wheel on the left on the top side of the rods of the vertical screws on the left of the curved counter-needle, corresponding to the direction IV-I.

Near the heel joint of the curved needle of the direction IV wheel on the right of the first axle derailed, hit and curved this needle.

Specific signs of derailment were found also in the area of the heel joint of the needles on the direction IV and in the checkrail of the double core on the right.

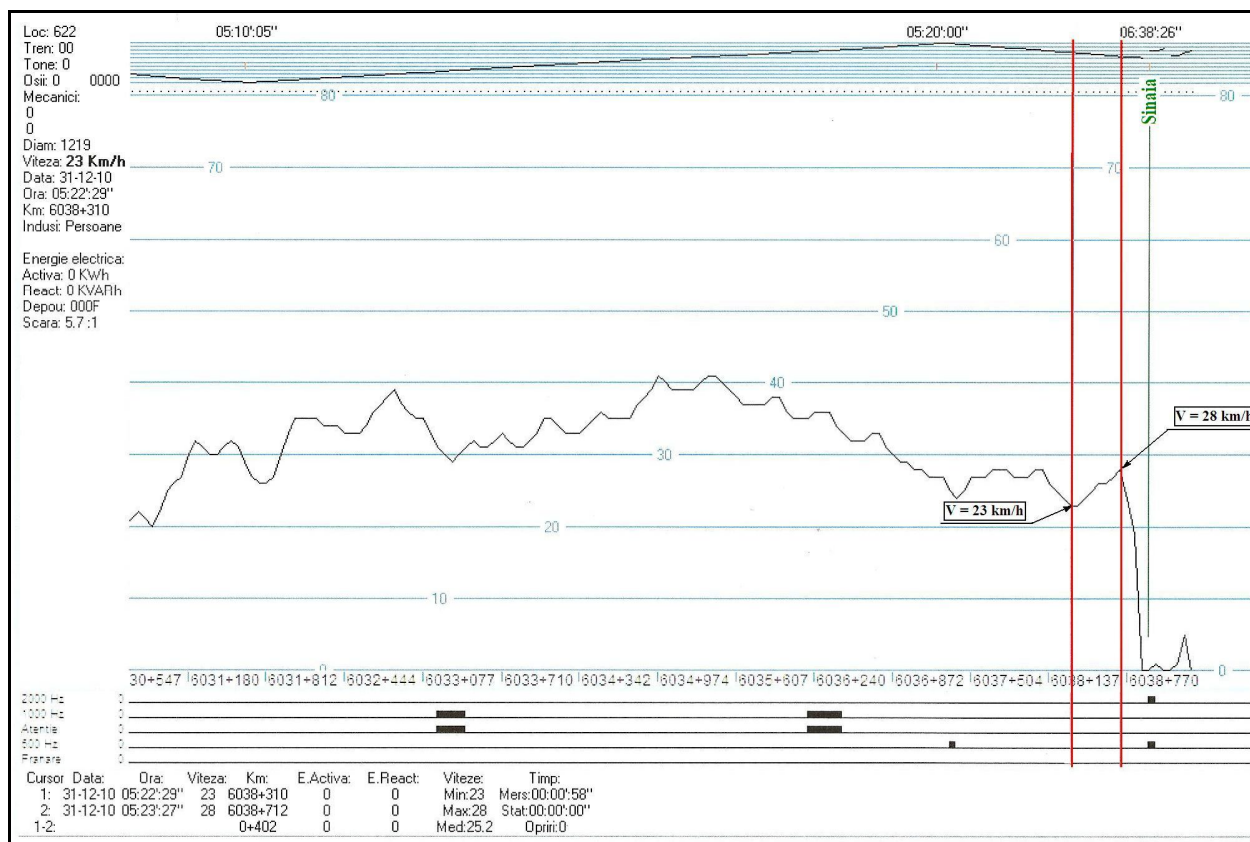
At 5:22:29" a.m. the locomotive driver increased the speed from 23 km/h to 28 km/h, increasing implicitly the traction force. At that moment the locomotive was with the 2nd bogie on the curve with left deviation and the radius of 735 m and with the first bogie on the curve of the switch no. 7 with right deviation (in the running direction of the train) having the radius of 300 m and in slope of 24.53‰ (gradient).

Due to the rotation phenomenon inherent to the electric locomotives with the separate operation of the axles, phenomenon that discharges the appeal wheel and charges appropriately the one in the back, under traction conditions, after a duty brake, at the running on a portion of line in curve and in slope with gradient of 24.53‰, the driving force of the appeal axle reduced considerably, which favored the escalation of the rail from the outer wire of the curve of the switch no. 7 by the wheel on the left of the axle.

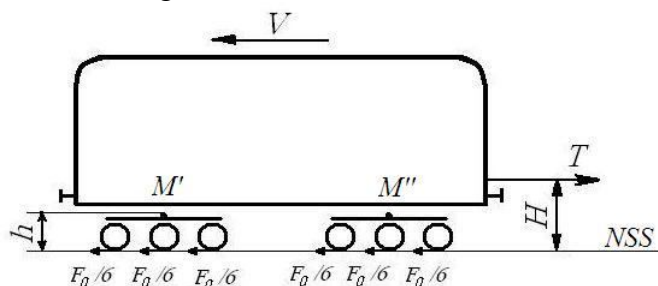
- a couple due to the fact that the force from the hook and the motor forces applied at the pivots are not at the same height;

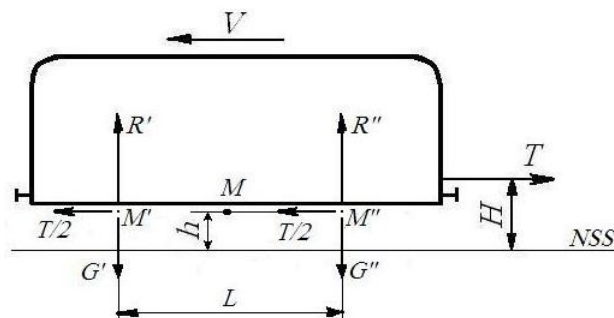
- a couple due to the fact that the weight of the locomotive box, in traction regime, is unequally distributed at the two supports ($R' < R''$)
