INVESTIGATING REPORT

on the fire occurred at the locomotive **DA 60-0945-0**
owned by SNTFM “CFR Marfa” SA, in the running of the train no. 83972,
on the current line Targusor Dobrogea-Nicolae Balcescu (km 31+000),
on the 23th of August 2010

Final EDITION

The 19th of January 2011

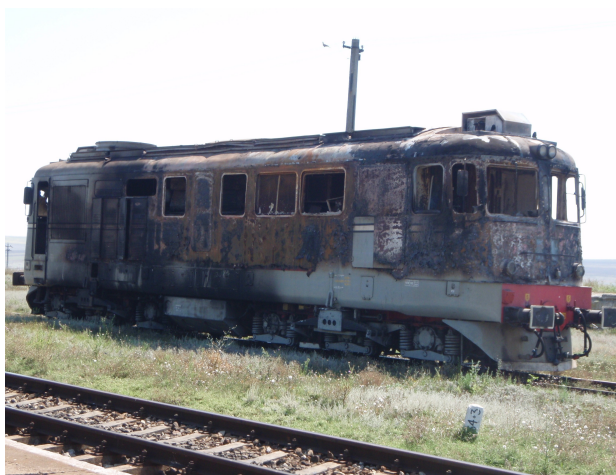
Photo 1

- thermal influence of the fire on the locomotive box and frame (photo1);

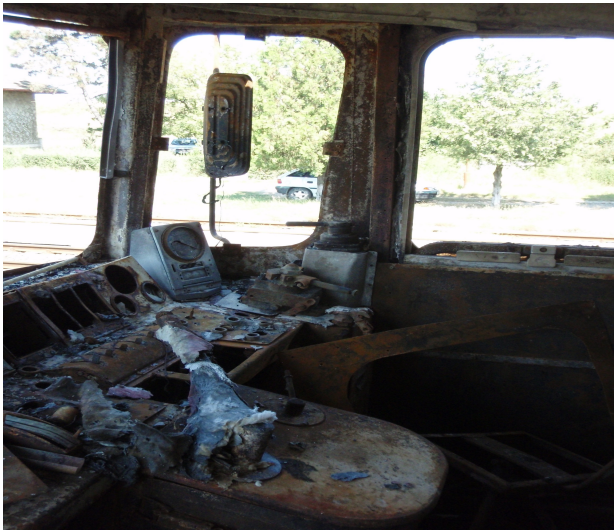
Photo 2

- effects of the fire on the driving, indication and protection equipment from the work station no. 1 (photo2)

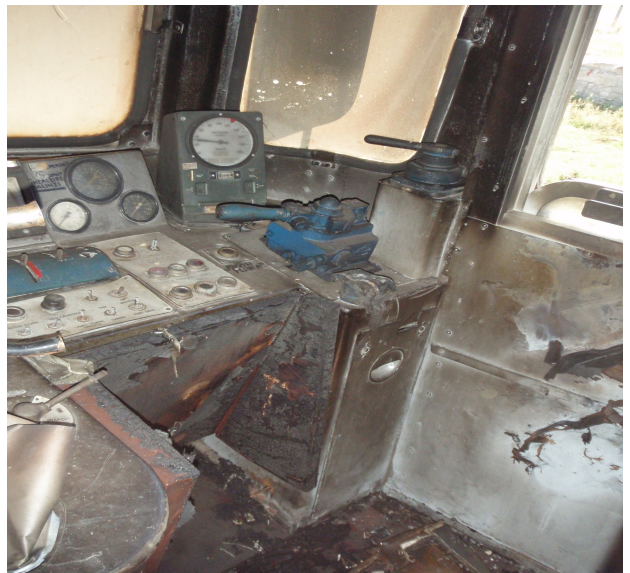
Photo. 3

- effects of the fire on the driving, indication and protection equipment from the work station no.2 (photo3)

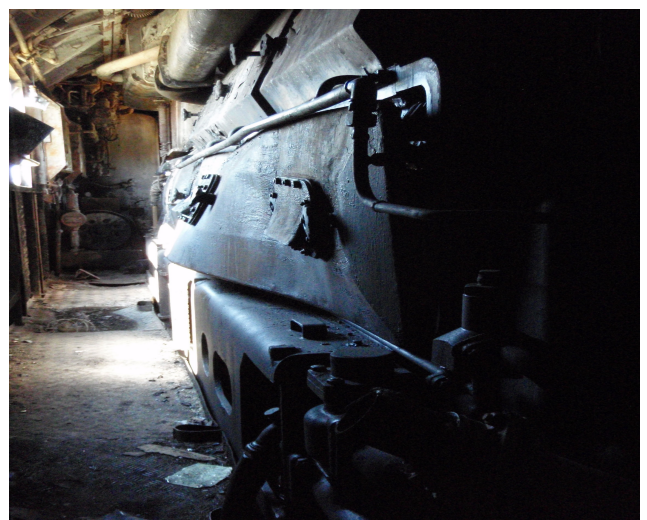
Photo. 4

- pronounced deformation of side covers of the diesel engine crankcase specific to an internal explosion (photo.4;5);

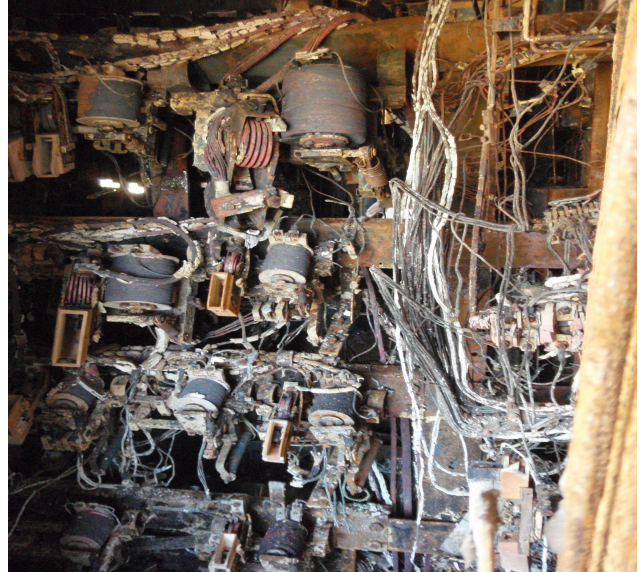
Photo. 6

- thermal degradation of the electric equipment and of the combustible structural elements from the engines box and the block equipment of connecting, switching, monitoring and protection (photo. 6);

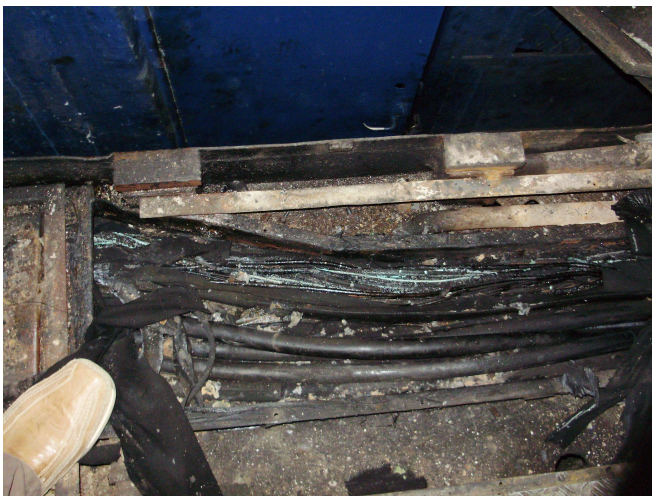
Photo. 7

The insulation of the power and command wiring completely burned, covers and fuel supports of the contactors, relays, switches, vigilance installations, INDUSI and speedometers with major thermal degradation.

Cable channel engines box (photo. 7)

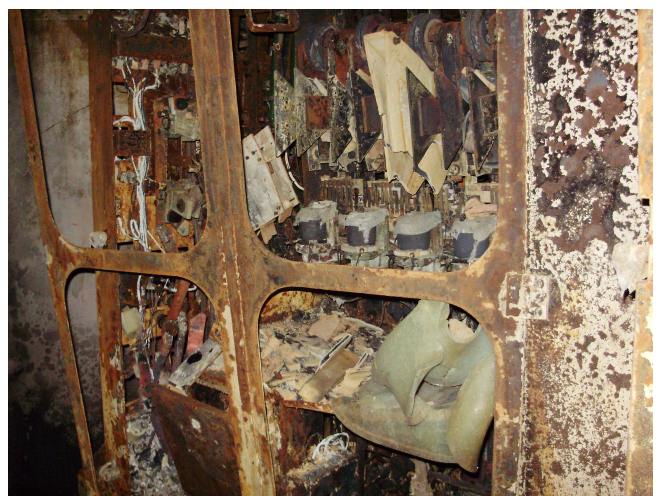
Photo. 8

Block devices – MT line contactors (photo.8)

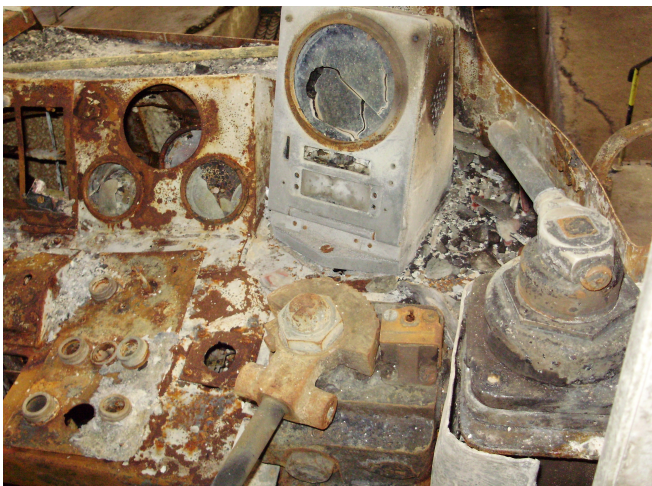
Photo. 9

Control panel – driving station no. 1 (photo. 9)

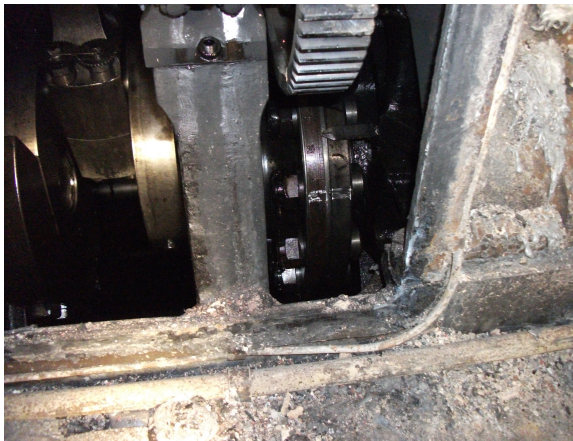
Photo. 11

- after removing the side covers of the crankcase and facing the engine mechanisms, one proceeded to rotate the engine manually without finding its locking, which implied that there were not landing or rod bearing melt (photo 11 and 12), further confirmed after dismantling;

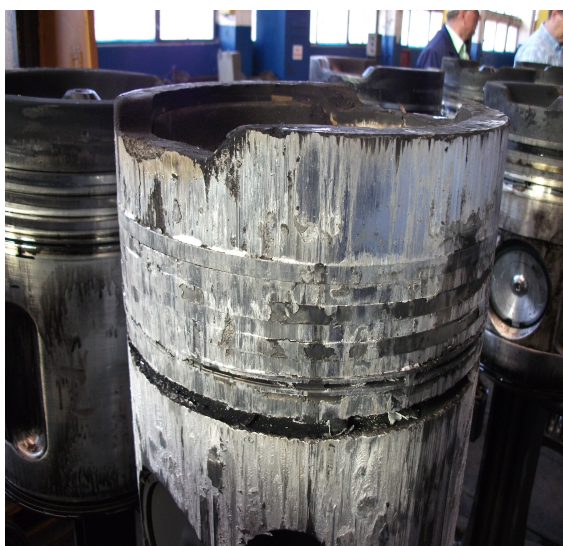
Photo. 13

- at the plunger no.3 (series 48309/1981) were found the following defects (photo.13):
 - two cracks at the top, diametrically opposed, in the same plane with the axis of the piston pin;

- the piston collar moved about 10 mm from the piston body, without affecting valves workspace, with strong traces of friction and material melting;

1. Including the work of checking the combination between the collar and the body of the piston, at each technical intervention, accidental repair, which involves the dismantling and removal of the piston from the diesel engine in the process of maintenance carried out by the economical operators, authorized as rail suppliers and who have technical rail agreements for the respective types of intervention.

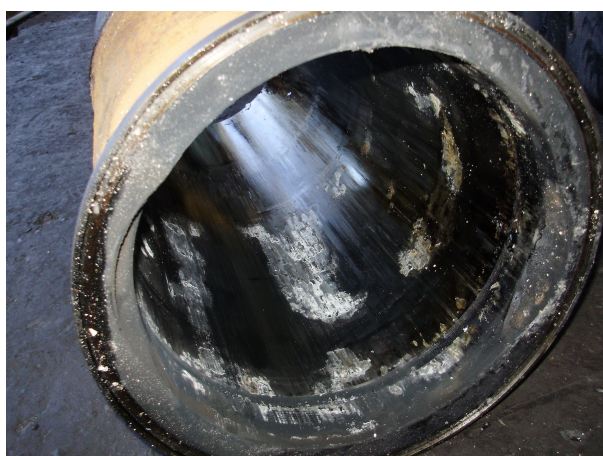
Photo. 15

- transfer of material (aluminum) from the body of the piston its deposition on the cylinder of the piston (photo. 15);

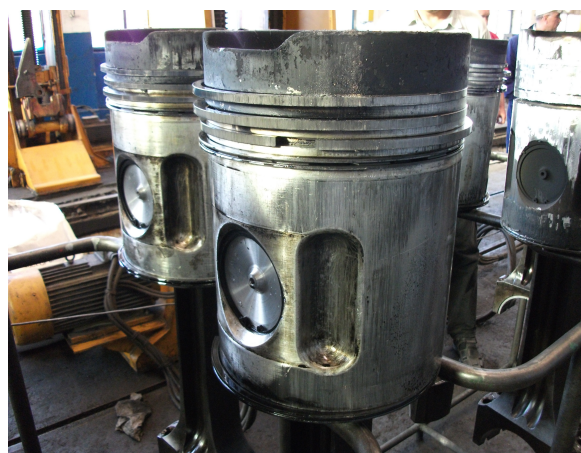
Photo. 14

at the other 11 pistons of the diesel engine were not found defects leading to malfunction of the diesel engine (photo. 14)

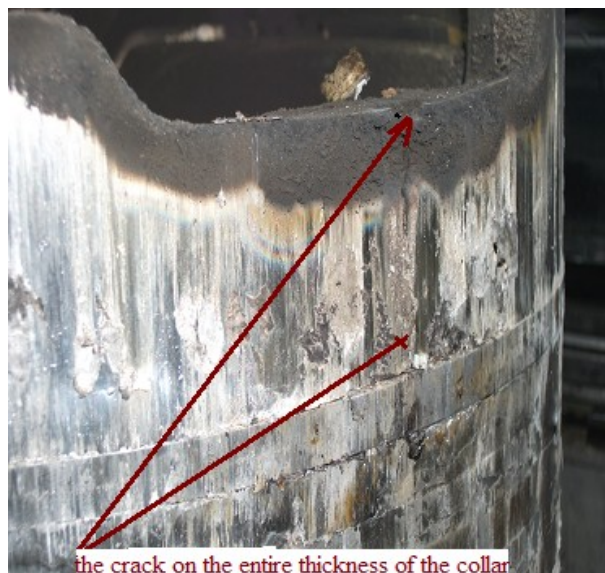
Photo. 16

The production of combustible vapors and gas was because of the cracks (photo. 16) of the collar piston no. 3, occurring its dislocation, which by moving with about 10 mm obstructed the internal oil channels that provide the lubrication and especially the cooling of the segments area.

Under these conditions, the operation of the piston without lubrication and cooling led to an increase of temperatures above the operating values (350-400°C), fast erosion of the segments, loss of compression so that the amount of diesel injected at temperatures over 700°C produced its aerating and of the oil from the piston body with their accumulation in the crankcase and causing the explosion through the explosion flaps, this being the first “smoke release” aspired by the turbocharger and the forced ventilation of the traction engines and that was noticed by the locomotive staff in the engines box to work station no. 2, respectively under the locomotive as it was noticed by the pushing locomotive staff.

The fire was caused by the auto-ignition of the diesel and oil vapors resulting from a technical failure caused by the emergence and rapid propagation of two cracks at the piston collar, started from the top in vertical plane which contains the bolt axis, followed by the detachment and moving of the piston collar no. 3, producing successively: cancellation of piston lubrication and cooling in the positioning of the segments and the phenomenon of dry friction, temperature increasing above the normal limits, rapid erosion of the compression and lubrication elements, melting of the peripheral layer side of the piston body and rapid accumulation of the diesel vapors in the oil tank over the technological limit of evacuation.

3. Initiation by the railway undertakings who hold this type of locomotive of a study to guide the development of the specialized services of the Romanian Railway Notified Body of a methodology for achieving the necessary checks to ensure the prevention of cracks at the piston collar of the diesel engine model 12 LDA 28 composition.
