ROMANIAN RAILWAY INVESTIGATING BODY

## **INVESTIGATING REPORT**

on the fire occurred on the 17<sup>th</sup> of May 2011,  
on the range of CF Bucharest Regional Branch, between the railway stations  
Titu - Nucet, at the locomotive DA 60-0793-4 (belonging to SNTFC “CFR  
Calatori” SA Bucharest) hauling the passenger train no. 9432

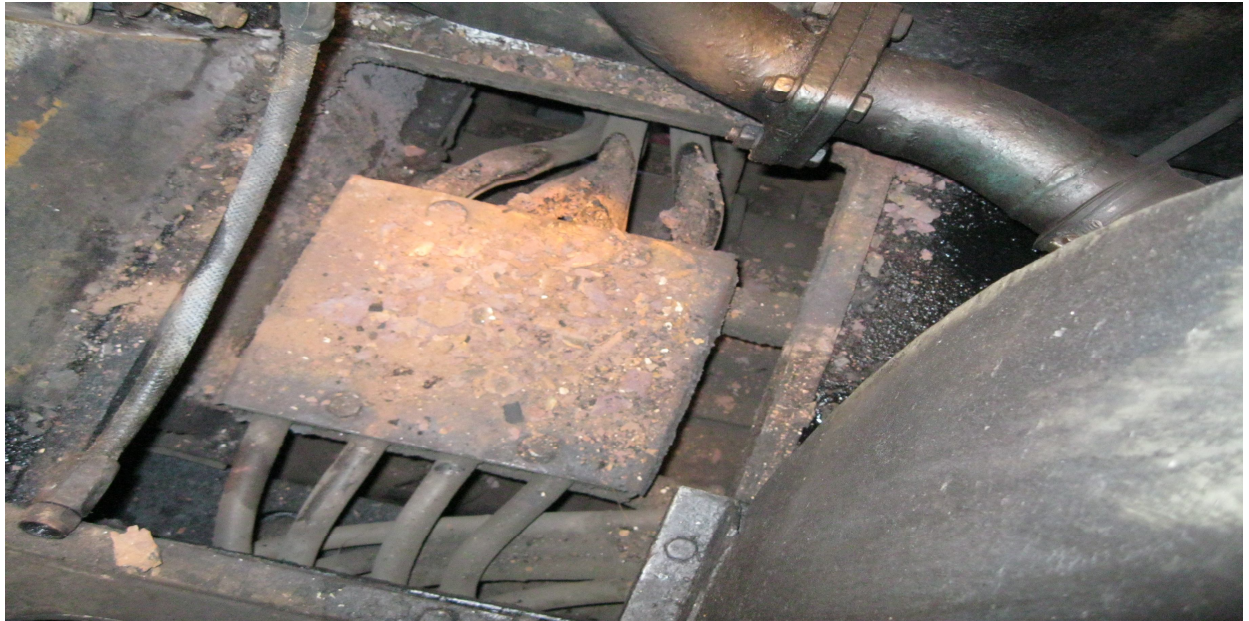
**Photo 1. – Dose EMT4**

- Cover doses of electrical connection EMT 4, ***thermally affected***;
    - Yoke fixing the electric cables EMT 4 upper side ***thermally affected***;

- The protection sleeves of the electric connections E and F from the dose MT 4 ***thermally affected*** at the upper side;

The fire occurrence was due to insulation piercing of the power cables H and F of the traction engine no. 4, placed outside the connection dose of the power cables, which led to the melt of the insulation of these cables, the occurrence of electric discharges between them and their insulation ignition.

1. Development of a study on the occurrence of switching over-voltages caused by the train heating installation type INDA and the traction engines together, to establish the protection methods of the power circuits, in order to prevent the occurrence of similar cases.

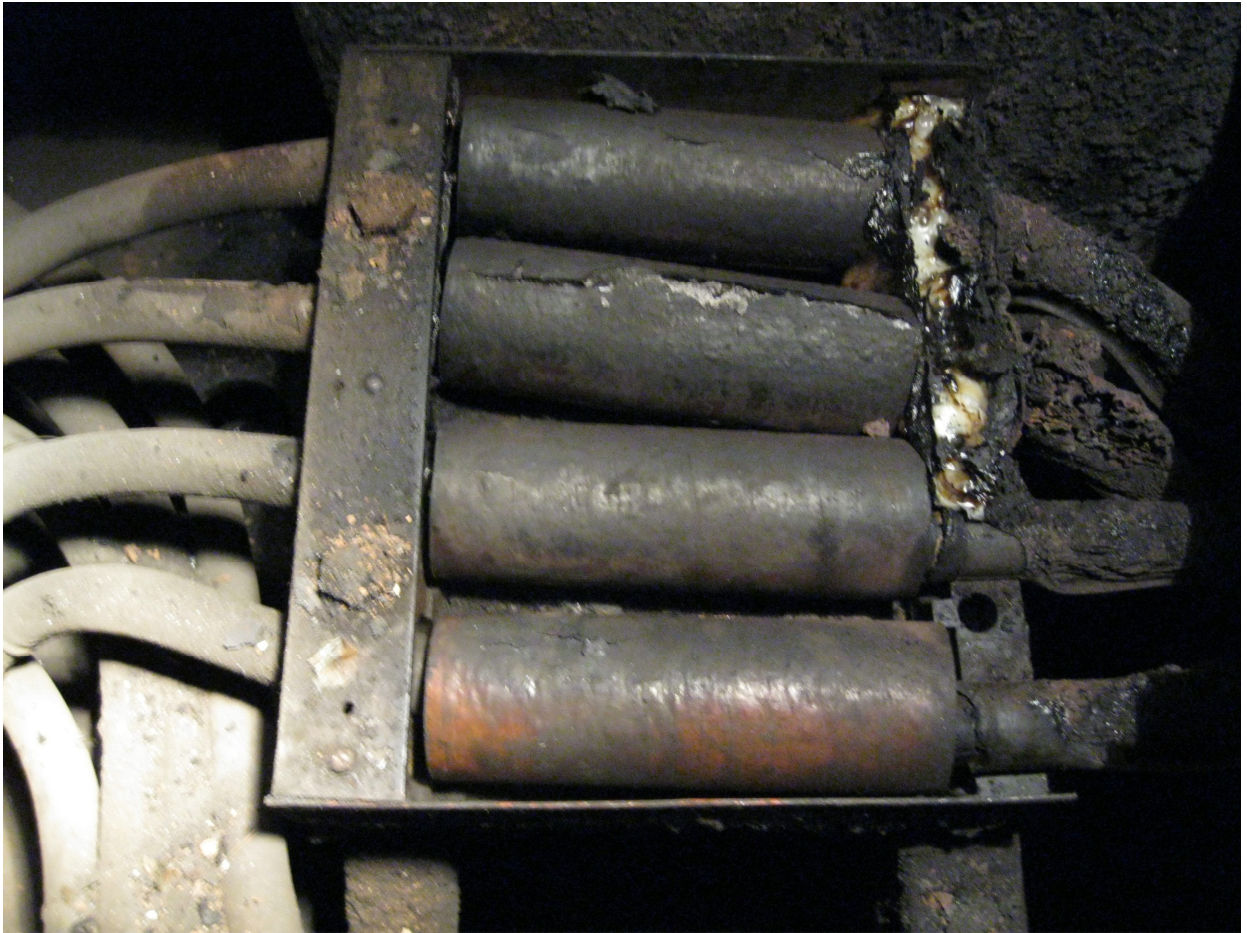
**Photo 3. – Connections dose EMT 4**

The piercing was due to the occurrence of over-voltages of switching caused by the train heating installation type INDA and the electric traction engines, given a minimum admitted value of the insulation resistance of the power cables associated to the traction engine no. 4.
