INVESTIGATING REPORT

on the fire occurred on the 22nd of September 2011 in the Regional centre for railway operation, maintenance and repairs Timișoara, between the railway stations Turdaș and Orăștie Km 457+003, at the locomotive LDH 80-0600-9 (belonging to SNTFC “CFR Călători” SA) hauling the passenger train no. 347-2

Final edition
The 22nd of November 2011

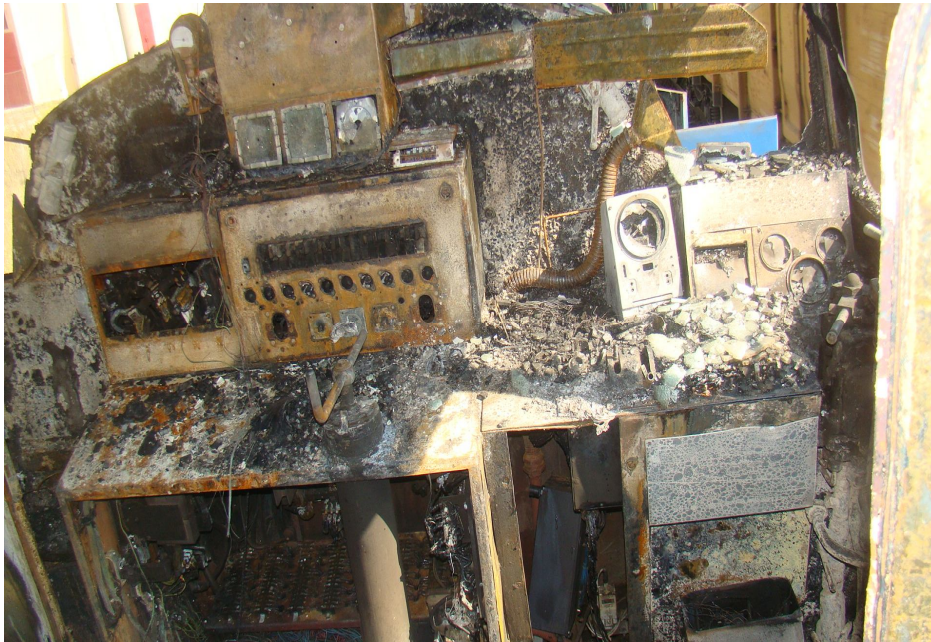
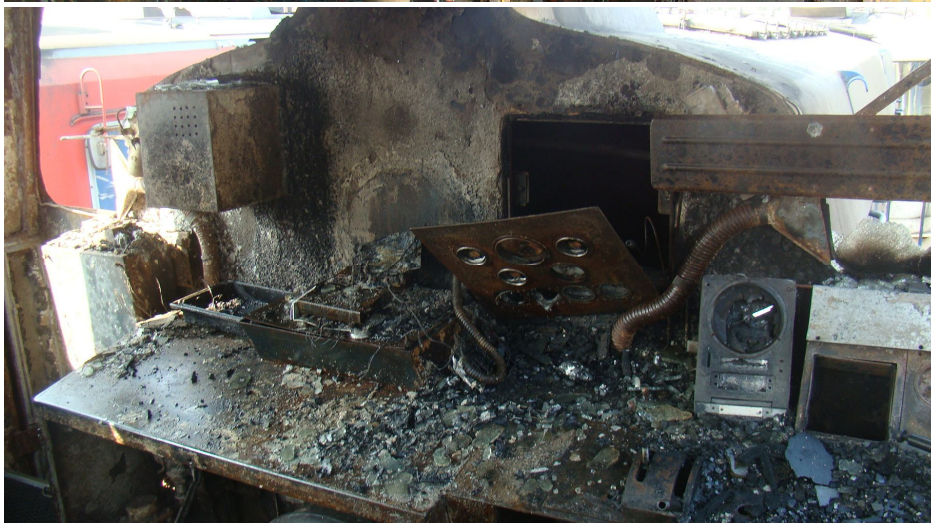
- The driver's cab of the locomotive with command and control equipment, electric wirings, automatic stopping devices panel , contactors and cut out panel, laminated PFL elements on the walls and floor destroyed by fire;

Fire effects
on driving cab
of the
locomotive

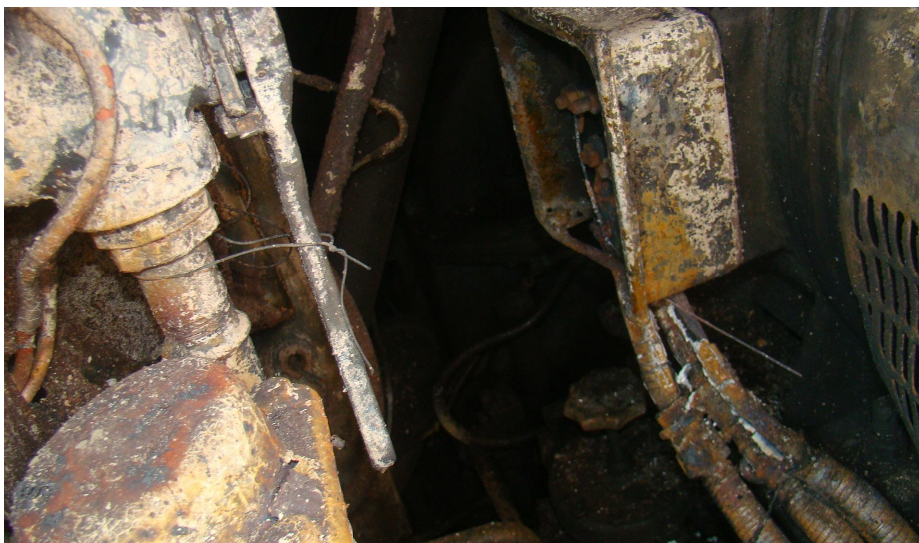
- The exterior box of the dynastarter with strong evidence of thermal damage to the top, inspection covers and in front of the and in the right of the terminal plate;

Fire effects on the left side of the terminal box of the dynastarter.

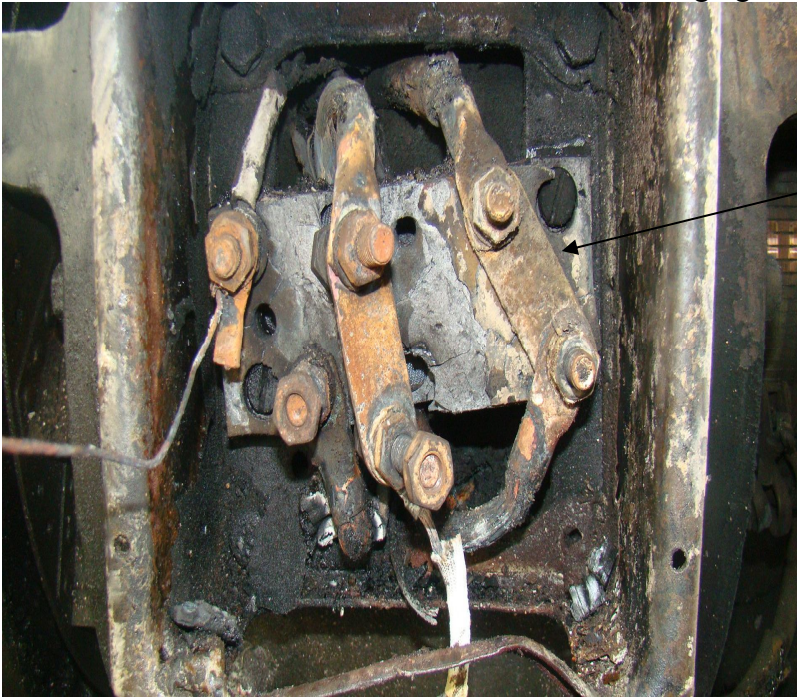
The fire started in the terminal box of the dynastarter as a result of overheating the contact area between terminal connector blade 1B1 and connection plate in the terminal E2 due to the imperfect contact followed by ignition of the conductor connection insulation of the terminal 1B1 with the pole auxiliary coil from field magnet.

Terminal B1 with imperfect contact between blade connector and connection plate with terminal E2

- The fire initiation was produced by the increase of the contact resistance due to imperfect contact of B1 corresponding to the terminal box of the dynastarter;
- The imperfect contact between the cable blade between the auxiliary pole and the connection plate with terminal E2 leads to overheating ground contact and melt the cable insulation followed by its ignition;
- During the dynastarter operation the air currents favored the burning of insulation cables of the field magnet. The Dynastarter being self ventilated, the fire spread inside it, particularly affecting the terminal box and upper side;
- When stopping the diesel engine and hence the dynastarter by the driver, the flame went out through the inspection covers of the dynastarter, ignited combustible deposits of the lower dynastarter and transmission extending the fire in the air filters and under the locomotive cab floor;

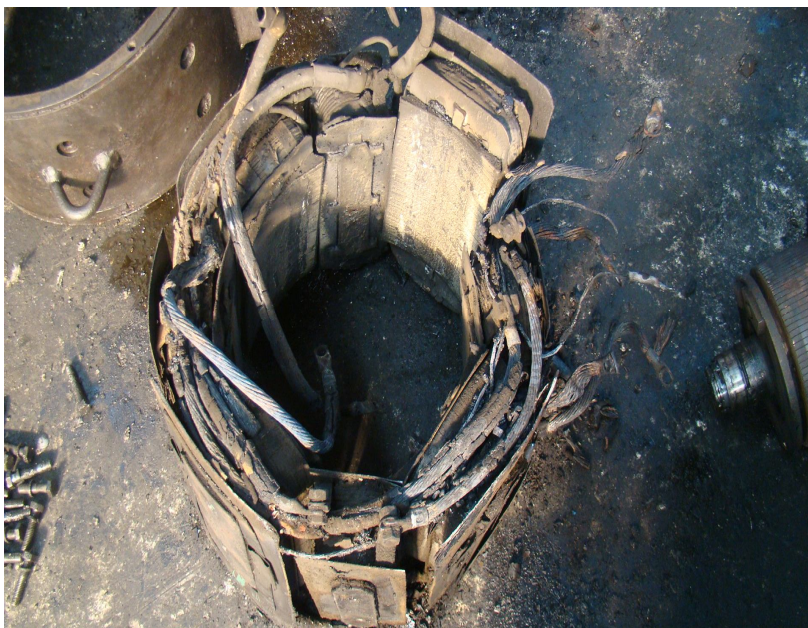
Area field magnet from behind the terminal box

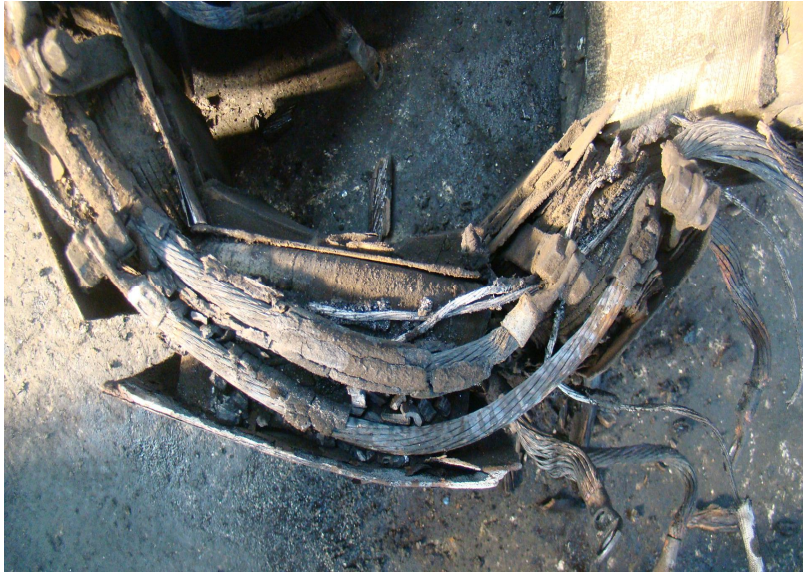
Detail with connection cables of the field magnet in terminal box

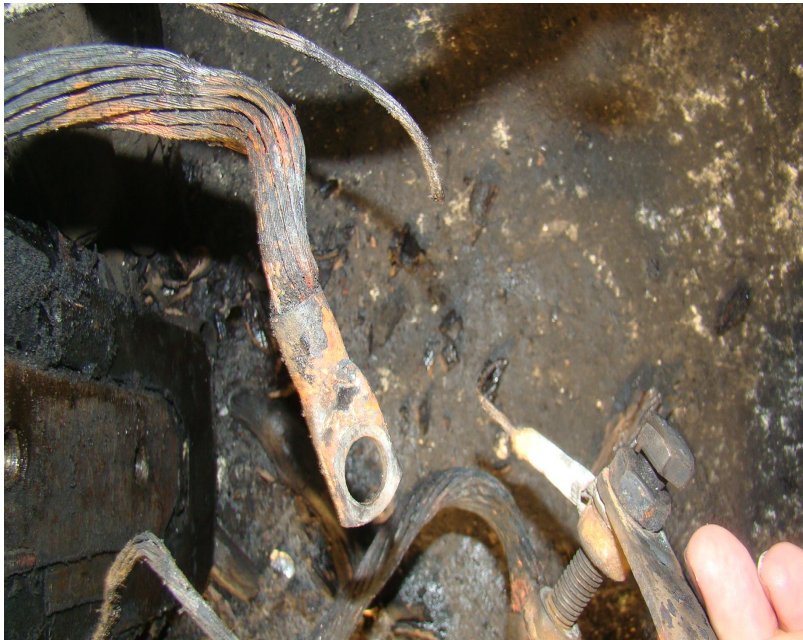
- Terminal box with thermal damage;
- The floor 1B1 – E2 (in the middle of the terminal box) overcharged as a result of the thermal effect of the power.
- The end winding the auxiliary pole to dynastarter (cable near blade connector) overcharged having the insulation burned from the terminal box until in the interior of dynastarter;
- Terminal connection E2 (conductor bypass) charged with melted insulation;
- The dynastarter case at the exterior affected by the fire at the top;
- Cables between motors poles with burned insulation;
- Main and auxiliary pole near the terminal box with strong traces of burning;
- Brushgear assembly free of breakthrough, carbon brushes untouched, pressing mechanism brush at the top damaged with no tension spring due to the thermal effect of heat;
- The armature has no traces of short circuiting;

Connection 1B1 for switching the auxiliary pole to terminal box
