MINISTRY OF TRANSPORTS AND INFRASTRUCTURE
ROMANIAN RAILWAY AUTHORITY - AFER

ROMANIAN RAILWAY INVESTIGATING BODY

INVESTIGATING REPORT

of the railway accident
occurred on the 16th of May 2010, on the running wire I,
between the flag station Valea Larga and the railway station CFR Sinaia

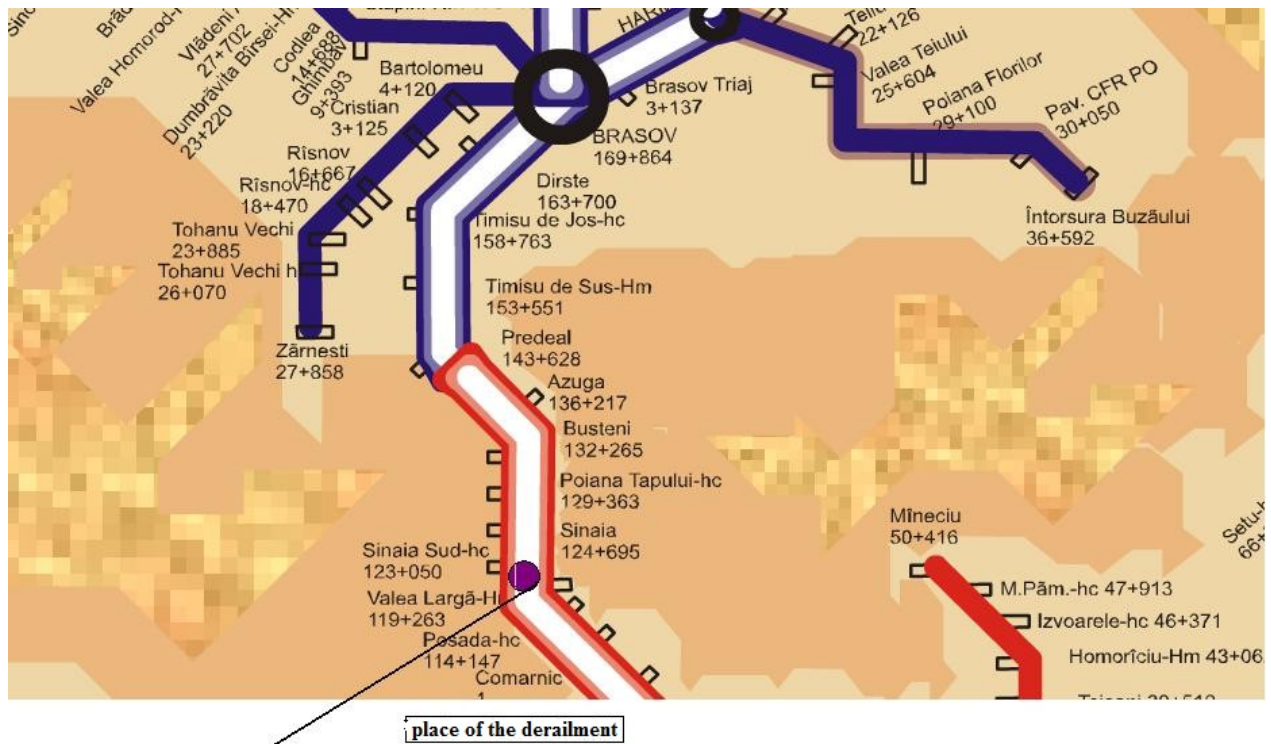
Under these conditions when crossing the freight train no. 24796-1 (belonging to the railway undertaking SNTFM “CFR Marfa” SA) occurred the escalation of the wheel on the right of the first axle in the running direction of the locomotive EA 40 0017- 0 (belonging to the same railway undertaking) followed by the fall of the wheel on the left of the same axle between the two rail wires.

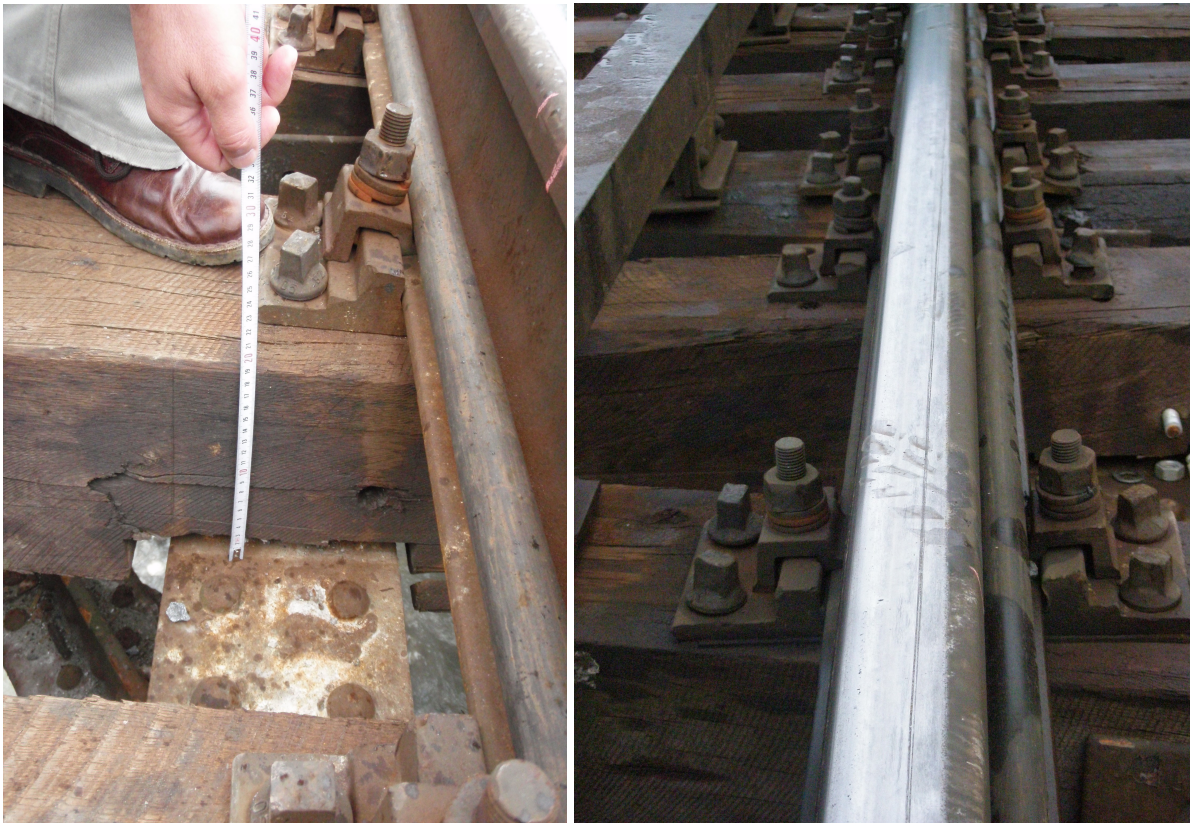
- there was not provided a perfect leaning of the sleepers on the upper soles sides of the bridge beams because some of them were leaning on the rivets head from the joints nodes;

- sleepers leaning with the bottom slope on the riveted joints, without an appropriate processing of the bottom slope to insure leaning without vertical strokes;
- excessive cut of the sleepers bottom slope combined with the unfixing of these sleepers on the metallic elements of the bridge (designed with this purpose) to prevent longitudinal and transverse displacements;
- sleepers with cracks placed in long to the horizontal axis;
- sleepers with cracks on the top of the leaning area of the metallic plates in the tightening direction of the coach screws.

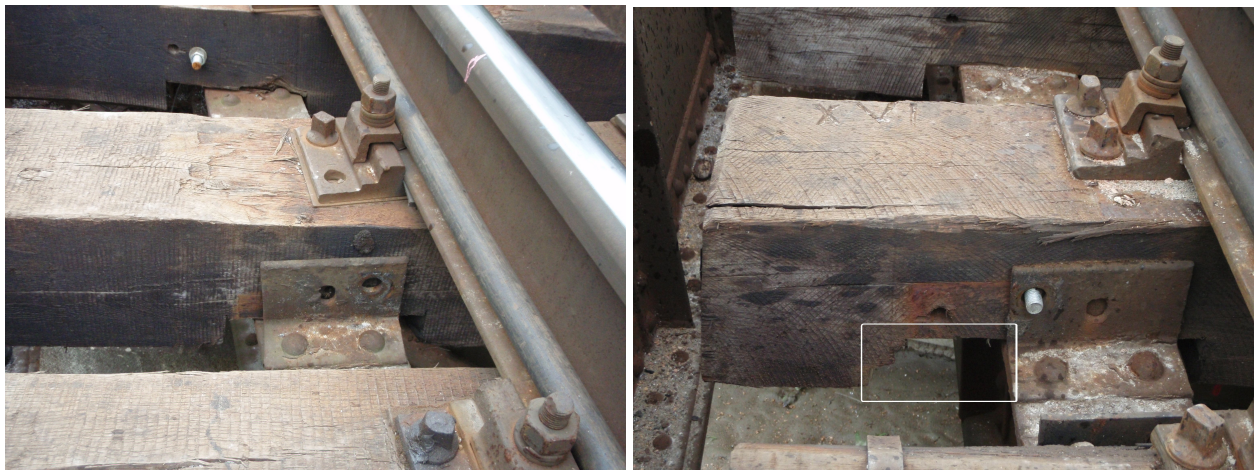
- bottom clippers of the sleepers in some cases were much bigger than the clipper that these should have had according to their position;

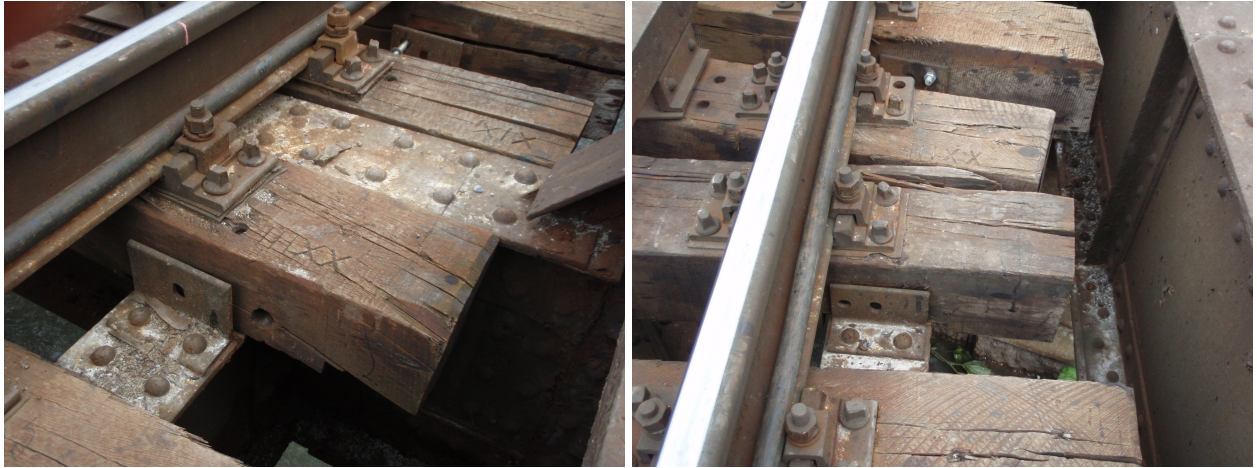
- sleepers displacement prevention was not properly ensured, because the horizontal screws which were fixing the sleepers on the bridge construction elements designed for this purpose, in some cases were missing on both ends of the sleepers or they were providing the fixing only at one end;

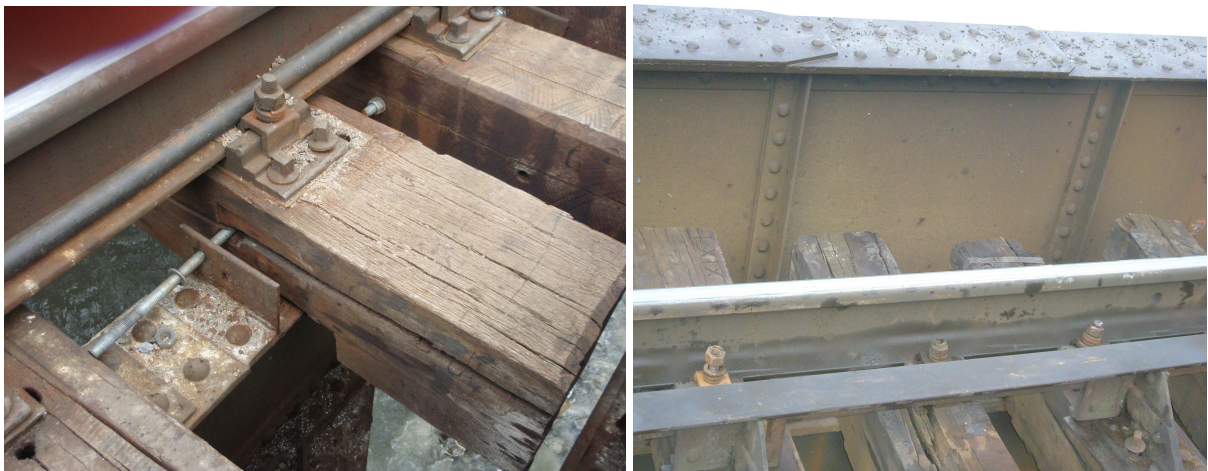
- some sleepers had cracks in the end section along the sleepers or in the fixation area of the metallic plates on the fixing direction of the coach screws.

- some sleepers had cracks in the end section along the sleepers or in the fixing point of the metallic plates in the tightening direction of the coach screws.
