MINISTRY OF TRANSPORTS AND INFRASTRUCTURE
ROMANIAN RAILWAY AUTHORITY - AFER

ROMANIAN RAILWAY INVESTIGATING BODY

INVESTIGATING REPORT

of the railway accident
occured on the 22th of December 2012, in the activity area of the Regional Center for Railway
Operation, Maintenance and Repairs Branch Timișoara, in the railway station Pui

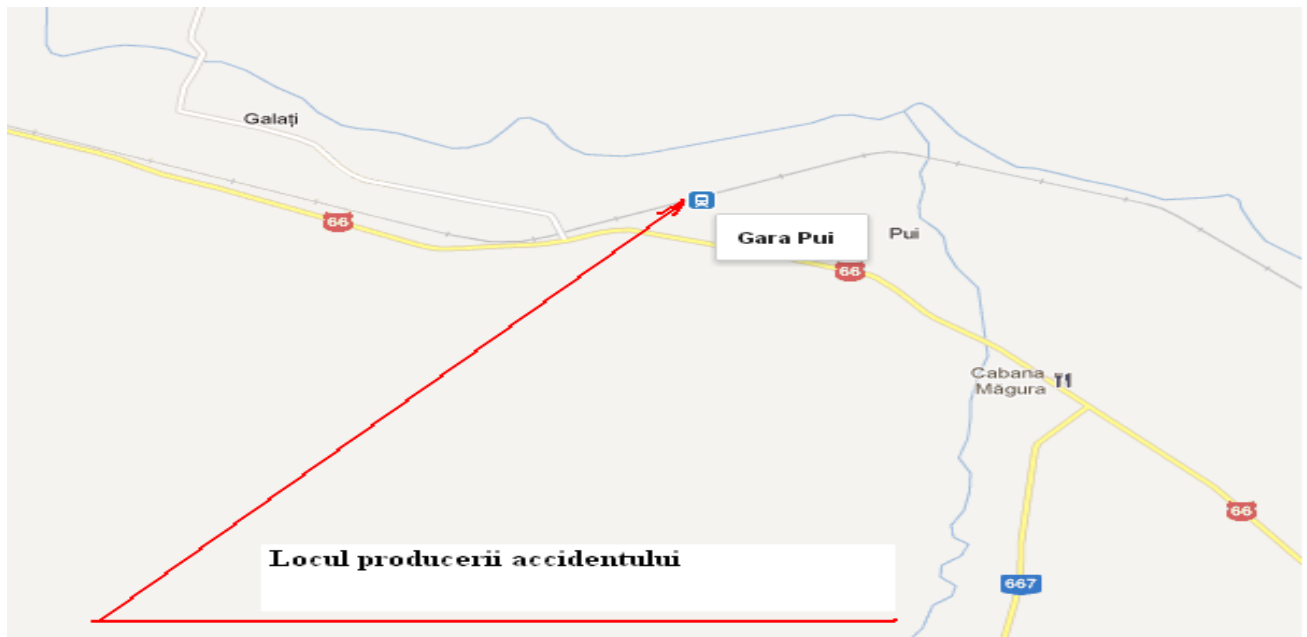
Photo 1

The place where the accident occurred is presented in photo no. 1.

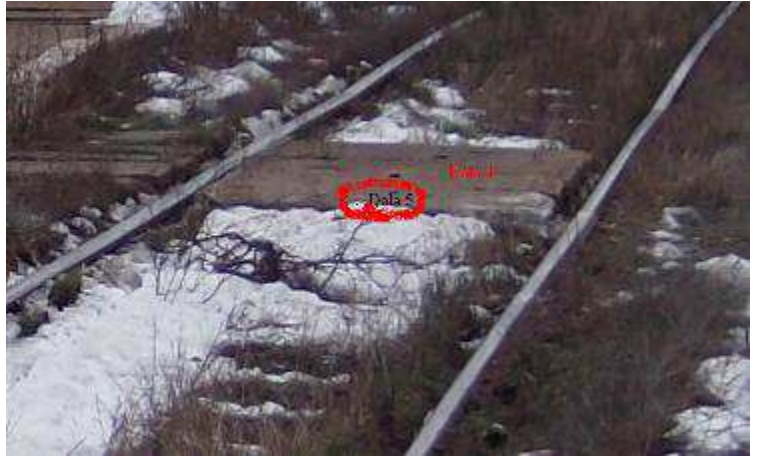
Photo no. 2

1. at the date of the derailment the running speed on the line 4 from the station Pui was restricted at 15 km/h;
2. within the track, at km 43 + 810 it is a passage between platforms from 5 standardized slabs (on exterior right side and in interior of the track), according to the photo no. 2;

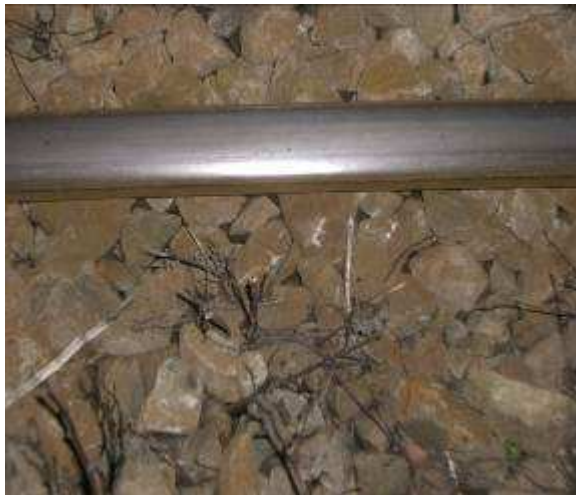
3. with about 300 meters before this passage between platforms, on the track bed can be observed friction traces of broken stone (from the track bed) by an object in movement, according to Photo no. 3 and no. 4;

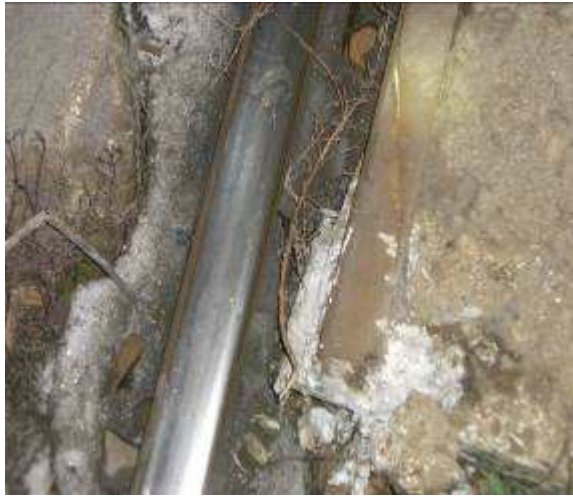
Photo no. 5

4. the slab no. 5 from the passage between platforms is strongly hit and broken on the side next to slab no. 4, on its left side (photo no. 6) and on the right side, beginning from the half width, to the X end of the station, one can see the over-climbing of the flange of the wheel no. 6 from the wagon no. 88536656800-8, according to photo no. 5.

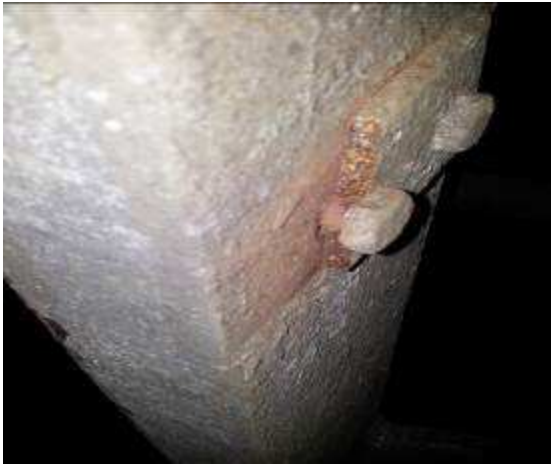
Photo no. 7

- second bogie, in the running direction, with both axles derailed at km 44 + 220;
- the safety strap from the front of the first axle (corresponding to wheels no. 5-6) of the bogie from left part (wheel no. 5) was missing, with an old breakage in the right of the fastening screws, visible in Photo no. 7;
- the superior fastening elements (bolt) of the brake hanger fell along the route (friction traces in the fastening hole from the bogie frame are visible glossy), photo no. 8;

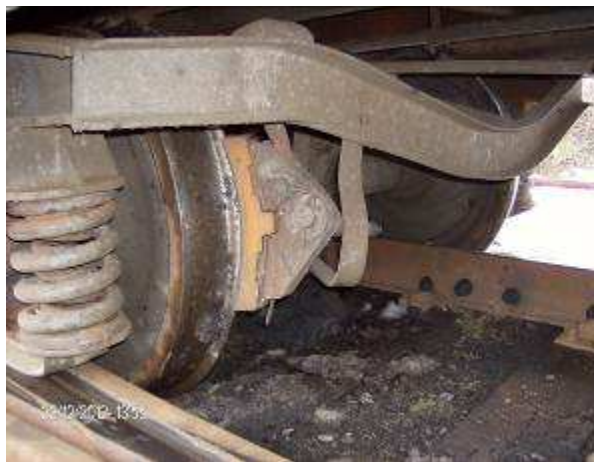
Photo no. 9

- the missing of the safety strap, the brake hanger and of brake block holder afferent to wheel no. 5, confirmation in Photo no. 9, and the brake block holder was found twisted (photo no. 10) between the rails of the track, at about 40 meters from the passage between platforms, at km 43+850.

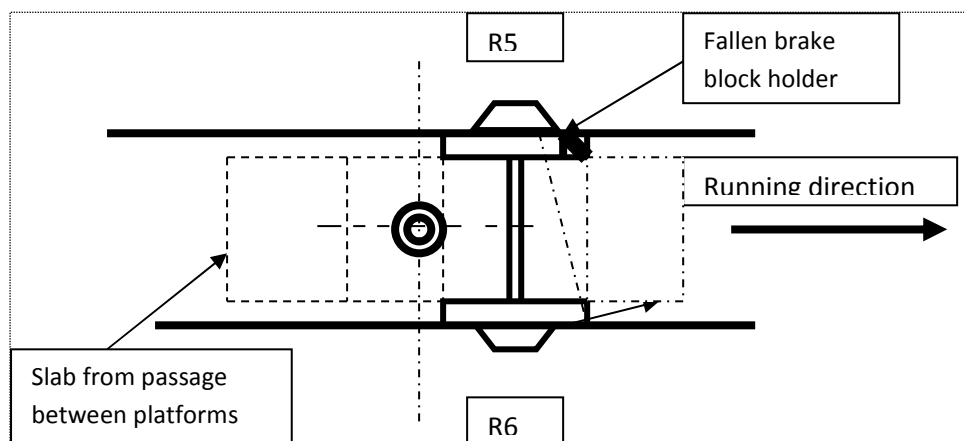
- at the dispatching of the train from railway station Pui, the brake block holder situated in the front of wheel no. 5 blocked in the trench between the rail of the left side, in the running direction of the train and the slabs of the passage between platforms situated at km 43+810, which led to the blocking of this wheel. The blocking of wheel no. 5 generated to the axle corresponding to the wheels no. 5-6 a turn against the blocking point, as it is presented in the drawing below and determined that the opposite wheel (no. 6) over-climb the slab no. 5 from the passage between platforms and, after running around 25 cm, its fall in the exterior of the track. The derailment of the axle corresponding to the wheels no. 7-8 is a consequence of the derailment of the axle corresponding to the wheels no. 5-6;
