MINISTRY OF TRANSPORTS AND INFRASTRUCTURE  
ROMANIAN RAILWAY AUTHORITY - AFER

ROMANIAN RAILWAY INVESTIGATING BODY

## INVESTIGATING REPORT

of the railway accident  
occured on the 28<sup>th</sup> of September 2012, in the railway station Târgu Jiu

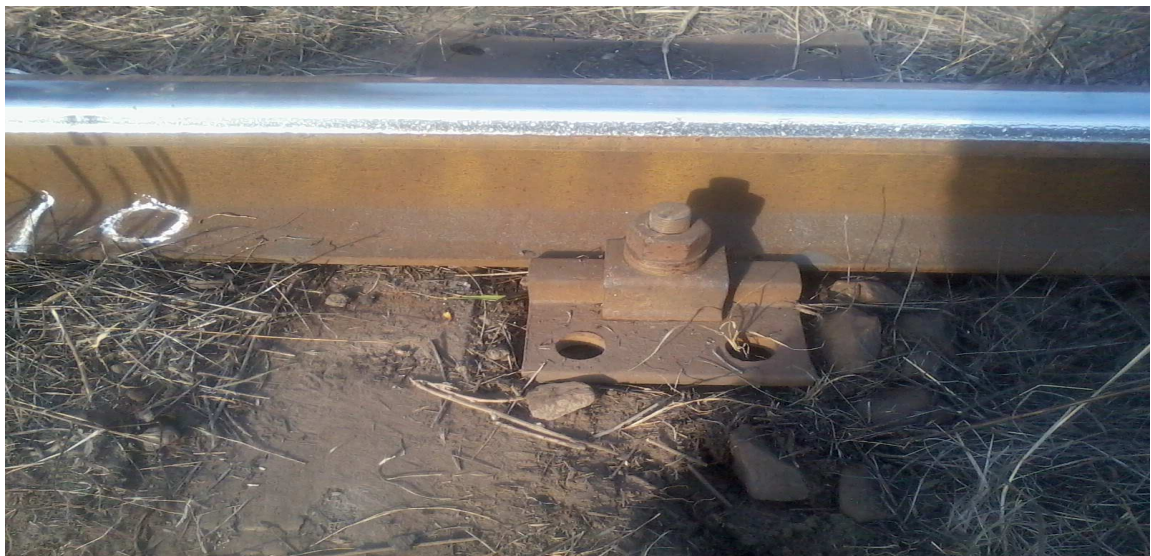
The derailment occurred at a distance of 8.10 m from the heel joint the switch no. 24 by climbing wheel right in the running, running it on the rail head 900 mm, followed by its fall outside the rail while the left wheel fall inside the rail.

Photo 1. The place where the climbing of the right wheel flange, in the running direction, on the head of rail, corresponding to the exterior curve rail happened.

The place of the derailment is on the curve after the switch no. 24, at 8,10 m from the last joint, on the deflecting section of this switch.

- starting from this point on the head of the right rail it can be observed on a 900 mm distance a running rail from the flange of wheel, followed by a print on the outer side surface on the head of rail;

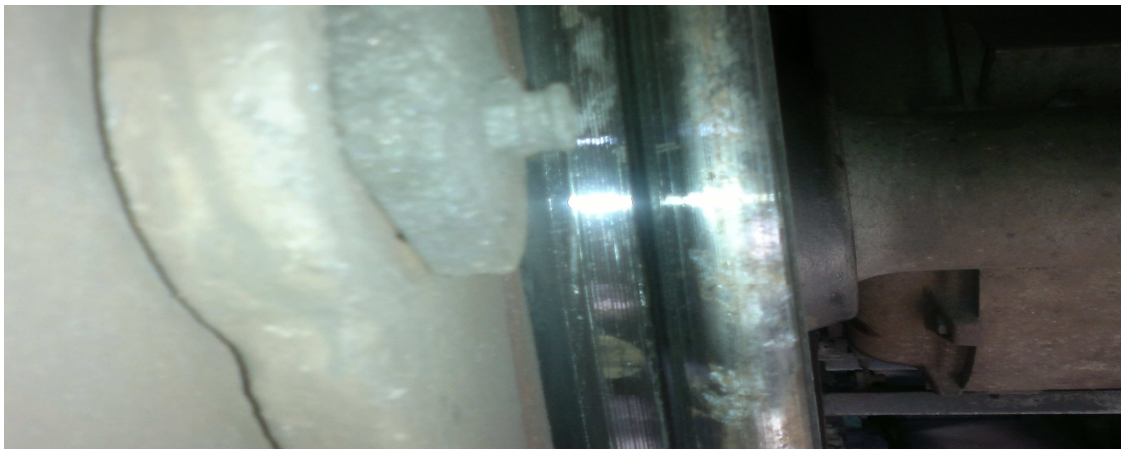
- the existence of witness marks, on the active flank of the wheel flange on the right side in the running direction of the axle no.1, resulted from the turning of the wheel;
- overcoming the horizontal clearance admitted between side rubber buffers and bogie frames:
  - 20 mm compared with the minimum 22 mm at the bogie no. 1;
  - 37 mm compared with the maximum 28 mm at the bogie no. 2.

- a difference of 2,19 mm between the wheel diameters (left-right) at the axle no. 1.
    - a difference of 2,19 mm between the wheel diameters (left-right) at the axle no. 2.

- The axles no.1, 2 and 6 were turned at IRLU Simeria.

Photo 2 Scoring existing on the axle no. 1, derailed wheel
