MINISTRY OF TRANSPORTS AND INFRASTRUCTURE  
ROMANIAN RAILWAY AUTHORITY - AFER

ROMANIAN RAILWAY INVESTIGATING BODY

## INVESTIGATING REPORT

Of the railway accident happened on the 12<sup>th</sup> of October 2012 between the railway stations Praid and Sovata, in the branch of the Regional Centre for Railway Operation, Maintenance and Repairs Braşov

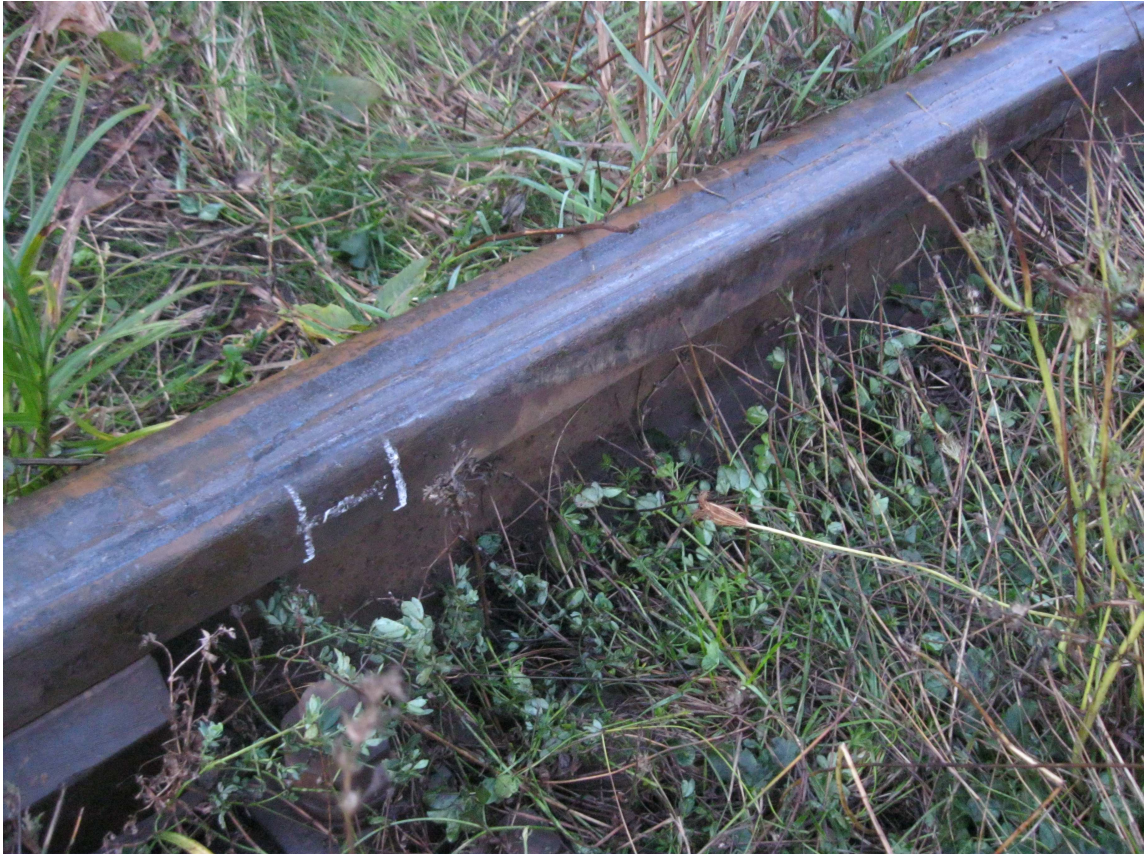
At the stabling in the railway station Sovata, at the main line 2, km 106+692, in an area where is a curve with left deflection (in the train running direction), occurred the falling of the left wheel from the first axle of the wagon's no. 338767359288 first bogie (the ninth wagon from the head of the train) between the strecht of the rails, the right wheel running normal – photo no. 1.

*foto nr. 1* – traces of running and fall of the wheel from left part

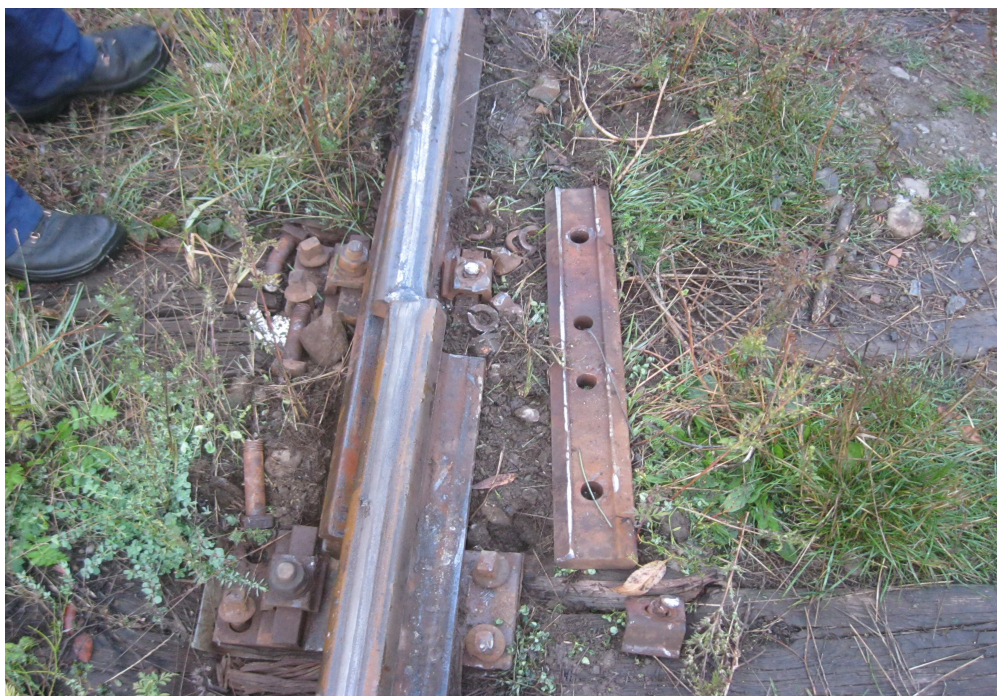
In the right of the first joint (in the train running direction), the left wheel of the wagon's first axle hit the upper shoulder of the fish plate from the track's inside. - *Photo no. 2.*

*photo no. 2* – the fish plate hitted and destroyed by the wheel from the left part

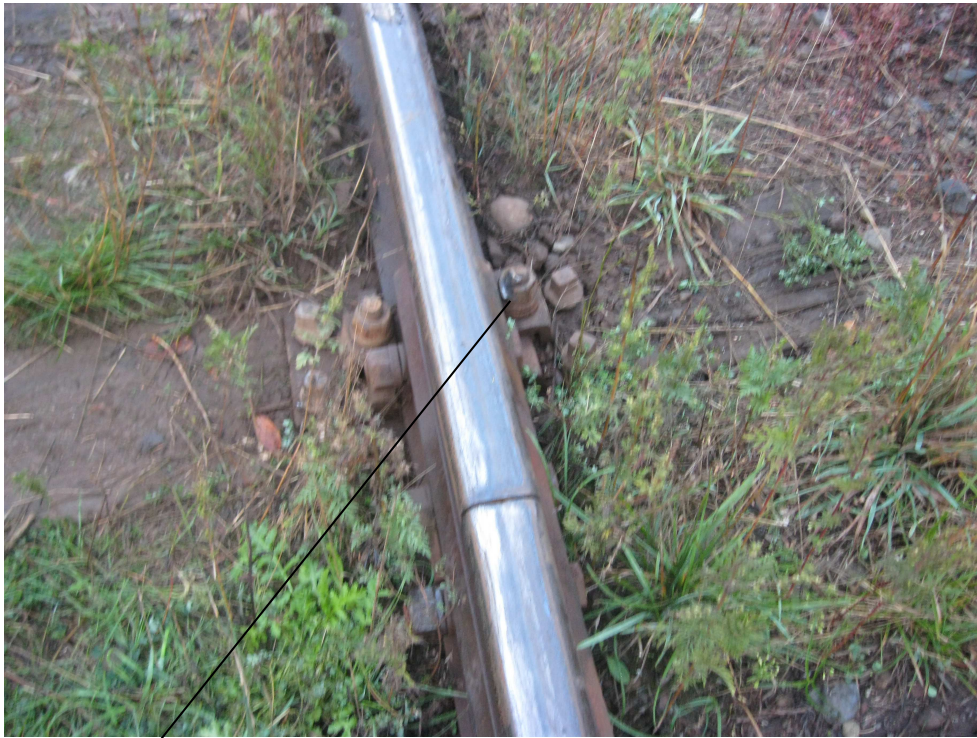
In all this time, the right wheel of the first axle (in the train running direction), ran normally until to the point in which the wheel from left part hit the upper shoulder of the fish plate. In that moment, the wheel from the right part climbed the rail towards the curve outside and fall on the head of the outside vertical screws. - (photo no.3)

*photo no. 3 – the first vertical bolt hit by the wheel from right part*

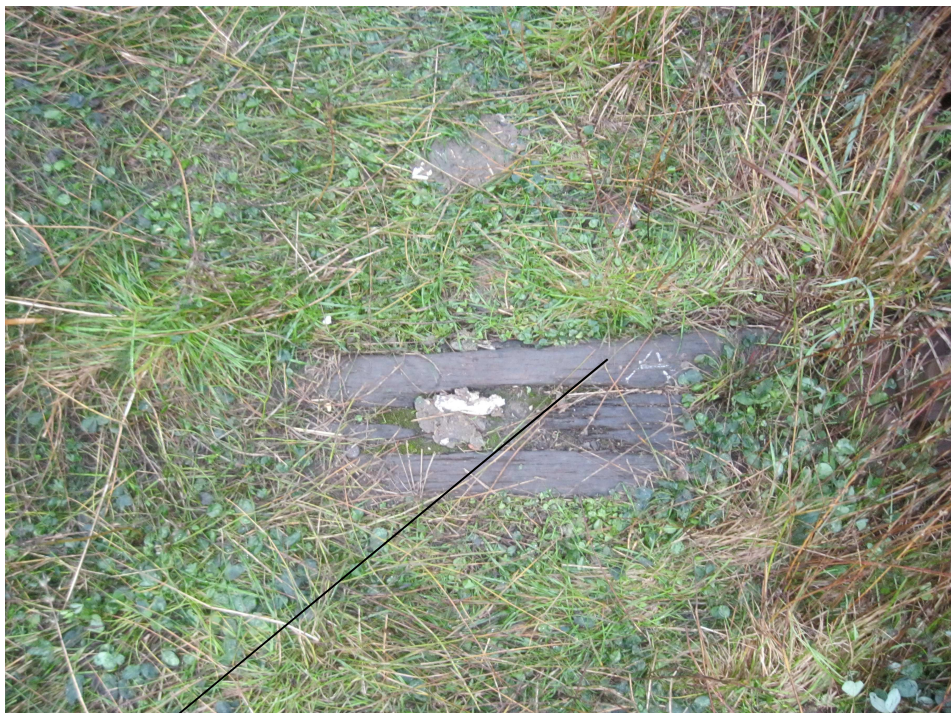
At the checking of the technical condition of the sleepers and of the way in which was insured the fastening of metal plates by these, one found out that a number of 7 consecutive sleepers was in a poor condition with longitudinal cracks, starting with the point 0 in the train running direction. There were found out that the broken stone prisms was chocked 90 % - *photo no. 4-5*.

*photo no. 4* – the sleeper from the falling point of the left wheel

The track overwidening at the km 106+692 (the gauge value being of **1490 mm**), one occurred because of the poor condition of the sleepers (longitudinal cracks on the coach screw direction) and of the broken stone prism that was choked 90%.

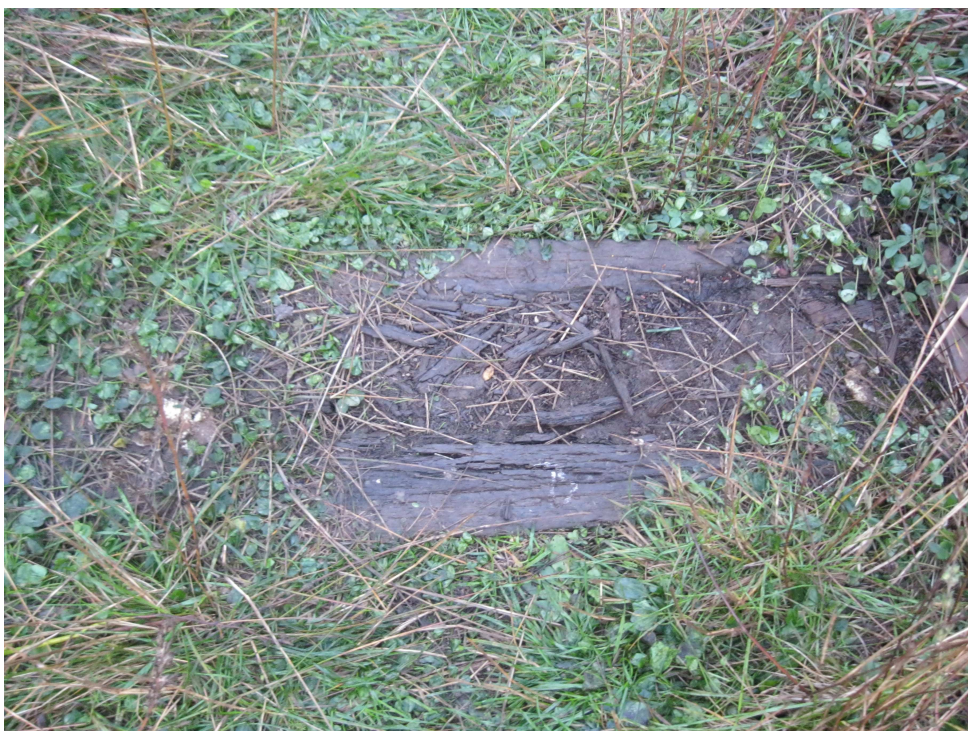
*photo no. 5* – the second sleeper after the falling point of the left wheel

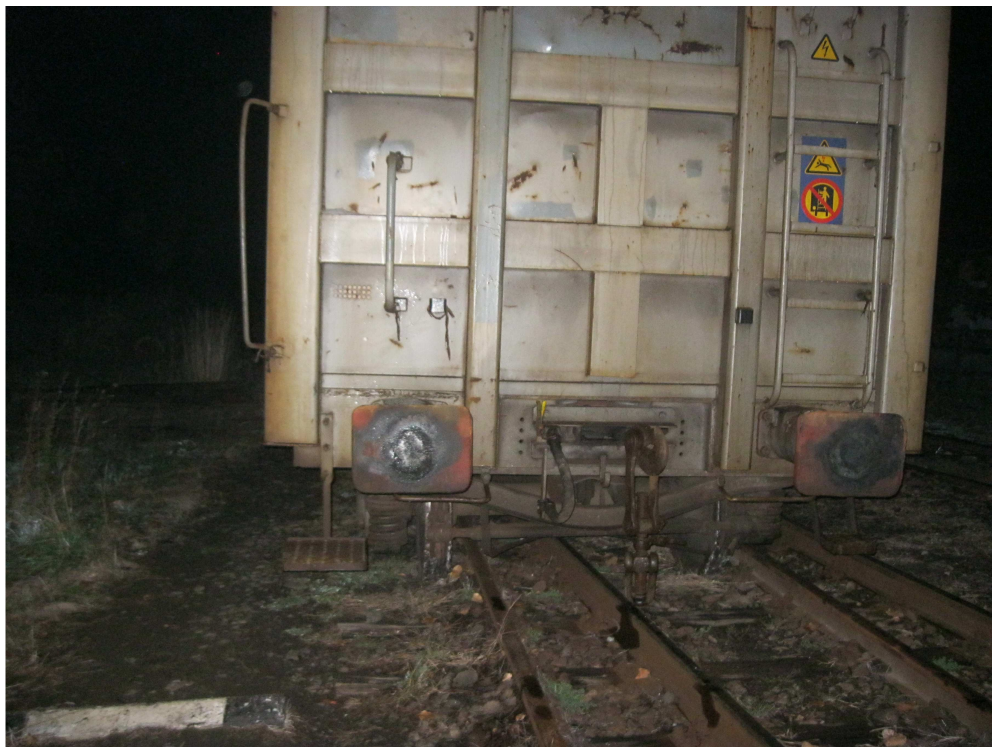
- the wagon was derailed by the first bogie in the running direction, the bogie with the wheels 1-2, 3-4, the wheels 1 and 3 being on the left part of the running direction;
- after the measurements that were performed at the derailed bogie, one found out that the distance between the outer faces of the wheels lips from the axle no.1 (in the running direction), had a value of ***1406,5 mm***, *opposite to the provisions of the Regulation for railway technical operation no. 002, Article 221 (2)*;
- the axles of the first bogie are not crooked;
- on the buffers (the front and rear) were not found out traces of abnormal friction in order to led at the conclusion of a running that did not respect the instruction (abnormal contact) between the wagon no. 9 and the front and the rear wagons. (*photo no. 6*)

*photo no. 6 – the frontal buffers of the wagon no. 9*

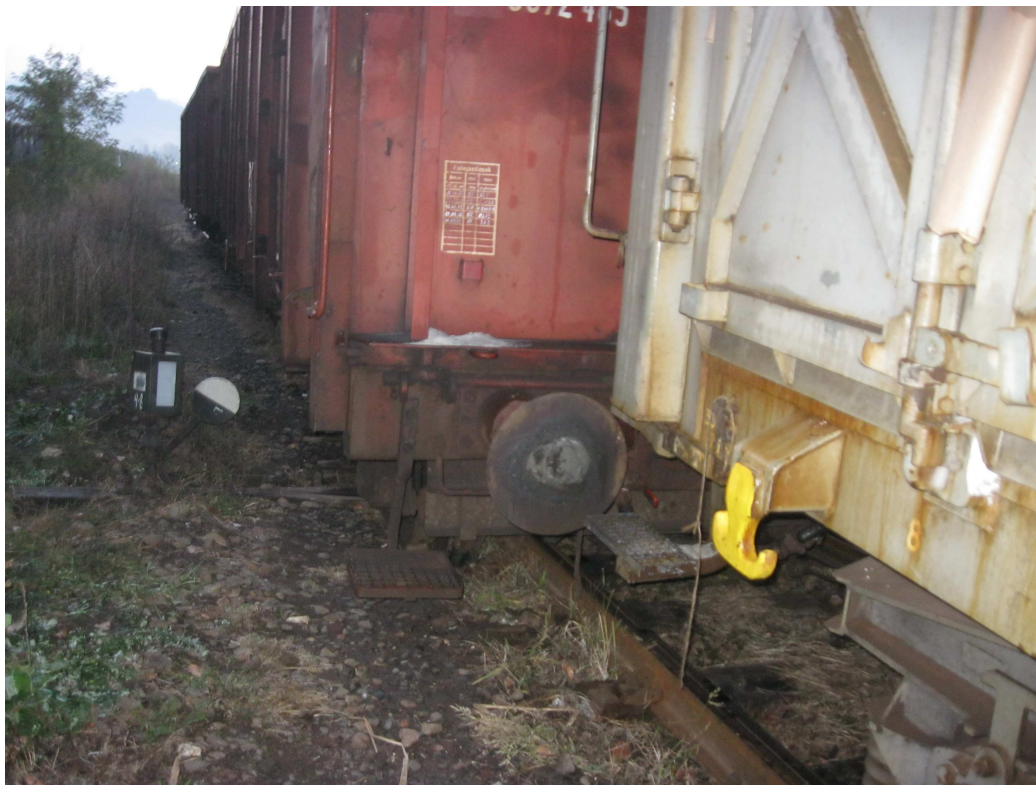
- the wagon was derailed by the first bogie in the train running directions, the bogie with the wheels 5-1, 6-2, the wheels no. 5 and 6 on the left part;
- after the measurements that were performed at the derailed bogie, one found out that the measured values were in the instructional limits;
- after the performed measurements one found out that the axles of the first bogie are not crooked;
- the bogie frame had deformation traces;
- on the buffers (the front and rear) were not found out traces of abnormal friction in order to led at the conclusion of a running that did not respect the instruction (abnormal contact) between the wagon no. 10 and the front and the rear wagons. (*photo no. 7*)

*photo no. 7 – the frontal buffing gear of the wagon no. 10*

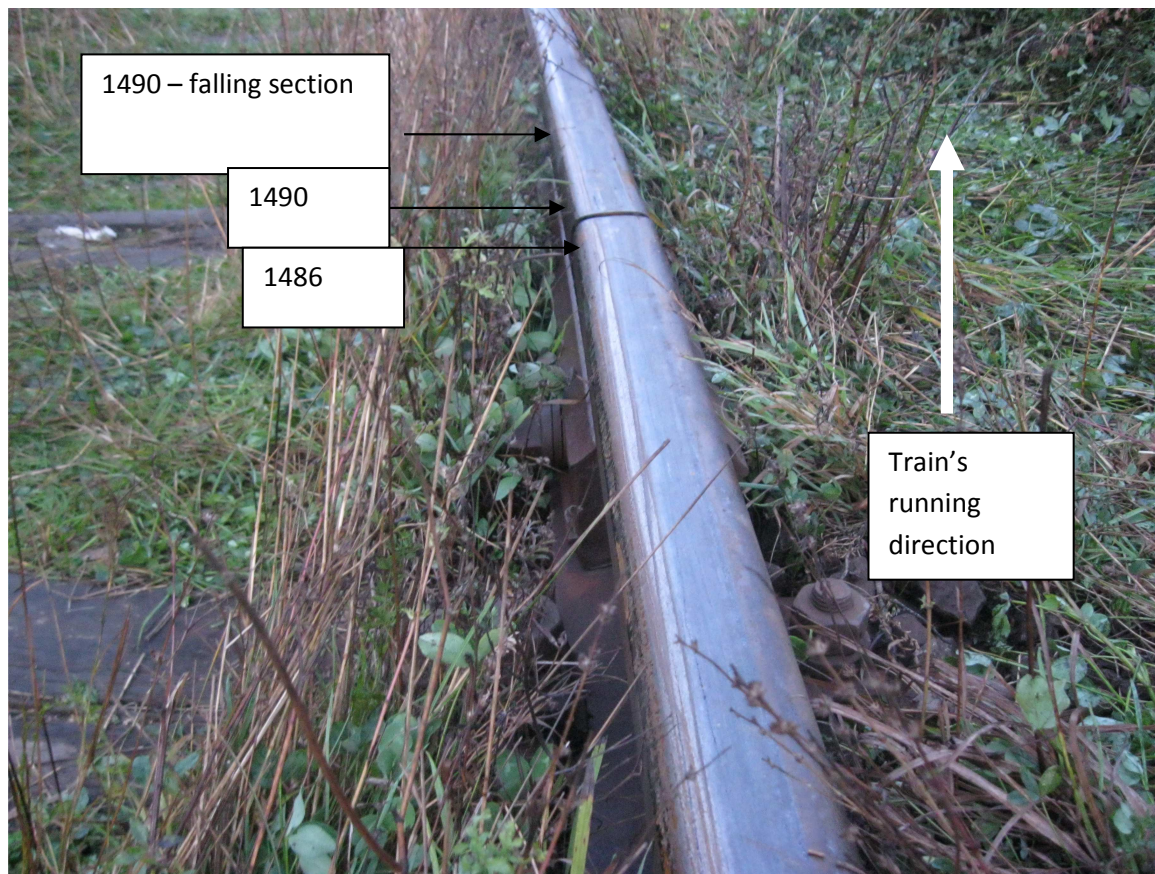
At the joint that is at about 43 cm before the ponit 0 in the running direction, the values that were obtained at the heads of the rails that make up the joanta were at **1486 mm** respectively **1490 mm** in the train running direction, the values between the active faces, measured with the tape measure that the exceeded the allowed maximum value of Instruction of norms and tolerances for constructions and maintenance of the line with normal gauge no. 314/1989, article 1, point 13. (photo no.8)

*foto nr. 8 – the joint before the falling point and gauge values from the outside rail of the curve*
