## **INVESTIGATING REPORT**

concerning the railway accident occurred on the 19<sup>th</sup> of August 2013, in the branch of Regional Center for Operation, Maintenance and Repairs – Cluj, traffic section Jibou – Sărmășag, between the railway stations Zalău Nord and Mirșid, consisting in the derailment of the wagon's no. 31530667181-1bogie from the freight train no. 69731, of the railway undertaking  
SC TRANSFEROVIAR GRUP SA Cluj-Napoca

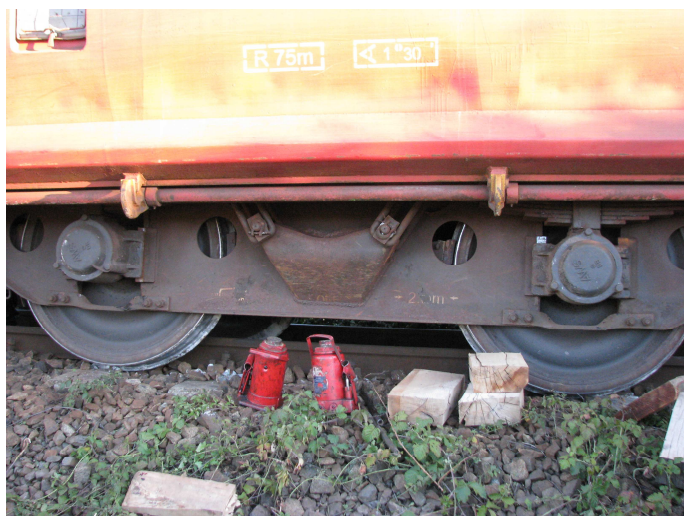
The train no. 69731 stopped in running line, at the km 102+040, between the railway stations Zalău Nord and Mirșid. The wagon no. 31530667181-1, the fifth from locomotive, derailed by the first bogie in the running direction.

The derailment of the wagon no. 31530667181-1 one occurred at the km 99+700 and ran in this condition since to the km 102+040.

**Foto 2 : Wagon no. 31530667181-1 derailed**

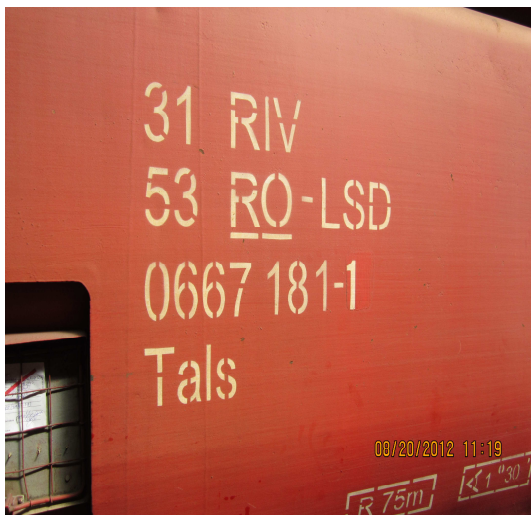
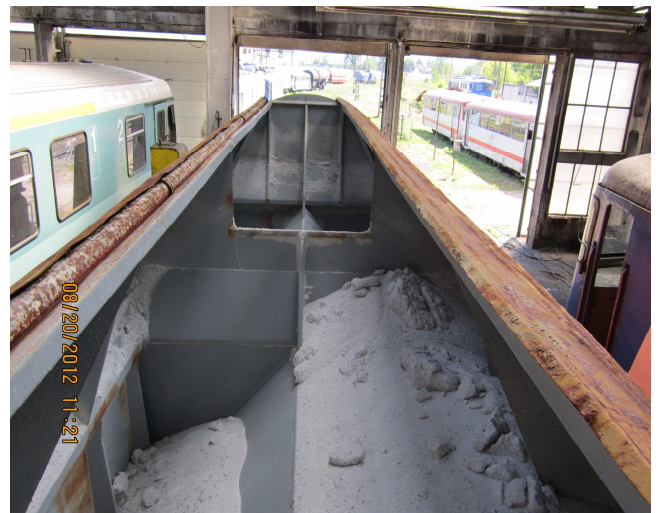
**Direct cause** of the accident was the exceeding of the allowed report of the wheel load at the second bogie's axles of the wagon in the running direction (the axles with the wheels no. 1-2, and 3-4), because of the wagon's incomplete unloading (the charge from the diagonal compartment opposed to the trailing wheel no. 8 was not unloaded).

This fact lead at the discharging of the load of the trailing wheel when the bogie entered in the curve, favouring the climbing of the wheel's lip on the head of the rail from the outside curve rail at the km 99+077 and the derailment of the axle with the wheels no. 7-8, followed by the training in derailment of the axle no. 5-6.

- One compartment from those four, was loaded with salt; this compartment corresponding to the wheels no. 1-3.
- after discharging and weighting resulted a salt amount of 11.530 kg.

**Foto 3:** *The rear compartment, the right part of the running direction, remained unloaded at the first bogie (in the running direction)*

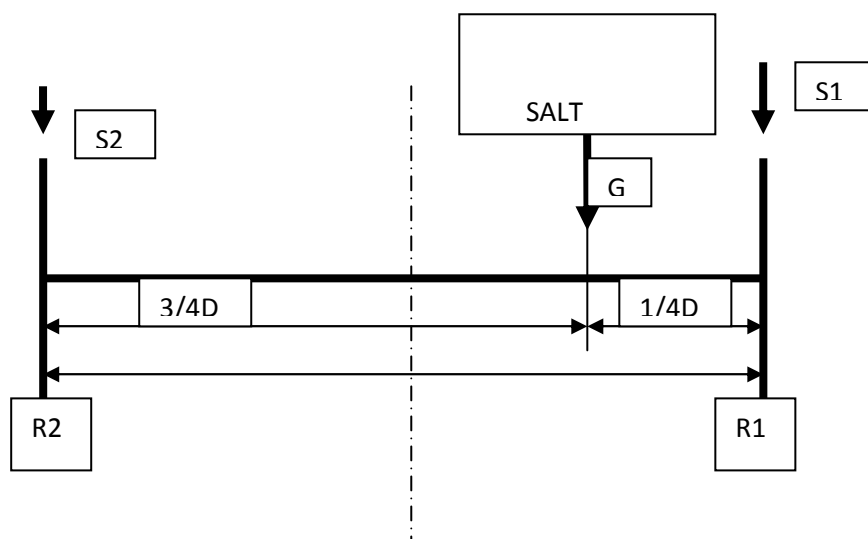
Performing the calculations we obtain  $S1=4256\text{kg}$  and  $S2=1418\text{kg}$ .

Resulted that the charge condition of the wheels axle-journals no. 1-4 was according to the below tabel:
