## INVESTIGATING REPORT

of the railway accident happened on the 2nd of September 2012, in the railway station Bucuresti Noi, consisting in the derailment of the first two axles, in the running direction of the locomotive EA 40-0526-0, hauling the freight train no. 84796-1

*Final edition  
The 8th of February 2013*

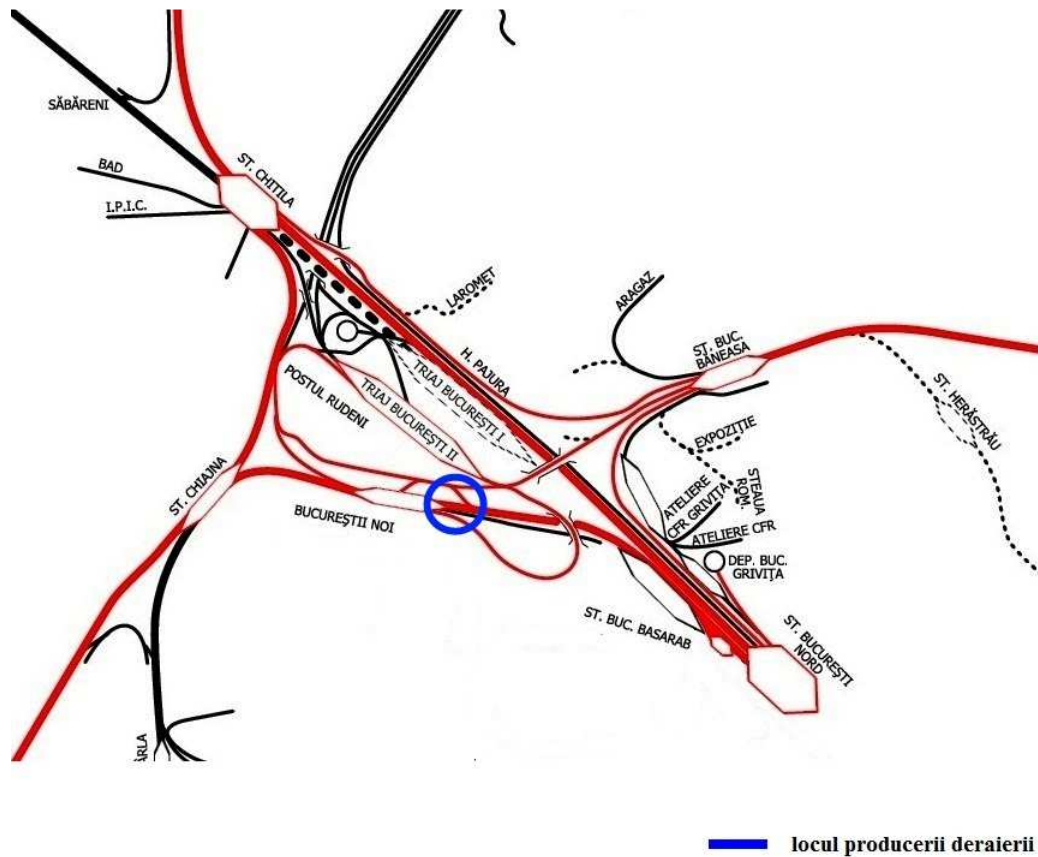
Drawing no. 1 – derailment place

The specialists arrived at the accident place found out the derailment of the first two axles in the running direction (axles no. 5 and 6) from the locomotive EA 40-0526-0, on the trailed switch no. 9C, to the deflecting section.

The accident place is presented in the picture 1

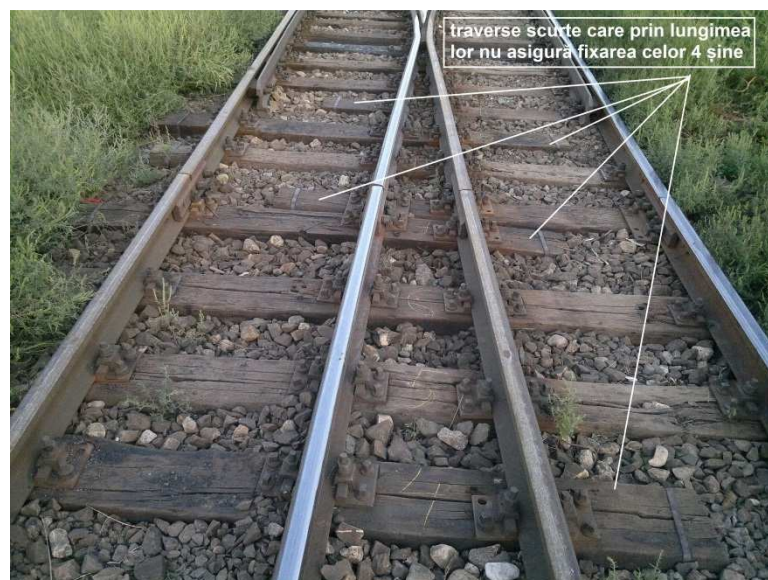
Photo no. 1

1. the freight train no. 84796-1 was dispatched from the line no. 1C, trailing the switch no. 9C to the deflecting section.
2. at the accident moment, the traffic over the switch no. 9C was made with speed restriction of 15 km/h, because its unsuitable sleepers..
3. the sleepers of the switch no. 9C, were mostly re-used, most of them having failures that did not allow the fastening of the metallic plates, by the fastening of the coach screws, especially between the last switch joint (switch end joint) and the overclimbing point (point 0)
4. between the last joint of the switch and the point 0 one identified special sleepers (sleepers with length over 2,60 m), that by their length could not ensure the fastening of those 4 rails (corresponding to those 2 directions of the switch), as it is stipulated in the assembling project of the switch – photo no. 1.

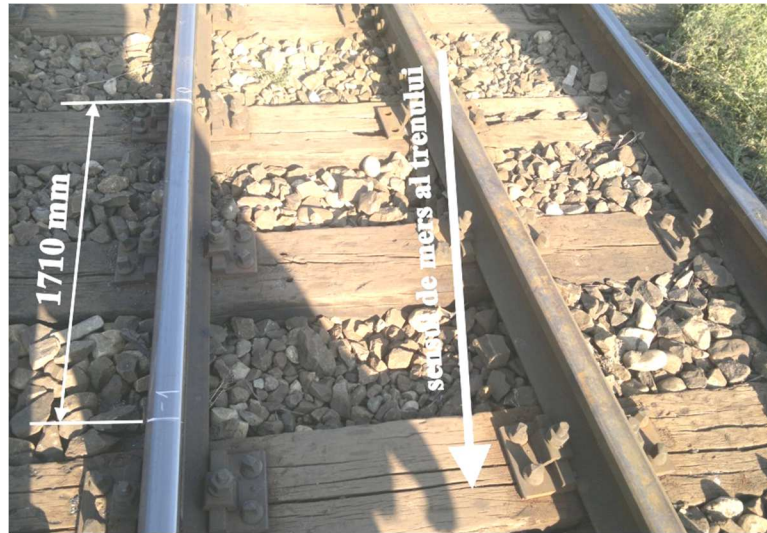
Photo no. 2

- at 4 m, measured from the tip joint of the switch no. 9C to its toe joint one identified the first overclimbing trace of the head of the connection rail on the right side in the running direction (corresponding to the outside rail of the switch curve) – point 0;

- from the point 0, in the running direction of the train, on 1070 mm, on the running surface of this rail head one observed first running trace of the flange of the right wheel, followed by the wheel fall outside the track;
- those 3 sleepers from those 1070 mm on which the flange of the right wheel run (the sleeper from the point 0 and the next 2 sleepers in the running direction of the train) had cracks on the vertical direction against the direction of the coach crews fastening – photo no. 2;

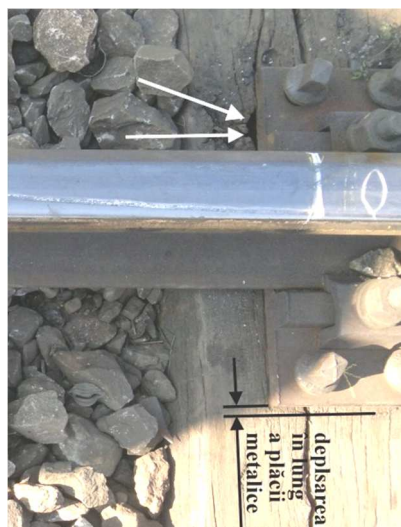
Photo 3

- at the sleeper from the point 0, on the upper side, one observed specific trace of metallic plate displacement along the sleeper. Also, on the right side, at the rod of a coach screw one observed gap in the sleeper – photo no. 3;
-

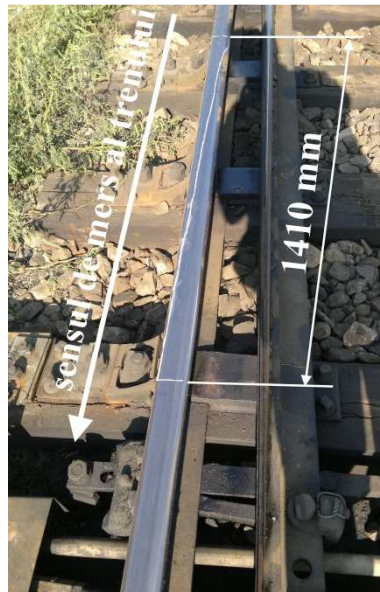
Photo no. 4

- from the point of the right wheel fall, the specific derailment traces continue on the right side of the connection rail corresponding to the outside rail of the curve of the switch and of the curved points, the traces made by the flange of wheel being on the upper side of the sleepers, on the metallic elements for the fastening of the metallic plates and on the first and second met **spacer for the curve switch keeping** (the 4th and the 3rd counted from the tip of the switch to the heel of the curved points);
- after the hit of the second **spacer for the curve switch keeping**, the wheel climbed, opposite it, the right stock rail, running with the tyre 6050 mm;

- after running this distance, the flange of this wheel climbed the running surface of the right stock rail, running a distance of 1410 mm (the second running trace of the flange of the wheel on the rail head), then it left the running surface of the stock of the rail, hitting on its right side **the shoulder of the slide chair from the curved points tip** and the horizontal screws for the fastening of the box for the locking of the right stock rail – photo no. 4;

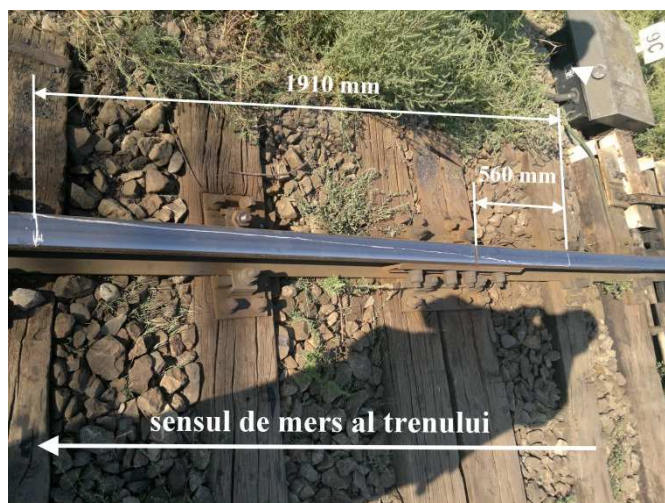
Photo no. 5

- at 560 mm measured from the first joint of the right stock rail heel, on the running surface of the stock rail and continuing on the running surface of the rail of the stock rail panel between the switches no. 9C and 7C, one found out the 3rd trace of running of the wheel flange, with a length of 1910mm – photo no. 5;

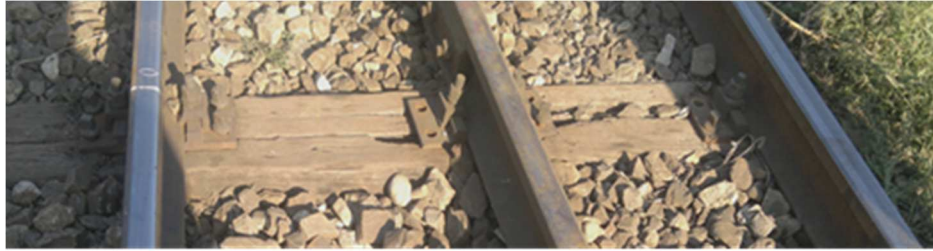
Photo no. 6

- In the point 0, the coach screws could not ensure the fastening of the metallic plates on the sleeper because the sleeper was cracked – photo no. 6;

**The direct cause** of this accident is the climbing of the right wheel flange, from the axle no. 6 (first in the running direction) because of loss of the guiding capacity, generated by the technical condition of the sleepers, that did not allow a suitable fastening.

- the use of the special sleepers that through their length could not ensure the fastening of all rails corresponding to those two directions of the switch no. 9C (their length ensured the fastening only for 3 rails)

Keeping in operation of the unsuitable sleepers in the switch no. 9C, because of the lack of supply with the all requested quantity of special sleepers for the switches. For this reason, one used recovered special sleepers, but with shorter lengths against the assembly plan, that did not ensure the fastening of those 4 rails corresponding to those two directions of the switch no. 9C.
