ROMANIAN RAILWAY INVESTIGATING BODY

# INVESTIGATING REPORT

of the railway accident  
occurred on 02.10.2012 in current line Popești - Copăceni

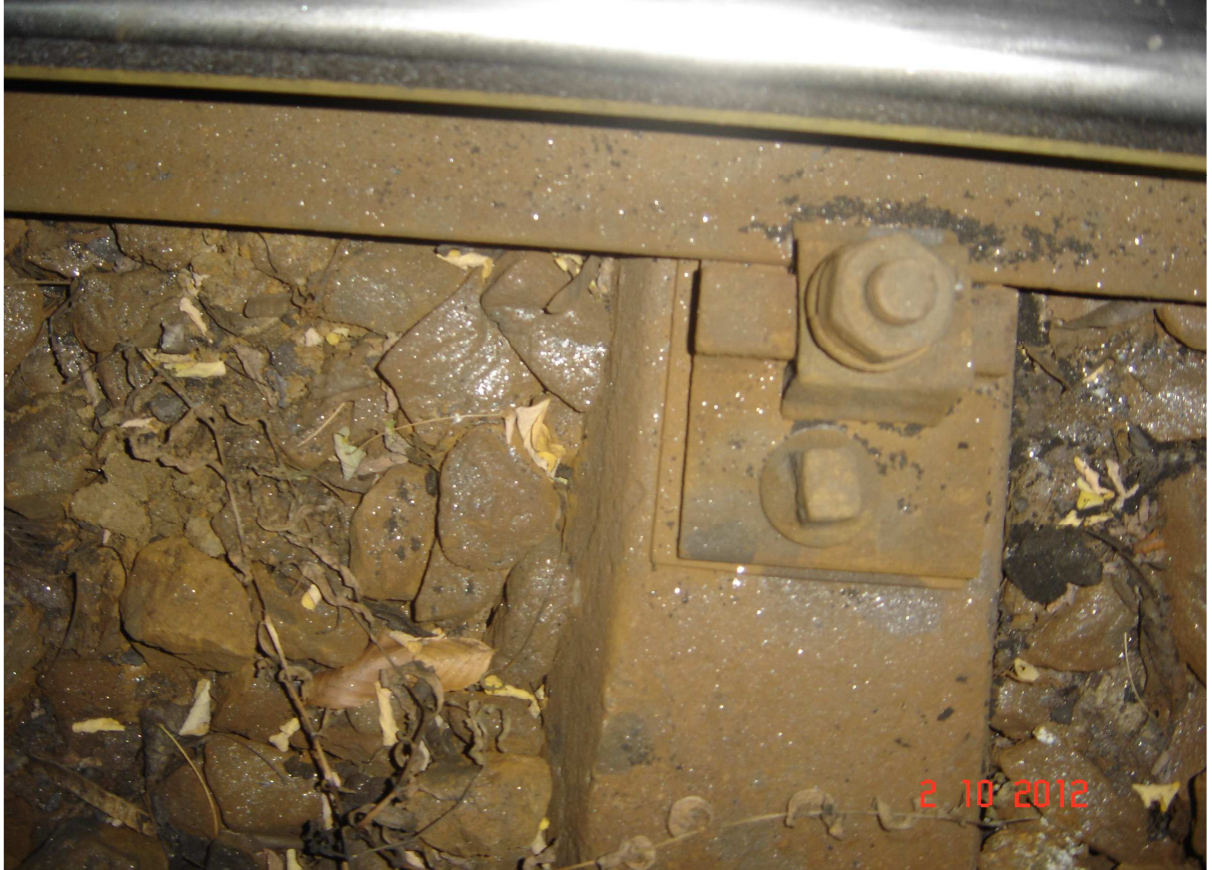
In the point where occurred the climbing of the outside curve rail by the right wheel of the locomotive first axle (in the running direction) is a lot of iron filings on a distance of 70 meters.

Photo 1. The trace where the rail was climbed by the right wheel of the inactive locomotive

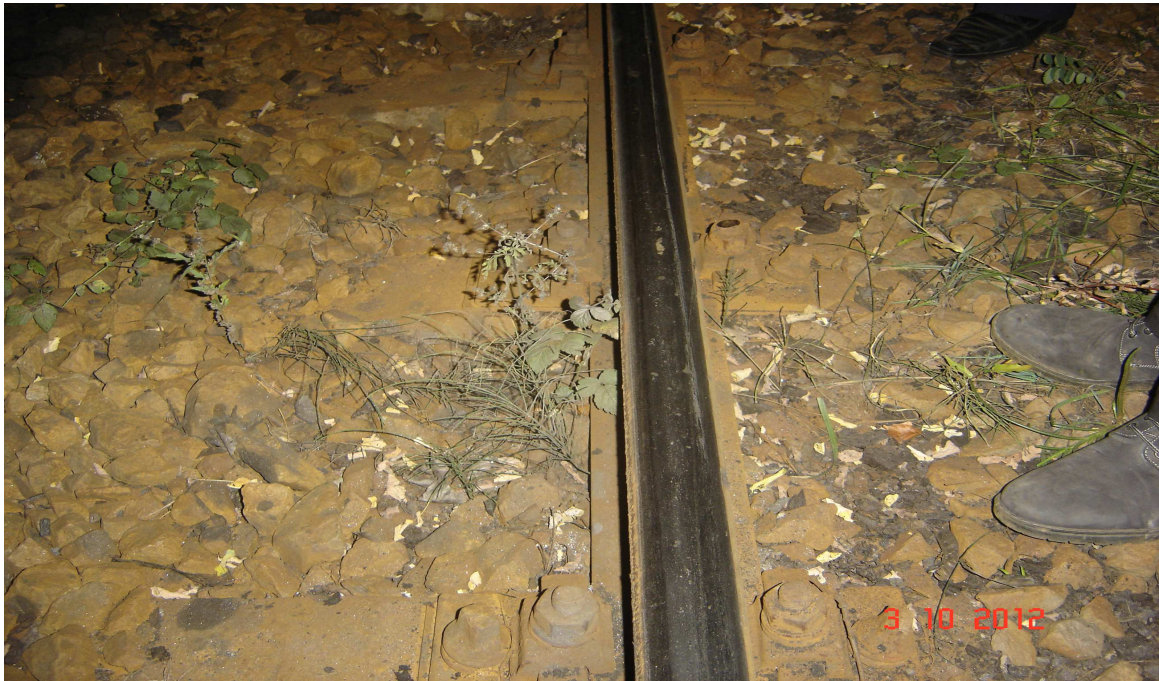
On a distance of approximately 15 meters from the derailment, one observe on the head of the right rail two traces from the flange of two wheels that ran in parallel with the derailed axle. Forwards those two wheels came back on the rail (the traces are accompanied by the ones left by the derailed axle).

Photo 2. traces on the head of rail by 2 axles that ran on the head of rail.
