ROMANIAN RAILWAY INVESTIGATING BODY

INVESTIGATING REPORT

on the railway accident
occurred on the 15th of February 2011, on the direct line II,
in the flag station Valea Alba on the 15th of February 2011

*Final EDITION
the 23rd of May 2011*

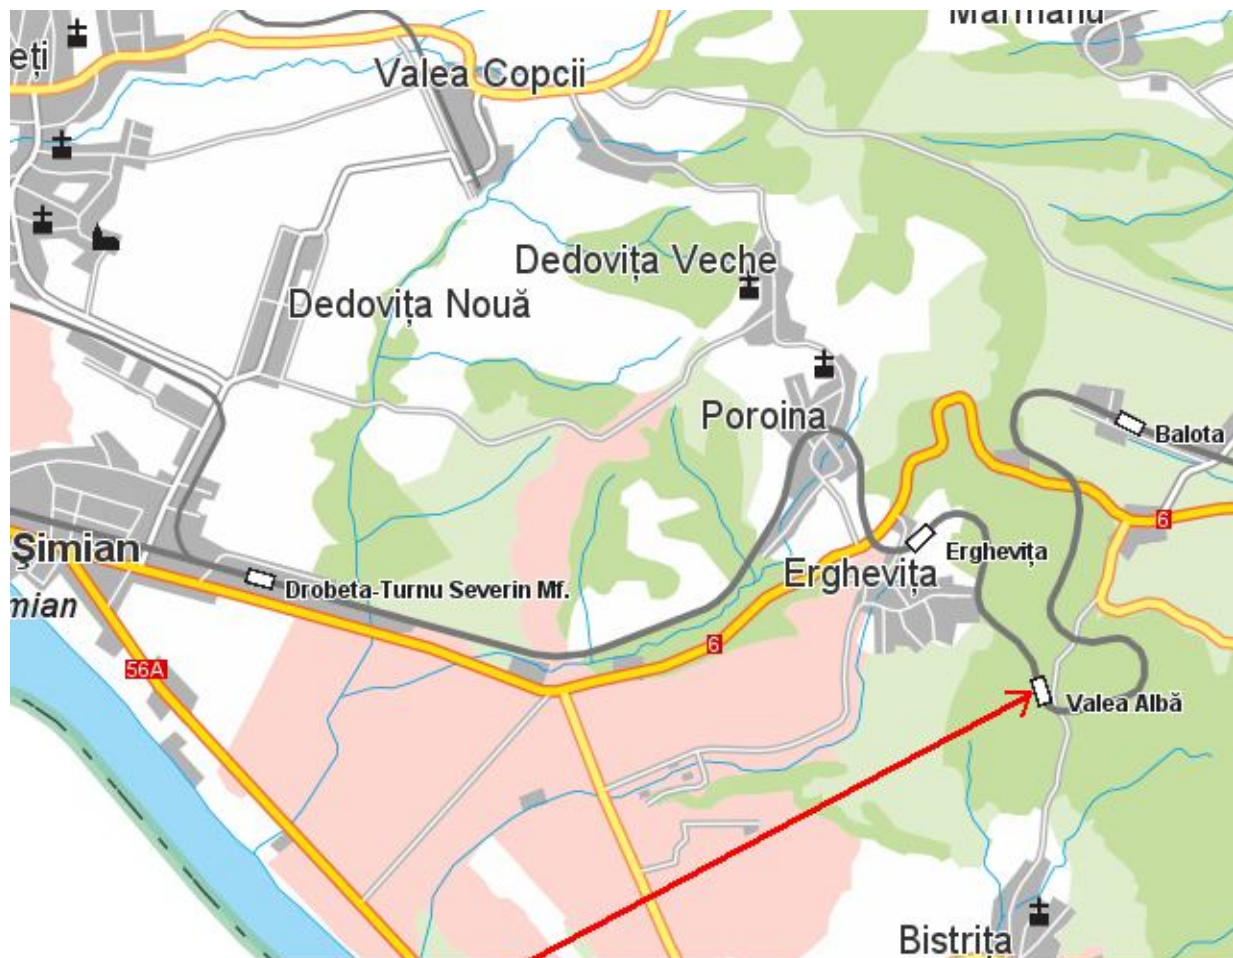
photo no. 1

Place of the accident

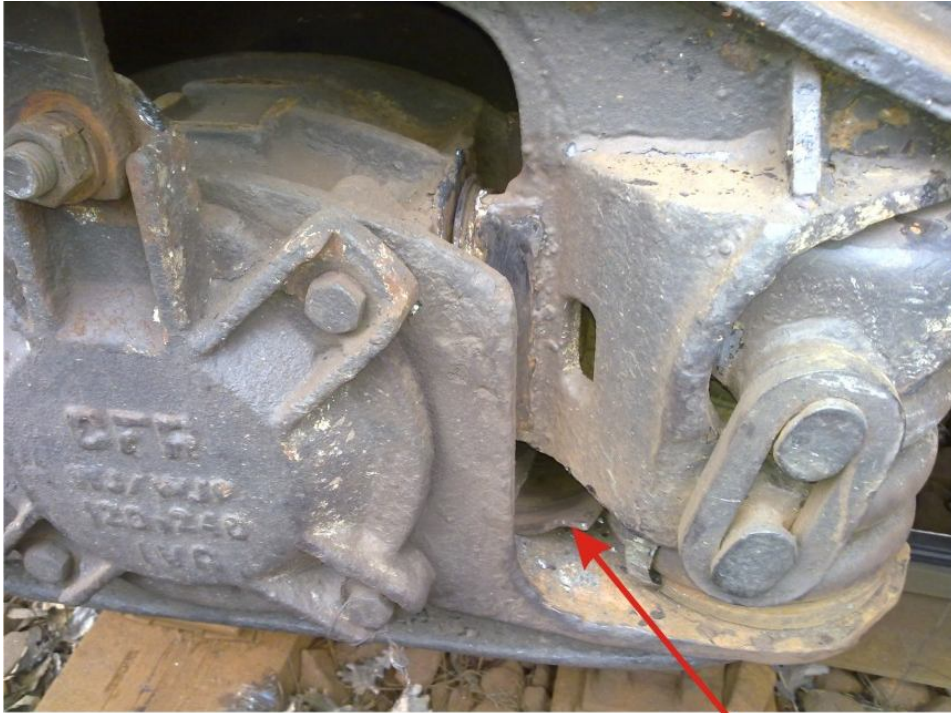
photo 2

- the wear plate of manganese austenitic steel from the dry friction damper type Lenoir, associated to the axle box from the wheel no. 7 was displaced from the welding without signs of tears or old cracks and it was deformed;

manganese steel plate deformed

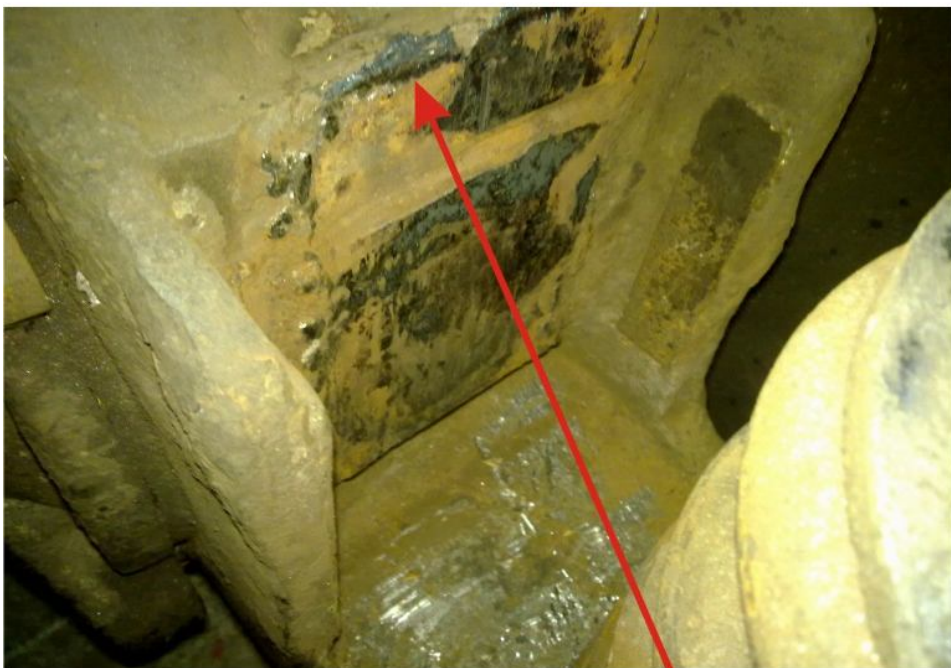
photo 3

broken weld cord

- the weld cord was broken on the entire perimeter of the wear plate of manganese steel. The break was new;
- the operation surface of the pressure part had hits and signs of overheating (bluish).

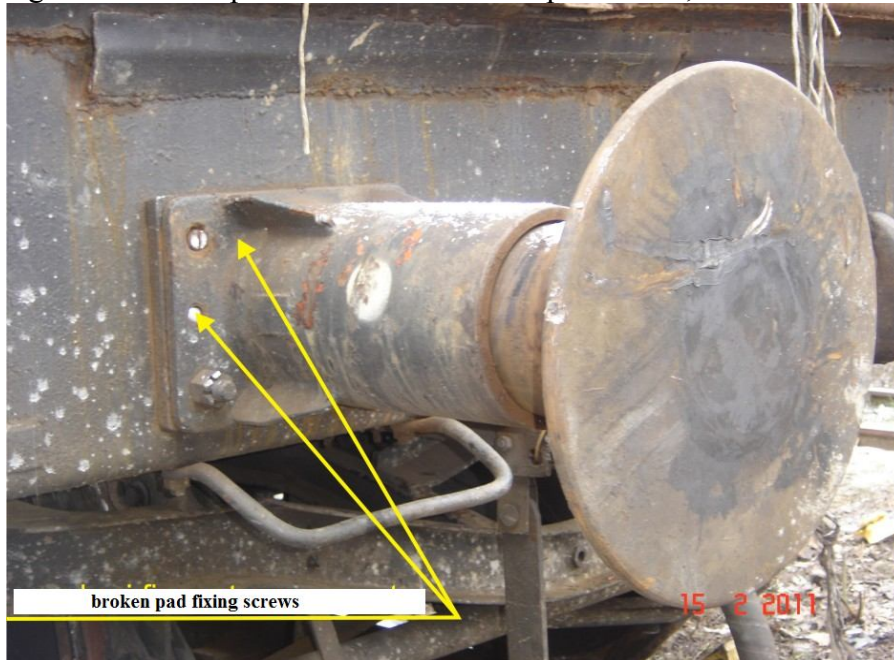
photo 4

- two fixing screws of the pad box on the front sleeper broken;

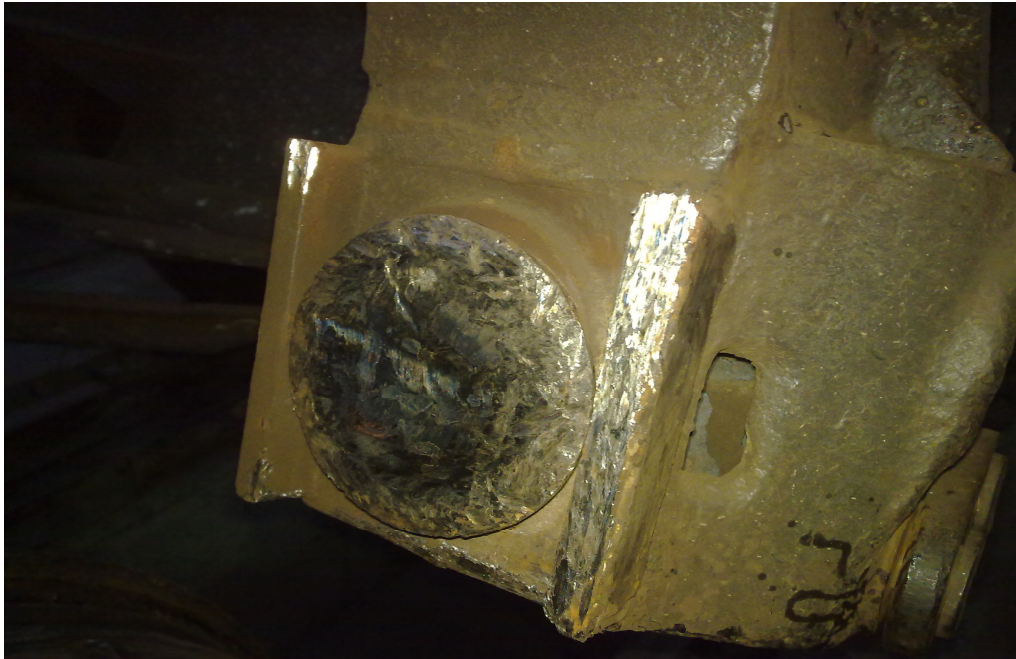
photo no. 5

As consequence of the manganese plate displacement, occurred the work perturbation of the damper Lenoir,

so that the pressure part (the piston) did not act anymore on the manganese plate. After the inclination of the piston a pronounced friction occurred, which led to the deformation of the manganese steel plate. After the measurements performed at the bogies type Y25Cs from the wagon series Eacs no. 31535481610-2 resulted that the amounted stroke between the friction stones (sliding) on the diagonal of the wagon right front – left back has the value 0, contrary to the provisions of the point 6.4.16 of the railway Technical Norm no. 57-001/2006 and to the provisions of the points 2.3, letter f) of the Instruction no. 936/1991.
