Accident Investigation Report

Train derailment

Stuttgart-Untertürkheim station

Derailment, Stuttgart-Untertürkheim, 15 March 2010

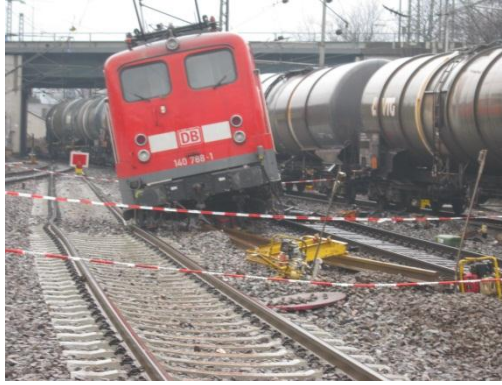
***Second locomotive, 140 788-1,
derailed first***

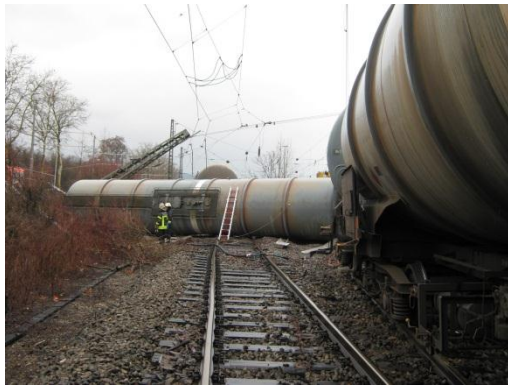
***First tank wagon
No 338078485525
overturned***

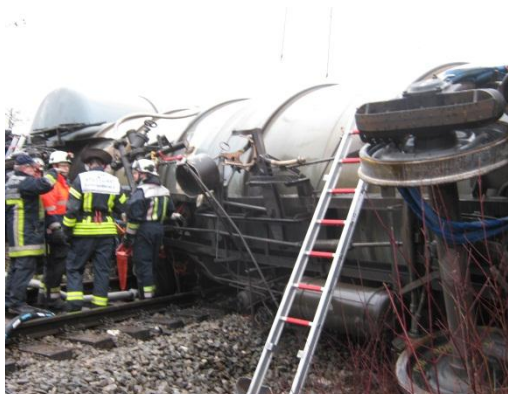
***First tank wagon,
transfer of tank contents
due to leakage***

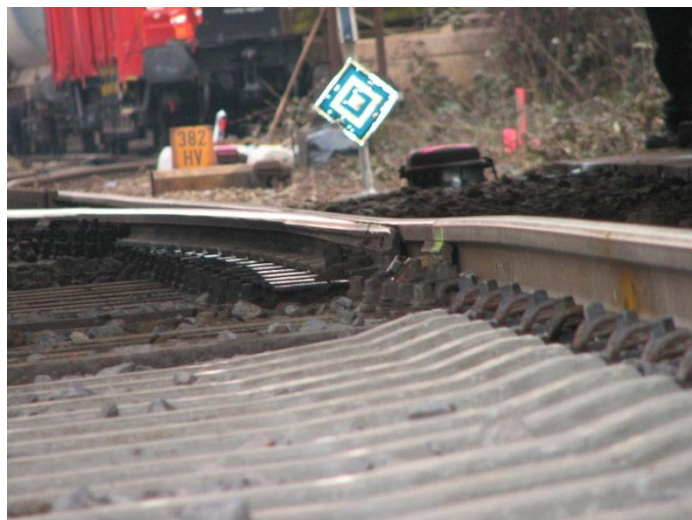
In this way, a steep gradient with a twist of some 8.2 ‰ was created. The limiting value for the 'twist' parameter in accordance with Module 821 'Inspection of the Permanent Way' was exceeded (it was 153 ‰ where the limiting value is set at 130 ‰). Since readings were not taken up to at least 20 m beyond the end of the work of the plain line tamping machine (as required by Module 824 'Carrying out work on the permanent way'), the fact that the limiting value had been exceeded was not recorded.

In accordance with Guideline 821.2001, a twist of greater than 130 % or 7 ‰ exceeds the limiting value. The limiting value is the value which requires the line to be closed in accordance with Guideline 821.1000.

Depression in the outer rail of the curve by the toe of No 391 switch (end of the tamping work)

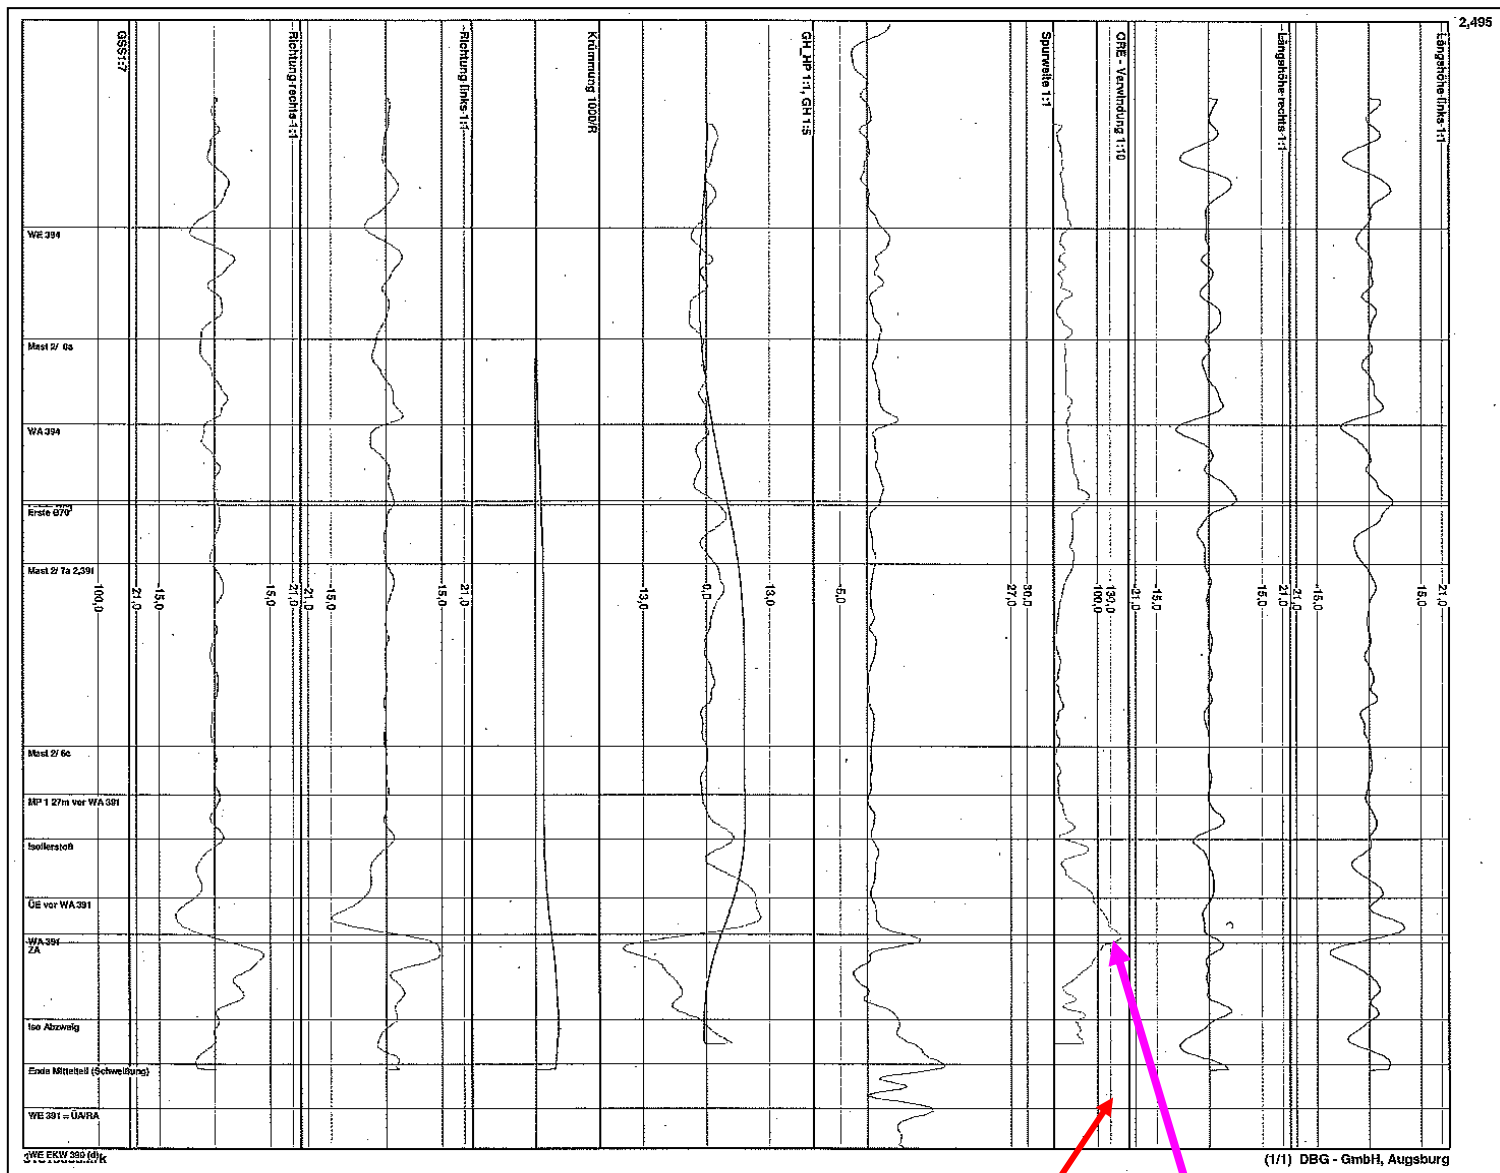
'Krabbe' record after derailment

After the derailment, the geometric layout of the switch and the condition of the switch blades (gauge 1) was checked. No faults were found. The exact track geometry between the frog end of No 394 switch and the frog end of No 390 EKW [simple crossing switch] was measured by using the 'Krabbe' measuring system. A depression in the outside rail of the curve before No 391 switch is apparent here (see the illustration below). This measurement reveals that there is a twist of some 8.2 ‰ in the area of the toe of No 391 switch. This constitutes a percentage factor of 153 % compared with the standard limit value of 130 % or the SR-100 value of 100 %: the measurements of 3.0 m or 3.5 m from the 'Krabbe' system are the criteria for this process. The slightly different twist fault of 8.41 ‰, given in the DB-Systemtechnik report and derived by spline interpolation, relates to a wheel base of 3.40 m. This wheel base is the same as that of the bogie of class 140 locomotives.

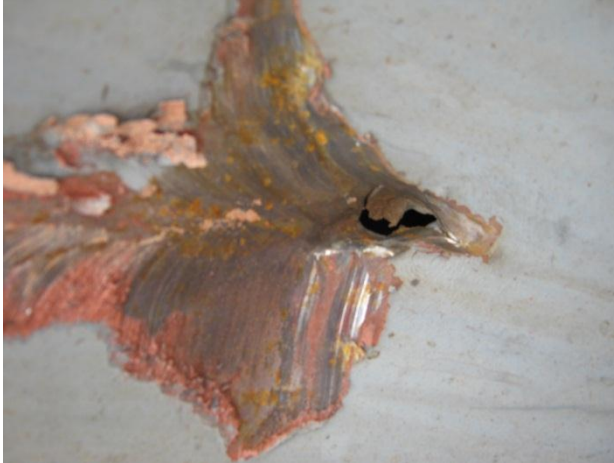
The following trailing load forced the first overturned tank wagon (3380 7848 552-5) against electrification mast No 2/3 and against its concrete base, standing on an embankment. One corner of the buffer beam of the second tank wagon pierced the rear-facing tank wall of the overturned wagon. Hence a 4 cm hole was made in the tank wall. A further leak occurred on the opposite side, close to the forward right-hand fillet between the tank and its

Leakage from the rear tank end – first tank wagon

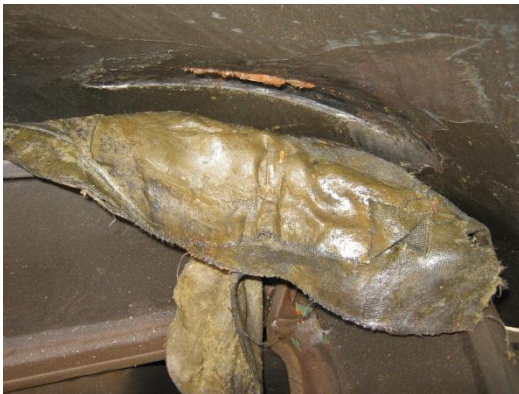
Leakage from the tank cradle fillet front right

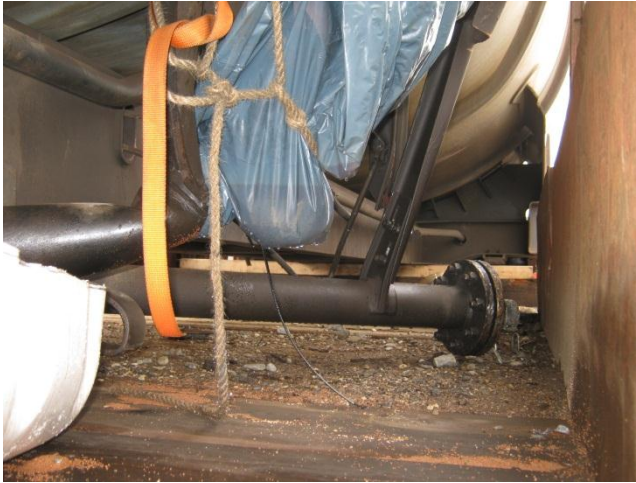
cradle. Most of the diesel fuel which escaped did so through the damaged bottom valve, the outlet pipe and the filling valve. The tank was within its 'next maintenance' date. All the damage which had led to the leakage was due to the high forces (in part selective) imposed by the following trailing tank wagons.

Damaged outlet pipe and filling valve

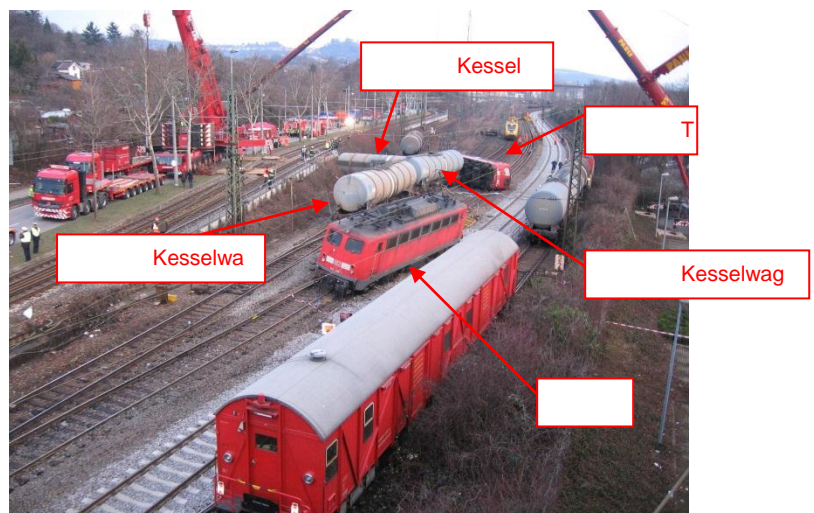
**Overall view
showing the damaged
vehicles**

The evidence from the derailment and the position of the vehicles involved point to the sequence of events being as follows:

- First of all one wheel set on the leading bogie of locomotive No 2 derailed on No 391 switch towards the right in the direction of travel.
- As a consequence of the derailment, locomotive No 2 veered off to the right. Both couplings became undone in consequence. Locomotive No 1 became derailed together with tank wagons one to three. The main brake-pipe was separated and the brakes applied automatically.
- The trailing load collided with locomotive No 1 and caused locomotive No 1 and the first tank wagon to tip over.
- Locomotive No 2 finished some 100 m beyond the first point of derailment.
- Overturned locomotive No 1 and the overturned tank wagon finished some 150 m beyond the first point of derailment.

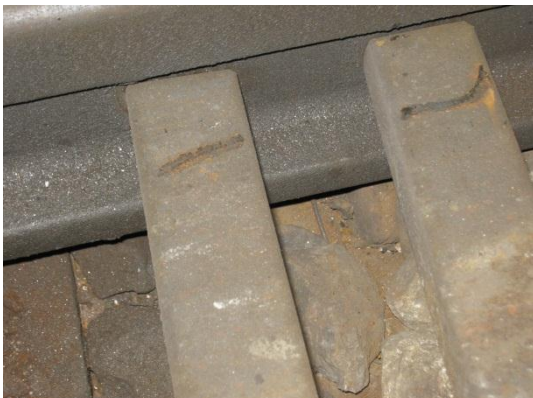
The first signs of climbing the rail are on the side of the right-hand switch blade shortly close to the toe. Disturbance of the layer of rust provides evidence of running on the tops of the blades. Further signs of derailment can be noted on the distance blocks of No 391 switch. In this case it is the impression of the wheel flanges. Some rail fastenings were also damaged by the locomotive. All further damage beyond No 391 switch is to be regarded as the consequence of the derailment.

Signs of derailment – distance blocks No 391 switch

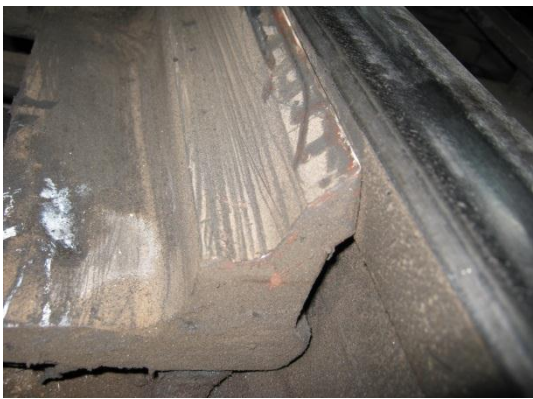
Signs of derailment – anti-creep anchor No 391 switch

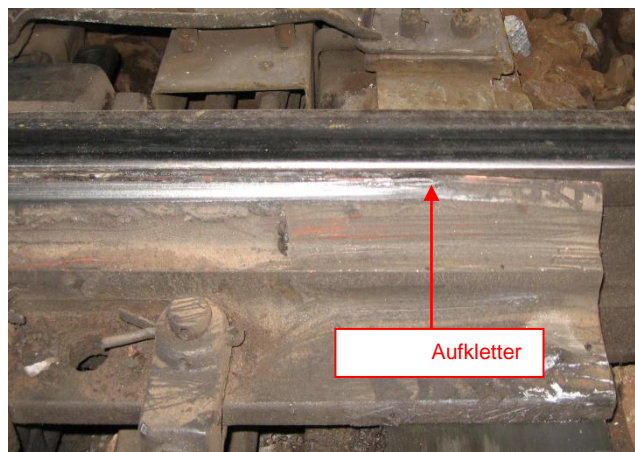
Longitudinal markings – right blade of No 391 switch

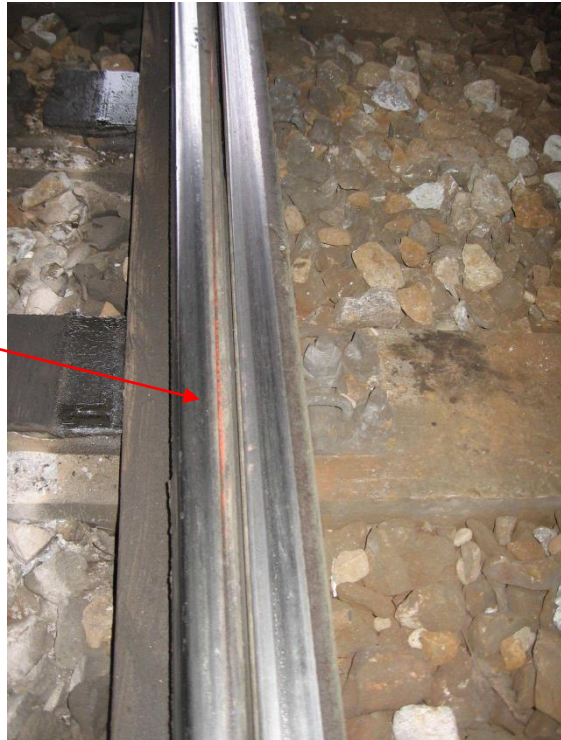
Signs of climbing - right blade of No 391 switch

Signs of over-running - right blade of No 391 switch
