SEKTOR ZA PREISKOVANJE ŽELEZNIŠKIH NESREČ
IN INCIDENTOV

Number: 375-16/2010/14

Date: 9 June 2011

**FINAL REPORT ON THE INVESTIGATION OF A RAILWAY
ACCIDENT – COLLISION OF LOCOMOTIVE TRAIN NO. 96366
WITH PASSENGER VEHICLE**

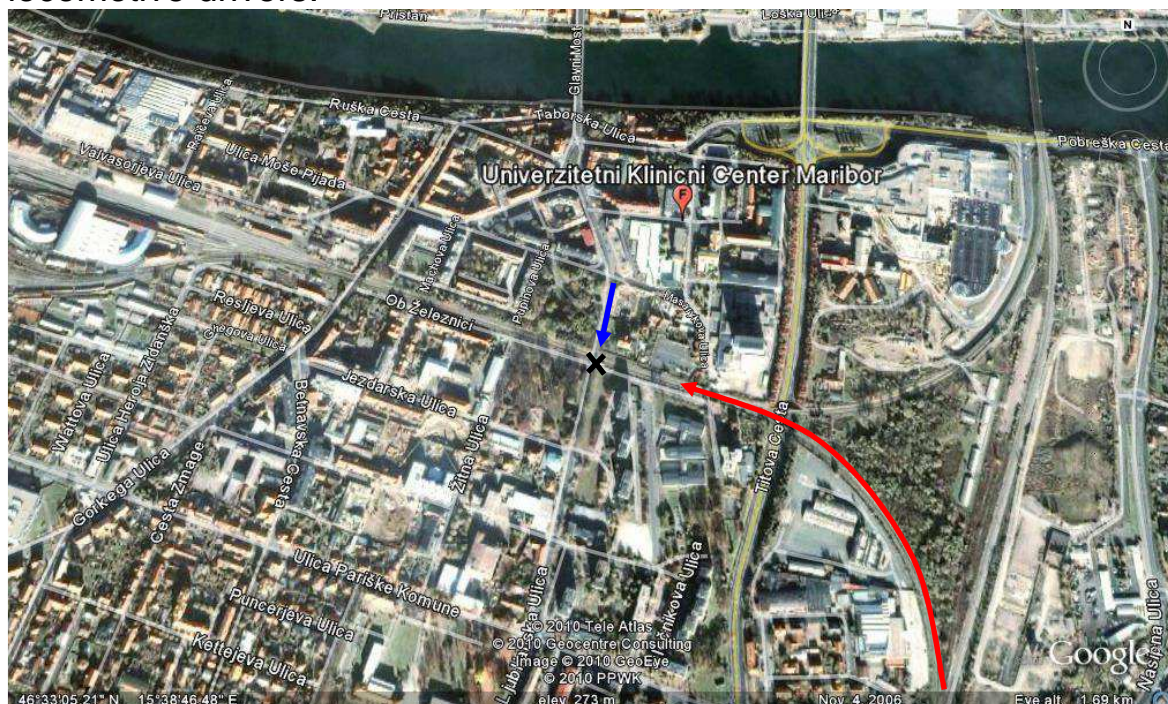
Figure 1: The red arrow shows the direction of the train, the blue arrow shows the direction of the passenger vehicle, and the black cross the point of collision

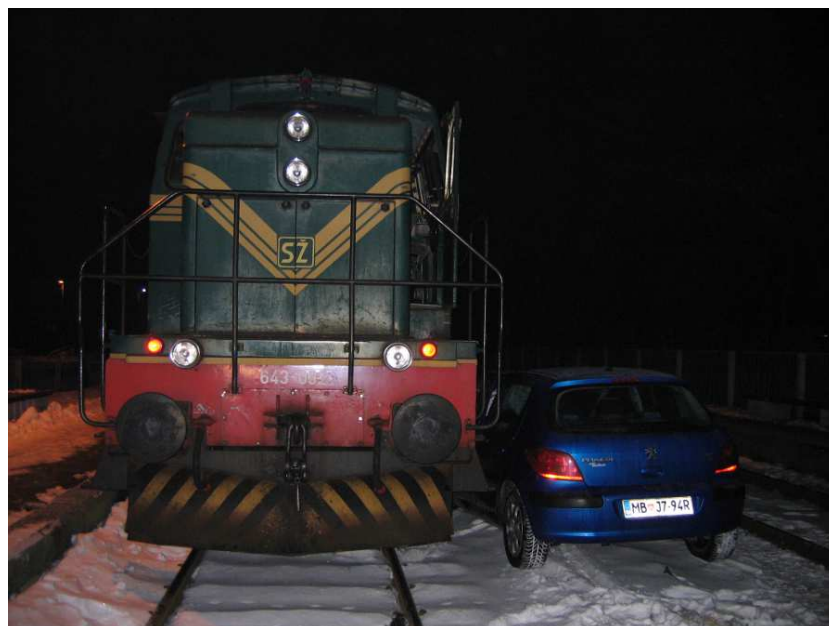
After the collision, the locomotive pushed the passenger vehicle forward for 49 m before the vehicle came to a halt in the area between the two tracks on the right-hand side of the locomotive. The locomotive then came to a halt after 10.8 m.

Figure 2: Rail and road vehicles involved in the accident immediately after the occurrence

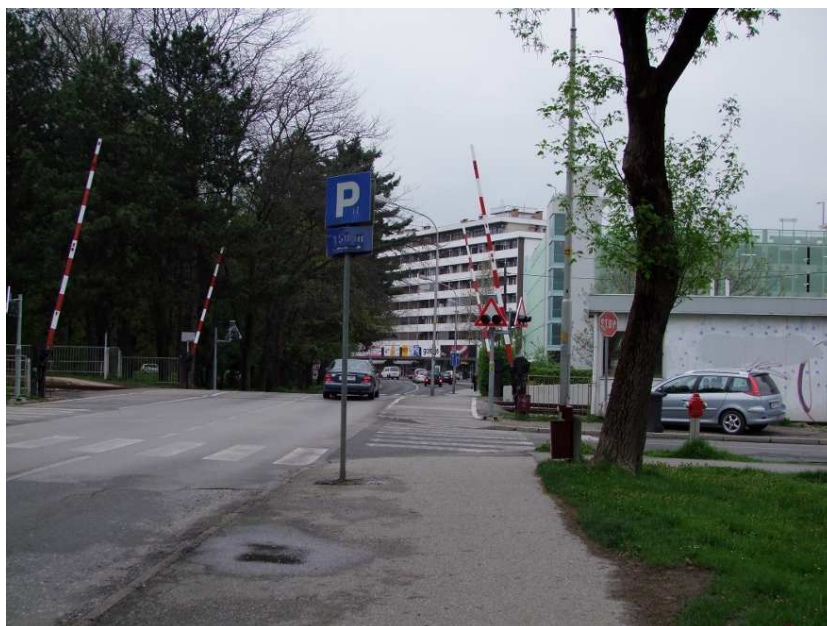
For road users approaching the level crossing in the direction of the University Medical Centre, the view of the railway line in the direction of Maribor station is obstructed by the level crossing guard box and the concrete noise barrier.

Figure 2: Road users' visibility or view of the railway line

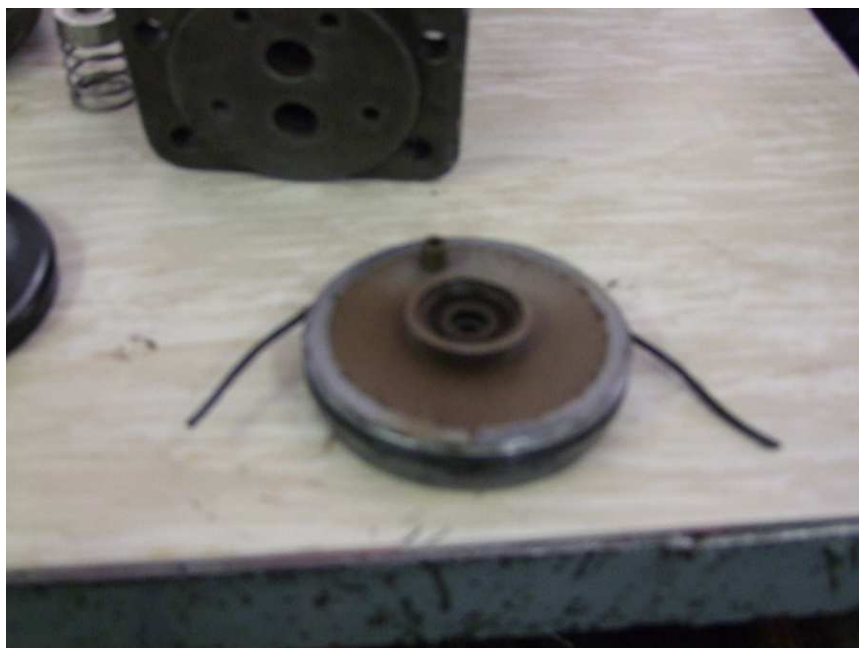
Figure 3: The ring seal of Öerlikon LST1 distributor no. 0326 was torn.

With respect to the impact of the torn ring seal of Öerlikon LST1 distributor no. 0326, in repeated tests the Commission did not establish that the failure had an impact on braking performance. However, a potential impact could not have been completely ruled out, since this failure could result in a deficiency in the braking system causing insufficient braking effect.

The ring seal of Öerlikon LST1 distributor no. 0326 was labelled with category no. 702006-3, which means that the seal originates from 2006 and the distributor underwent an inspection on 12 February 2002. There was no entry in the records that the ring seal of the distributor had ever been replaced.

1. In the case of regular or extraordinary maintenance of traction vehicles, especially the maintenance of their vital components (i.e.

braking systems, tread profiles and safety devices), traceability must be provided on the basis of detailed internal regulations for individual types of vehicles.
