Number: 275-18/2010/9

**FINAL REPORT ON THE INVESTIGATION OF A RAILWAY ACCIDENT – COLLISION OF
FREIGHT TRAIN NO. 42083 WITH A PASSENGER VEHICLE AT PUCONCI-2 LEVEL
CROSSING AT KM 44+435 BETWEEN LJUTOMER AND DANKOVCI STATIONS**

Ljubljana, 1 December 2011

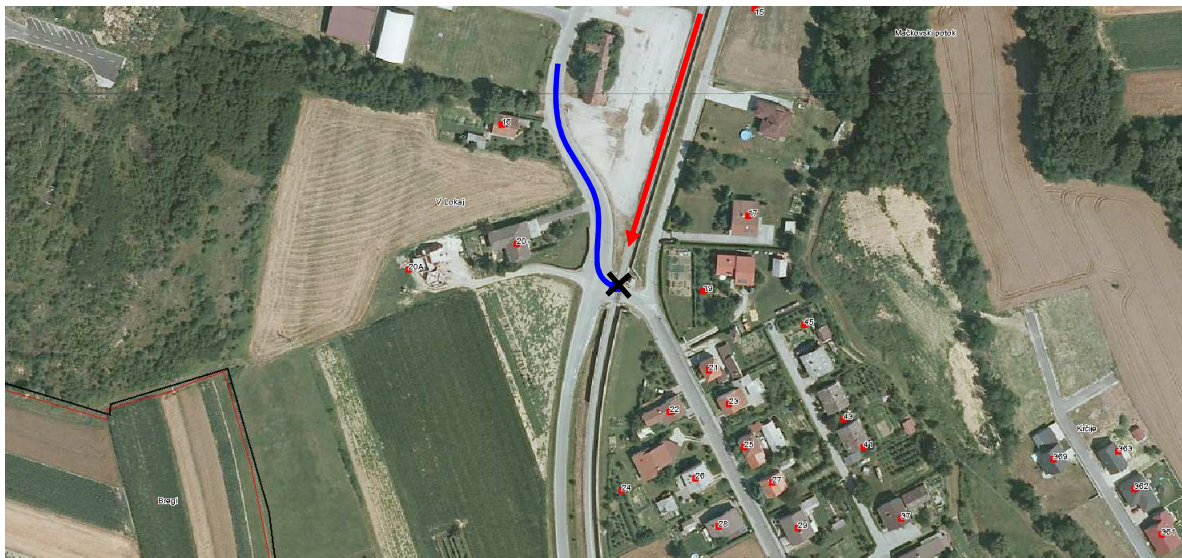
The train had been catching up with the passenger vehicle travelling parallel to it for 140m; for the last stretch of 110m, the train was catching up with the passenger vehicle at an angle of 30°.

At the level crossing the train hit the left-hand side of the passenger vehicle, pushing it forward for 286.6m, where it stopped with the vehicle wedged under the locomotive's right fender.

Figure 1: The red arrow shows the direction of the train, the blue arrow shows the direction of the passenger vehicle, and the black cross the site of collision

Protection at Puconci 2 level crossing at km 44+435 between Murska Sobota and Dankovci stations should be upgraded with half barriers for all the lanes, owing to the micro-location of the level crossing and noise barriers (the level crossing is located within the area of the junction, and noise barriers diminish the ability to register the colour of half-barriers).

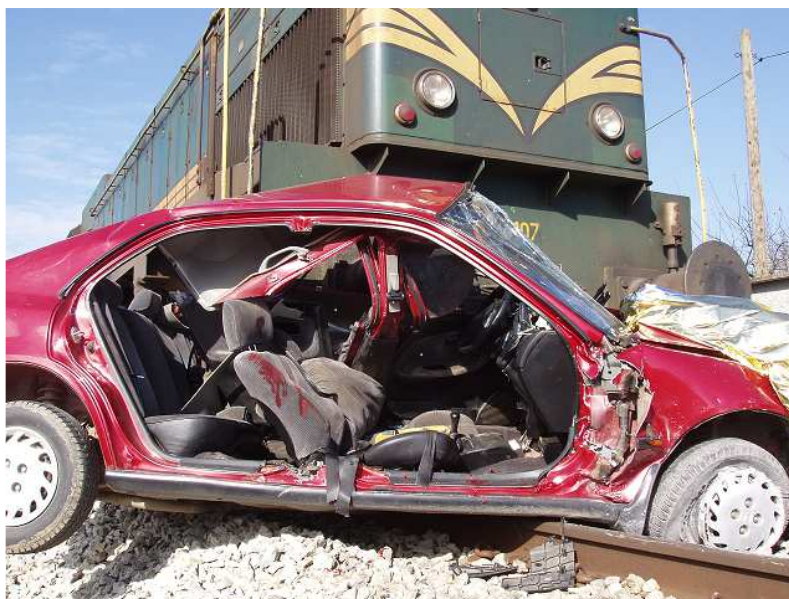
The road vehicle was occupied by the driver, who would have turned 70 in three months, and his wife aged 68 on the passenger seat. The driver of the passenger vehicle was driving along the local road from Šalamenci to Puconci. At the aforementioned junction, he turned left onto the opposite lane of the main road running through Puconci settlement and proceeded towards the level crossing protected with two half-barriers. He entered the level crossing driving along the opposite lane and thus circumvented the lowered half-barrier. The front right-hand side of the locomotive crashed into the middle of the passenger vehicle. The right-hand side fender of the locomotive pushed through the window of the driver's door and the passenger vehicle was then hooked onto the fender. The train pushed the vehicle for 286.6m until it stopped.

Figure 2: Consequences of the train's collision with the passenger vehicle at Puconci 2 level crossing

Only the right-hand step and the plough of diesel locomotive 664-107 were damaged in the accident. Maribor Traction Section (*Sekcija za vleko Maribor*) assessed damage at EUR 2,500.

The passenger vehicle was completely wrecked in the accident. According to a non-expert assessment, material damage to the road vehicle amounted to EUR 3,000.

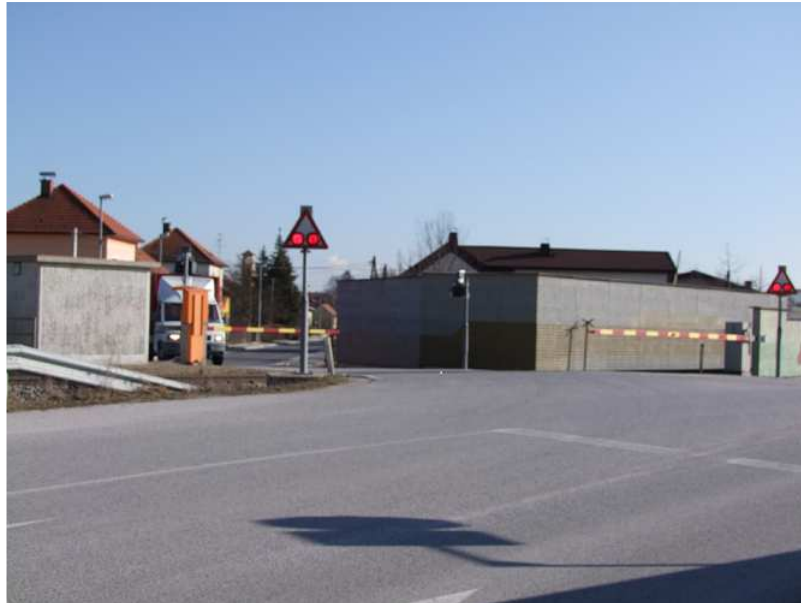
Road users have an unobstructed view of the railway line in the direction of Dankovci for 350 m, but visibility can be deceptive for road users due to the colour spectrum of the high concrete noise barrier erected on the opposite side of the railway line. It should be stressed, however, that visibility does not have to be provided, since the crossing is protected by half-barriers. The barriers were lowered across the road at the time of the accident.

Figure 3: Colour spectra of half-barriers and illuminated road signs

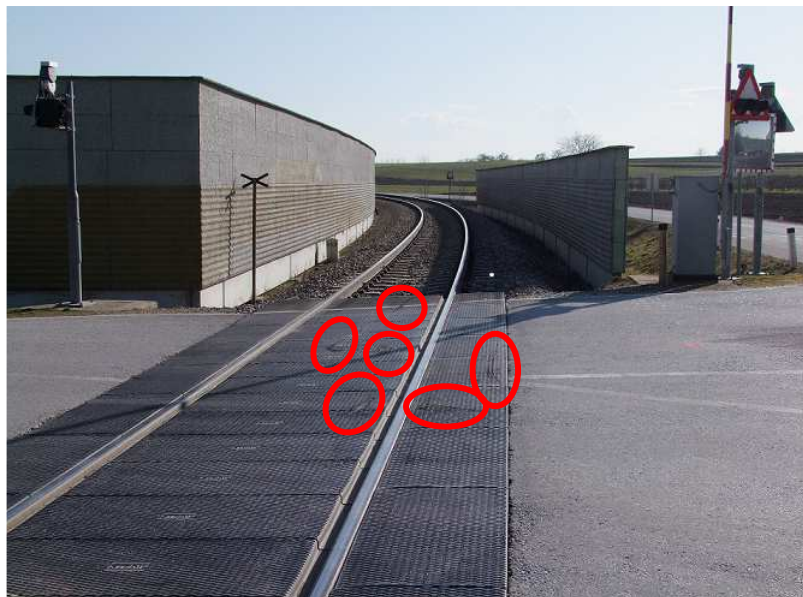
The elements of the device protecting Puconci 2 level crossing were not physically damaged in the accident.

Figure 4: Traces of the collision on the rubber elements of the level crossing
