Number 375-15/2009/7

Date: 30 October 2009

**FINAL REPORT ON THE INVESTIGATION INTO THE RAILWAY  
ACCIDENT – RAIL WORKS MANAGER RUN OVER BY FREIGHT  
TRAIN NO 52102 ON THE LEFT-HAND TRACK BETWEEN RAILWAY  
STATIONS LAŠKO AND RIMSKE TOPLICE AT KM 514+930**

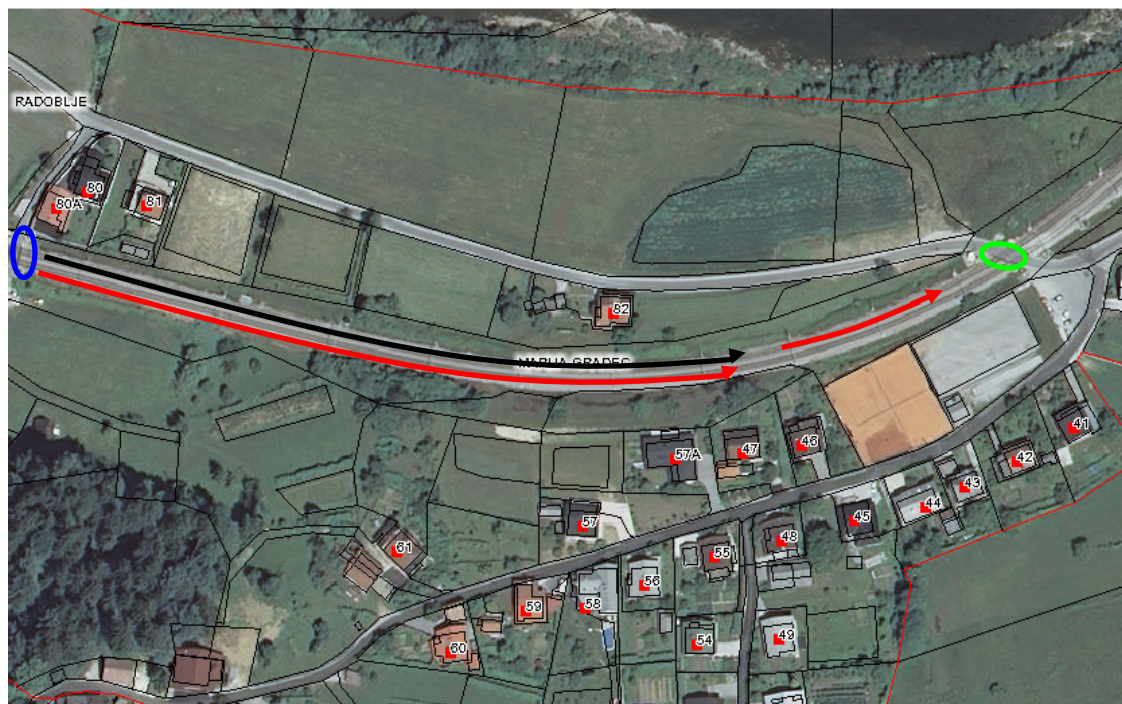
Figure 1: The blue ellipse marks level crossing 2, the green marks level crossing 3, and the red arrow marks the direction in which the rail works manager was walking; the black arrow marks the direction of train no 52102

The road runs in a curve similar to that of the railway line, and is approximately 40 m from the railway line at its farthest point.

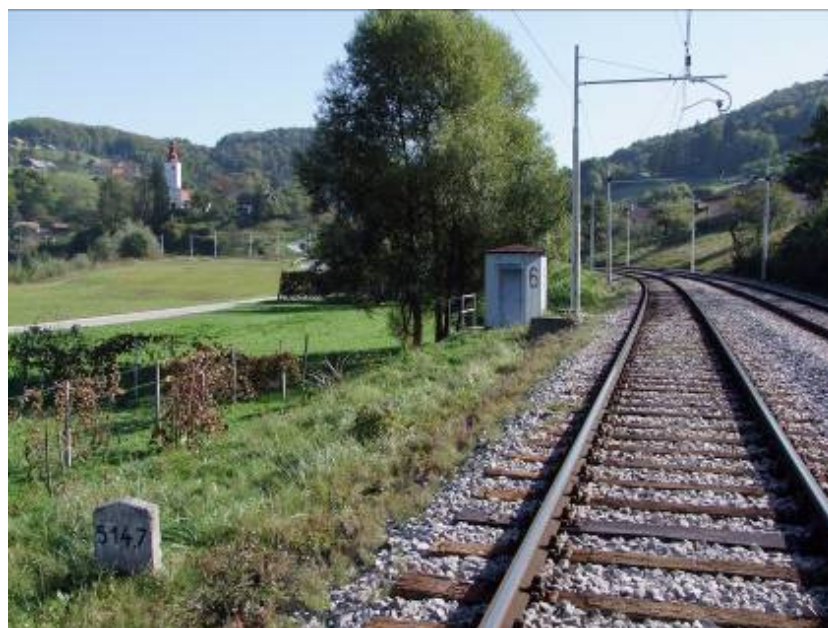
Because of the left-hand curve, the railway line cutting, a residential building and the vegetation at the left-hand side of the railway line ahead of the accident site, the field of vision of the locomotive driver of train no 52102 was reduced to 150 m.

Figure 2: Reduced visibility on the left-hand railway track, 230 m before the accident site

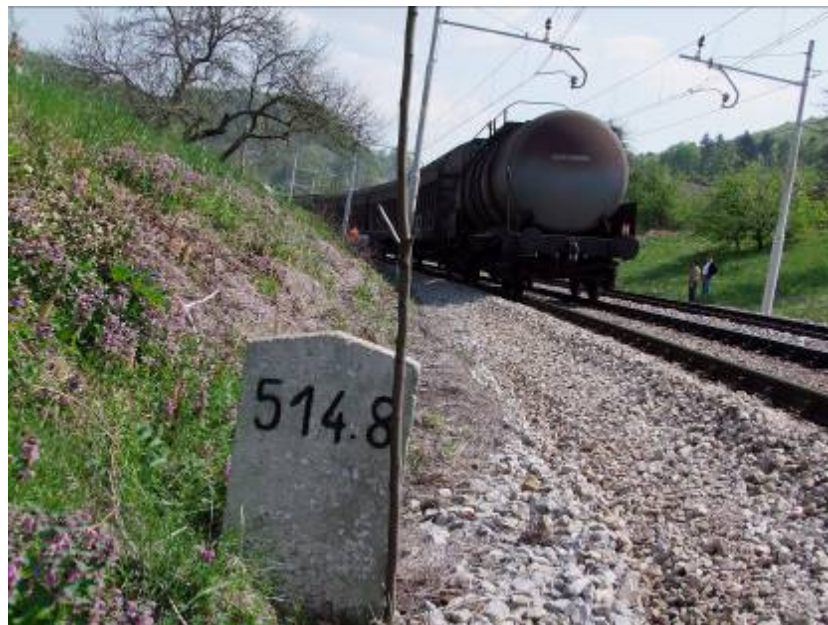
Figure 3: The rear of stopped train no 52102 located at km 514+848

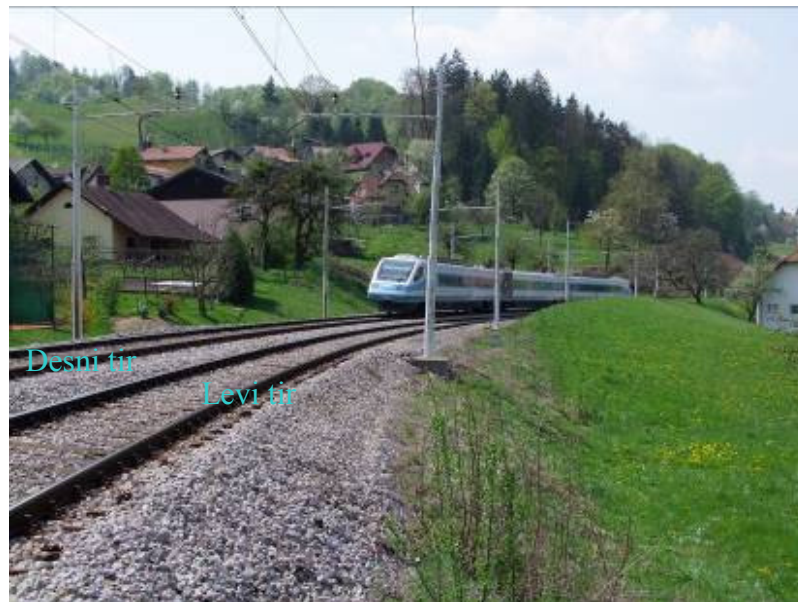
One of the reasons for the rail works manager’s walk in the very track of this section may also have been the fact that it was difficult to walk next to the track because of the rising ground continuing immediately under the railway ballast and because of the drainage duct for rainwater.

Figure 4: Layout of the terrain at the left-hand track in the area where the rail works manager was walking in the left-hand track

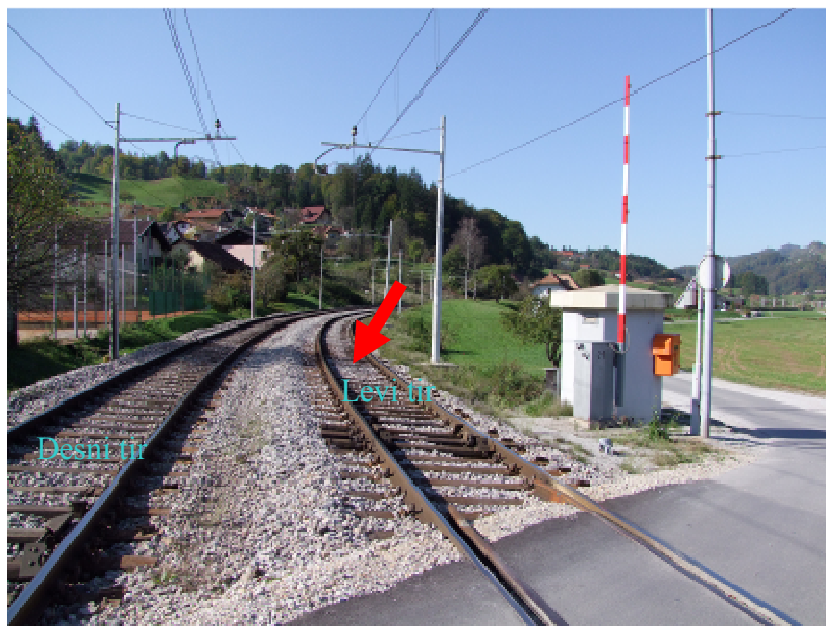
It is probable, that the rail works manager was looking for a suitable place to withdraw from the track since he was only 43 m away from the LC 3 level crossing – which is at km 514 + 973 – when he was run over. The railway is running in a minor cutting and is pressed against the side of a hill at this section and there are, moreover, residential buildings along the track; therefore, the sound emitted by the train is absorbed to a large extent. Because the sound of the whistle rebounds from the hill and is then attenuated among the buildings, it has a different level than in areas without obstacles. It is also possible that, when walking on the track, the rail works manager relied chiefly on what he heard. The locomotive driver sounded the signal “Caution!” as early as at km 514+065, at the point where the signals for work-site (signal 207) had been placed, which is 865 m ahead of the accident site; the rail works manager may have inferred from the sound level – that was attenuated for reasons mentioned above – that the train was not so near.

Slika št. 5: Layout of the terrain next to the track and on the track in the area where the rail works manager was walking on the left-hand track; the red arrow marks the accident site.
