Transporta nelaimes gadījumu un incidentu izmeklēšanas birojs

## **Railway accident investigation final report**

### **№ 5-02/1-22**

The railway traffic accident occurred on January 1, 2022 at 15.55 at Zilupe station, where, during the arrival of the train number 2624 at the 5th track of the station with a fractured wagon number 52673068 bogie side frame, the first bogie (in the direction of the train) derailed.

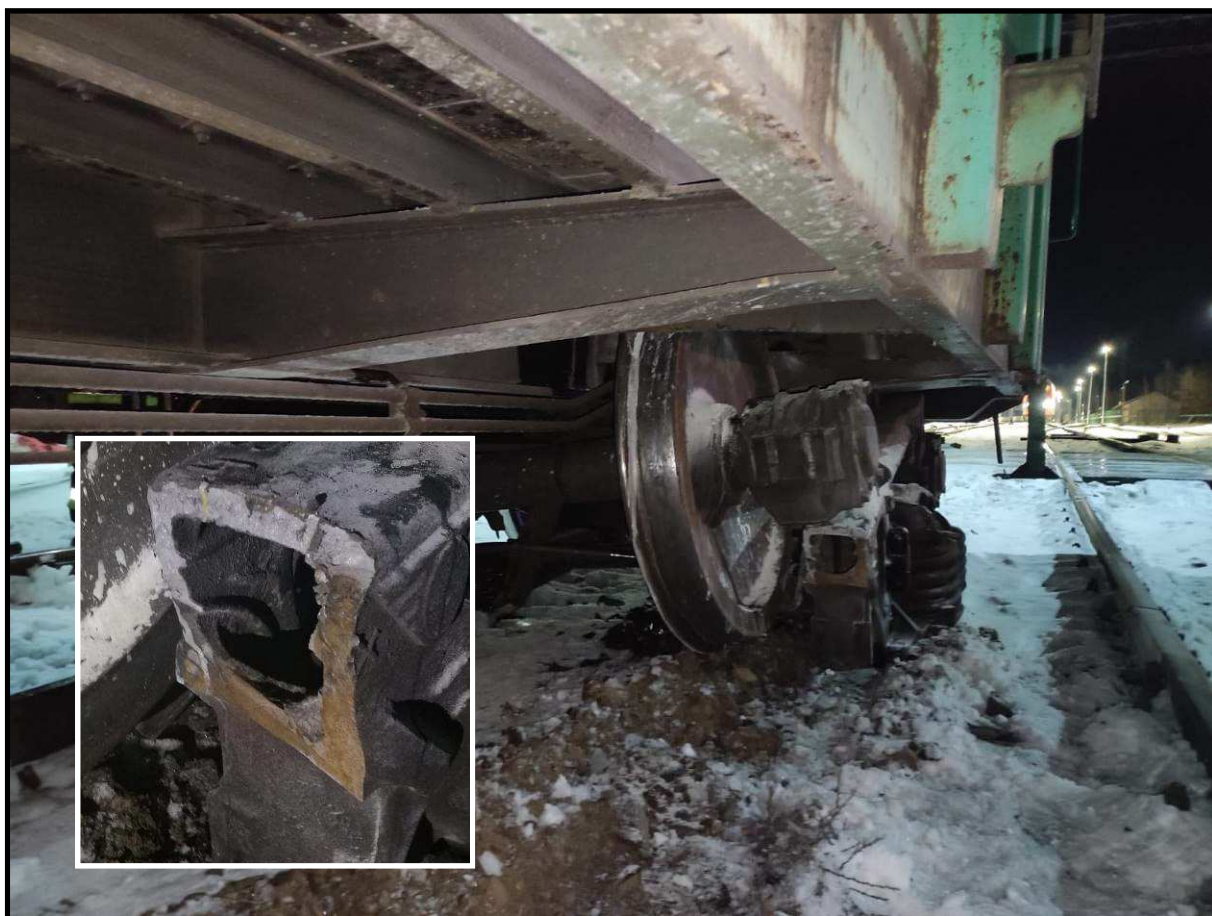
The cause of the accident was the internal defects of the metal casting of the side frame of the bogie, which led to the formation of a fatigue crack during the operation of the part, the fracture of the side frame of the bogie during the movement of the train with the subsequent derailment of the wagon.

The cause of the accident was technological deficiencies made during bogie side frame number 1291-17648-2008 production, as a result of which gas cavities formed in the metal R 55 area of the side frame, which led to the formation of a fatigue crack during the operation of the part, its development with the subsequent fracture of the part and the derailment of the wagon.
