Investigation Report No. R2010 – 004

**Malahide Viaduct Collapse on the Dublin to Belfast Line,
on the 21st August 2009**

Title	Malahide Viaduct Collapse on the Dublin to Belfast Line on the 21 st August 2009
Document type	Investigation Report
Document number	R2010 – 004
Document issue date	16/08/2010

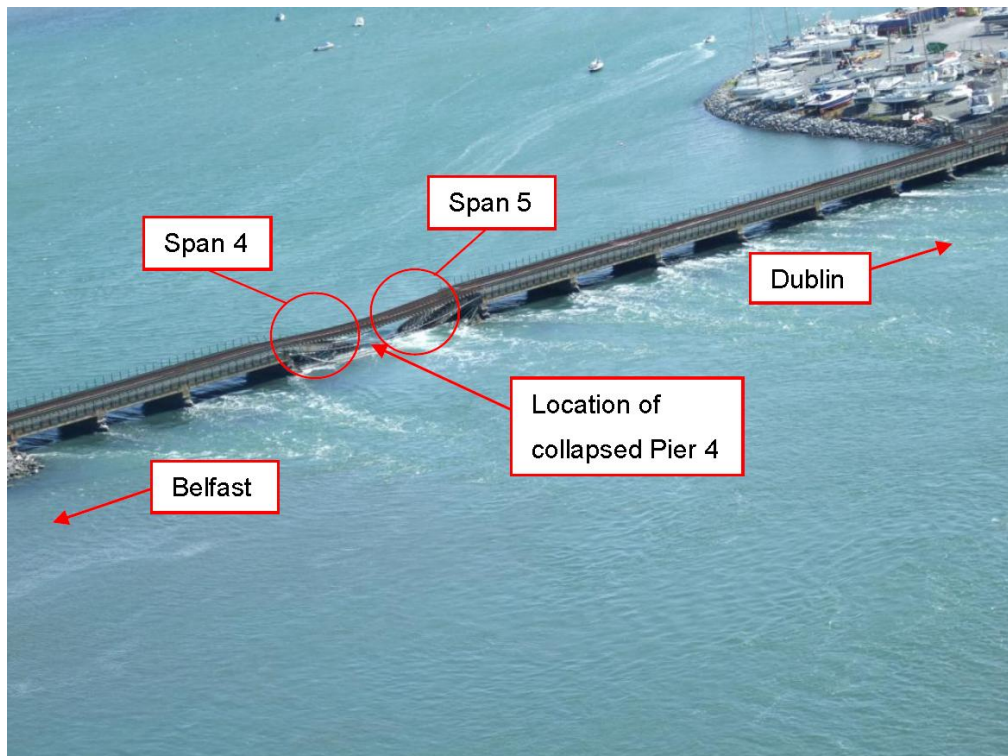
The immediate cause of the collapse of Pier 4 was as a result of the undermining of the weir that surrounds and supports Pier 4 through the action of scouring. This was as a result of a combination of factors:

Photograph 4 – Collapsed Malahide Viaduct

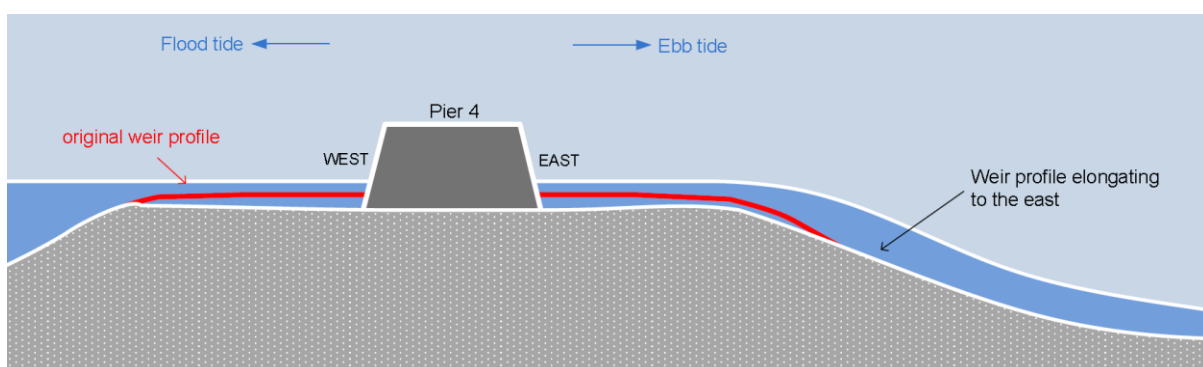
This movement of stones, simulated over a period of many years, resulted in the material being eroded from the crest of the weir; this process is generally referred to as *winnowing*. This erosion resulted in the weir's profile changing over the years from the original weir profile, illustrated in Figure 7, to a more elongated weir on the eastern side, illustrated in Figure 12.

Figure 12 – Weir elongating to the east due to erosion

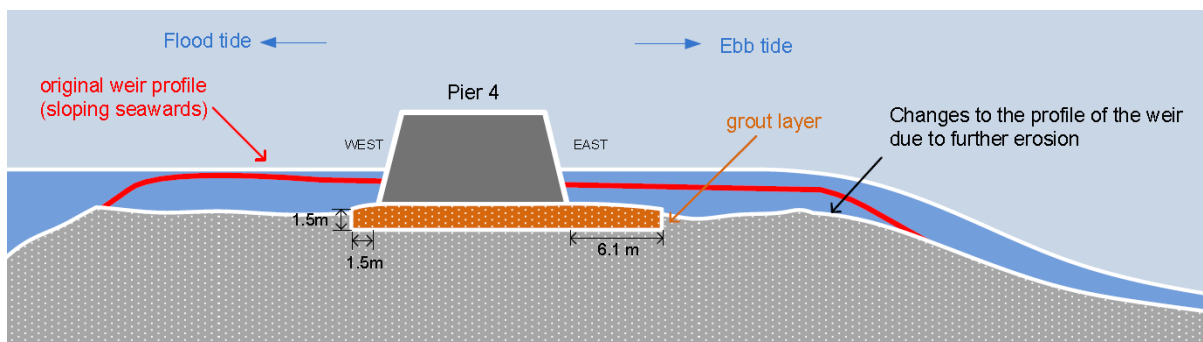
However, the grouted rock armour began to break down as a result of degradation of the grout (the grout on the west side remained semi-intact). This led to further transport of cobble and grout from the weir crest. However, with the non-replacement of materials to the crest of the weir further erosion resulted under the eastern side of the pier, (see Figure 16).

Figure 16 – Erosion of the eastern side of the weir

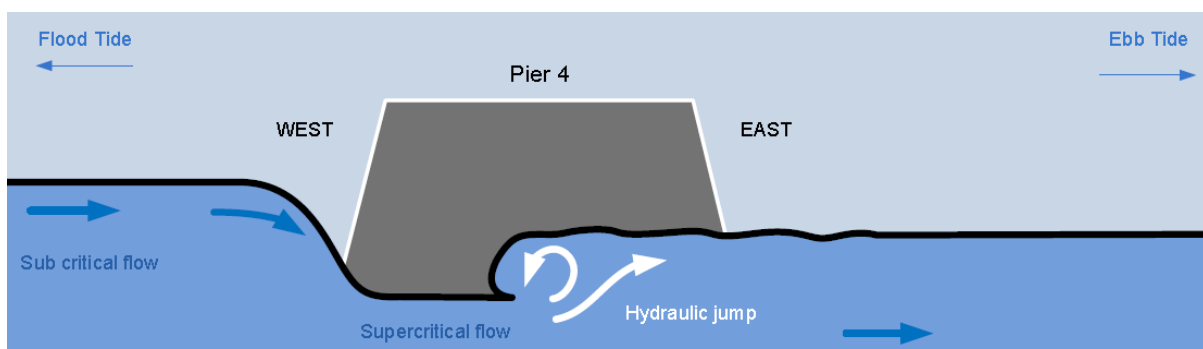
However, the 3-D 1:80, simulating the high spring *ebb tide* flowrate, showed that when the tide reached certain critical levels on the eastern side, a hydraulic jump formed between Pier 4 and Pier 5, the location of the collapsed pier (see Figure 18 and Photograph 8). Velocity measurements were taken from the model at the mid-point of the pier to the downstream side of the weir. These measurements were recorded in the model and scaled to the prototype giving values in the range of 4m/s to 5.5m/s.

Figure 18 – New position of hydraulic jump, between piers 4 and 5

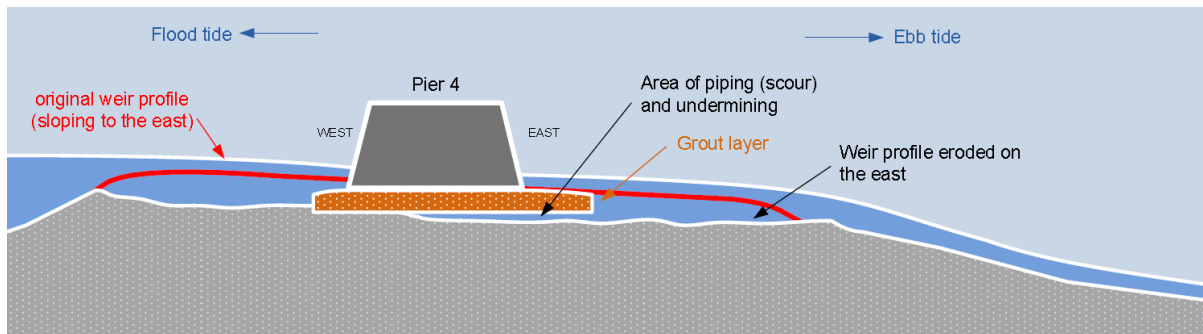
The turbulence from the hydraulic jump at the mid-point of Pier 4 would have meant that the materials were at the threshold of movement, and started being transported from the crest of the weir, with the materials being deposited on the eastern side of the weir, creating an even more elongated weir profile (see Figure 19).

Figure 19 – Transport of materials after the movement of the hydraulic jump

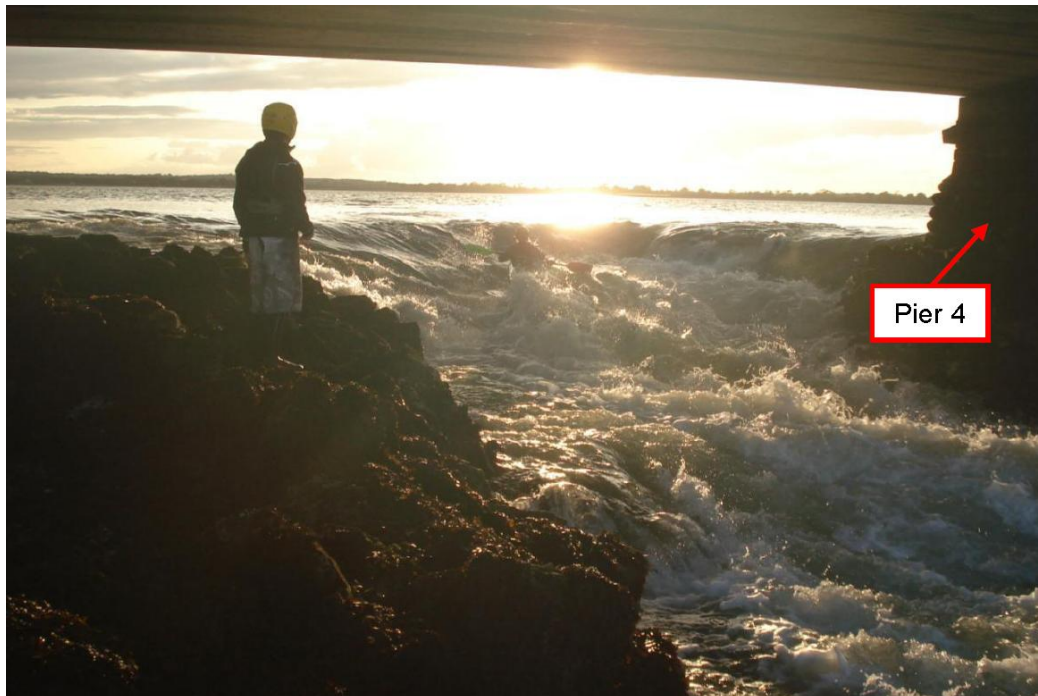
This erosion resulted in the area between Pier 4 and Pier 5 to deepen forming a channel (see Photograph 9). This resulted in changes to the water flow under the structure, with the flow of water no longer being evenly distributed through all twelve spans.

Photograph 9 – Deepened channel between Pier 4 and Pier 5

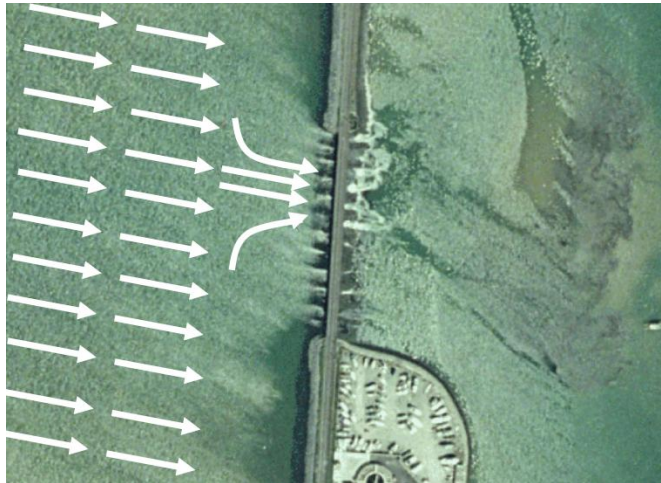
As a result of the deepened flow path, through Pier 4 and Pier 5; and the increased hydraulic gradient resulting from the erosion of the crest of the weir, the potential for the winnowing of smaller stones from the weir was increased.

Photograph 10 – Majority of water flow between Piers 4 and 5

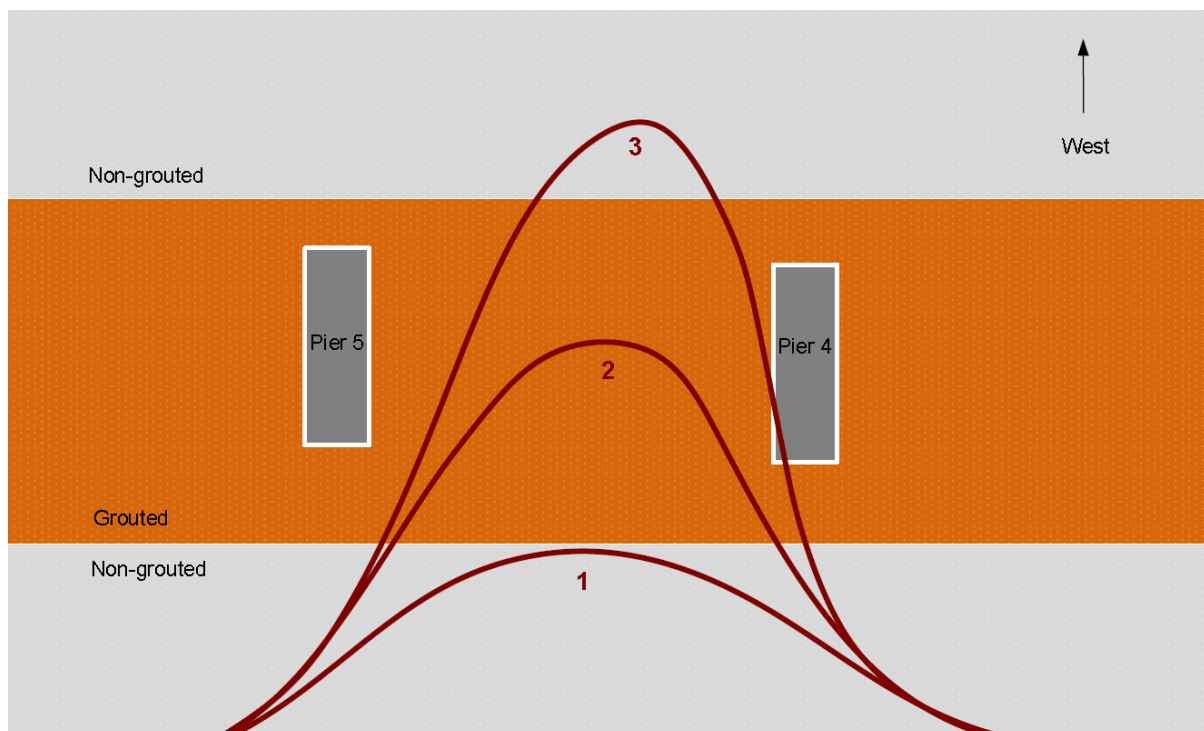
Figure 20 illustrates the grouted and un-grouted zones of the weir, as well with the red lines indicating the general westward propagation of the hydraulic jump where the grouted and non-grouted weir material has been removed by the scour action.

Figure 20 – Westward propagation of the hydraulic jump and erosion due to scour action

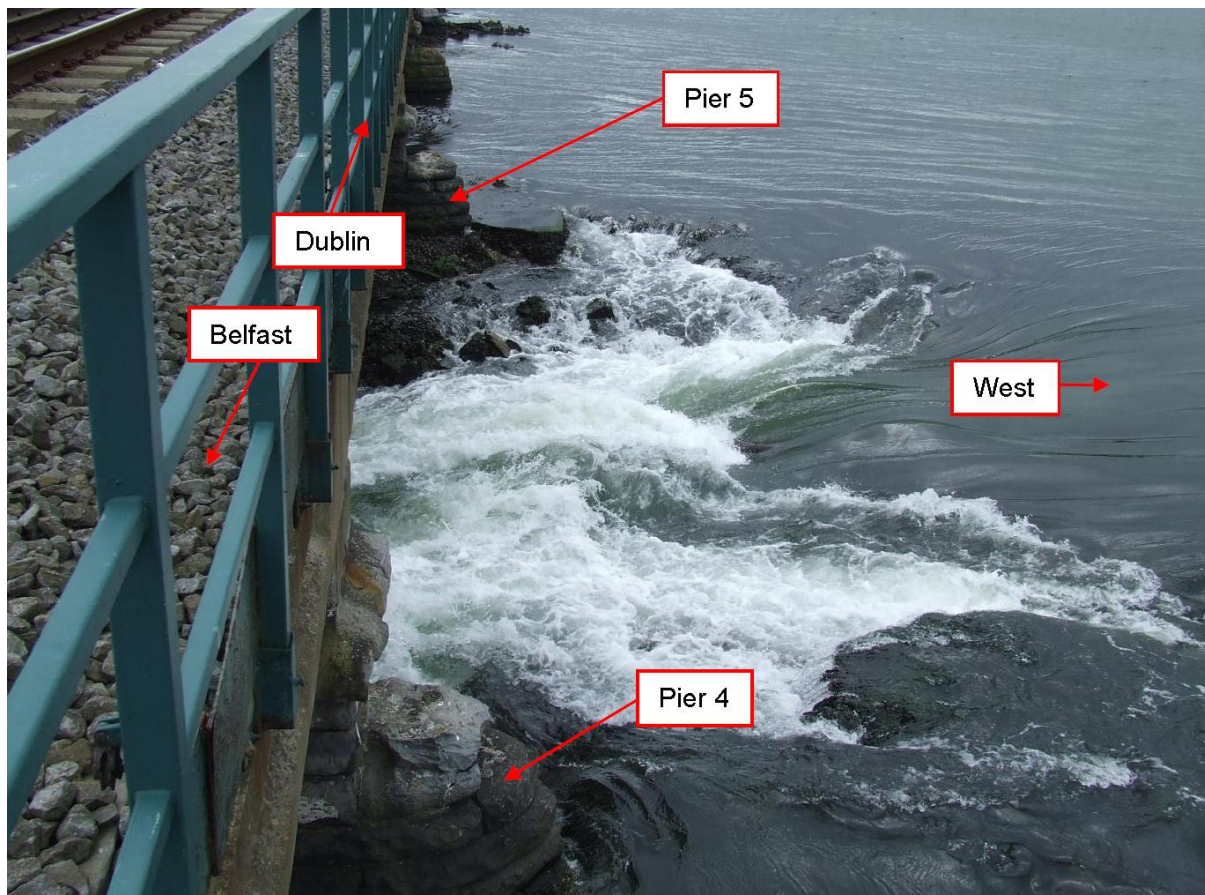
The reported washing away of 'stones' would indicate that the erosion mechanism had accelerated and the stones close to the foundations of Pier 4 had started to be displaced on the western side of the weir. This can be verified from the photograph taken by IÉ during the structural inspection on the 18th August 2009 (see Photograph 11). It can be seen, from the photograph, that the ebb flow hydraulic control point had moved further west at Piers 4 and 5. This suggests that serious erosion was occurring in the months leading up to the collapse of the viaduct, confirming the flow was accelerating over the crest, resulting in high velocities upstream of the western foundations of Pier 4.

Photograph 11 – Photograph taken during inspection of Viaduct on the 18th August 2009

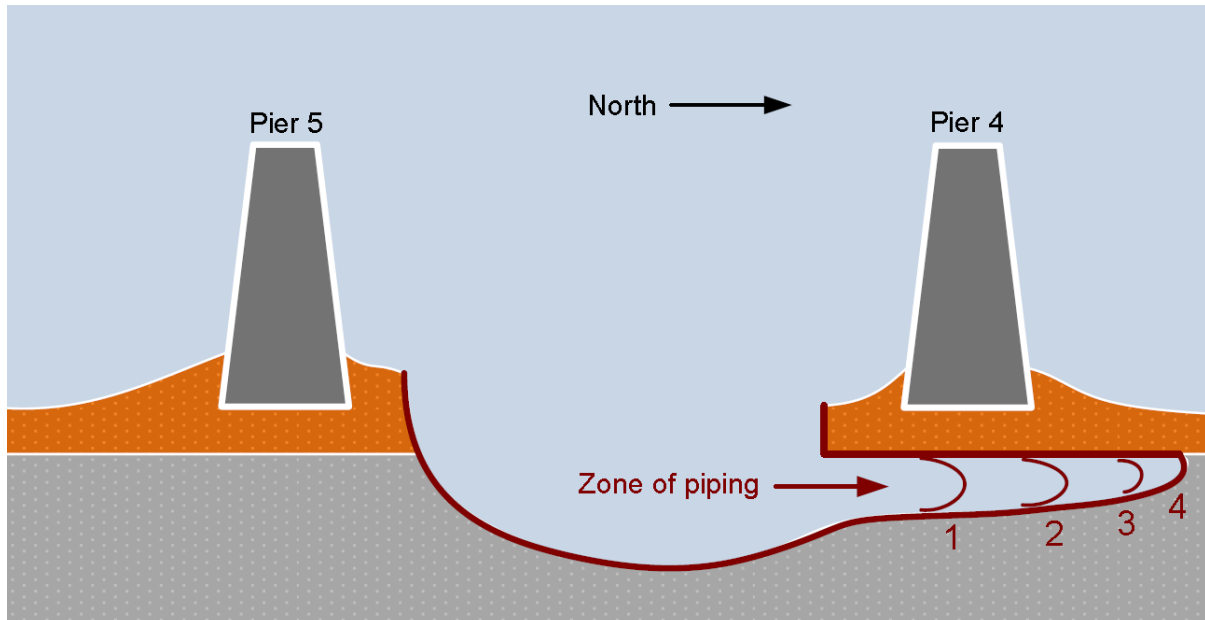
The narrowed flowpath and the remaining semi-intact grout rock armour on the western side meant there was an increased potential for *piping*. Piping occurs when there is a sub-surface formation and progression of a continuous ‘pipe-like’ tunnel. The material is eroded by the flow of water through the tunnel, which then carries away these eroded particles, (see Figure 21).

Figure 21 – Piping under Pier 4.

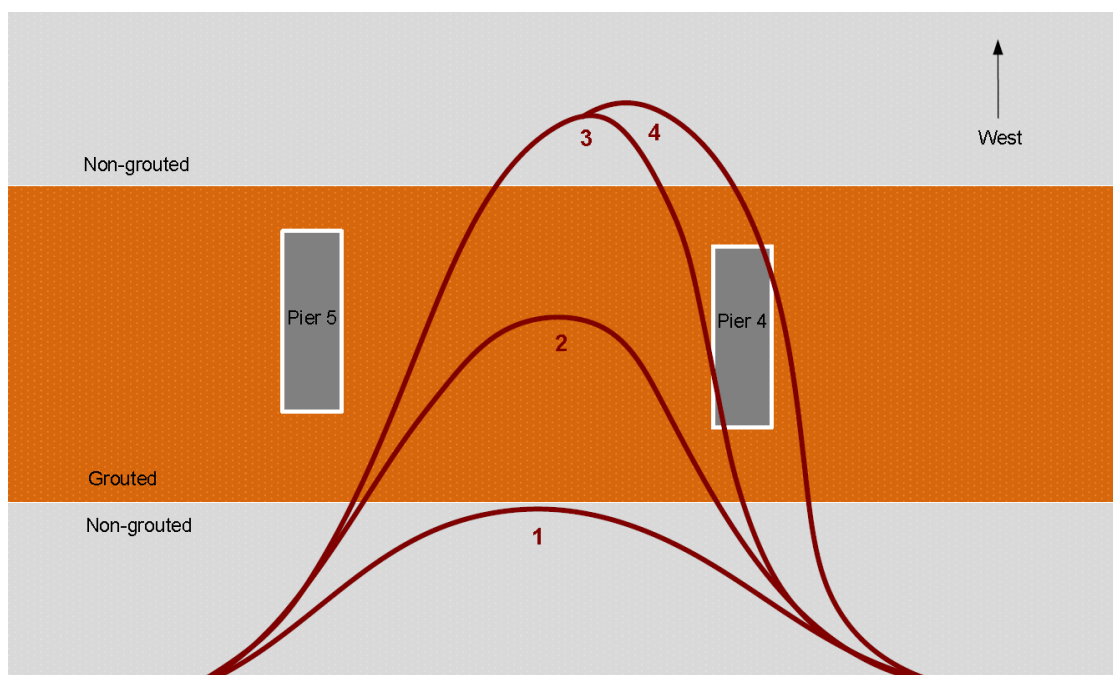
The piping flowpath was under the remaining grout layer on the west side of the weir with the grout layer acting as an upper boundary to the flow pipe, causing undermining of Pier 4 (see Figure 21).

Figure 22 - Undermining of Pier 4 as a result of piping

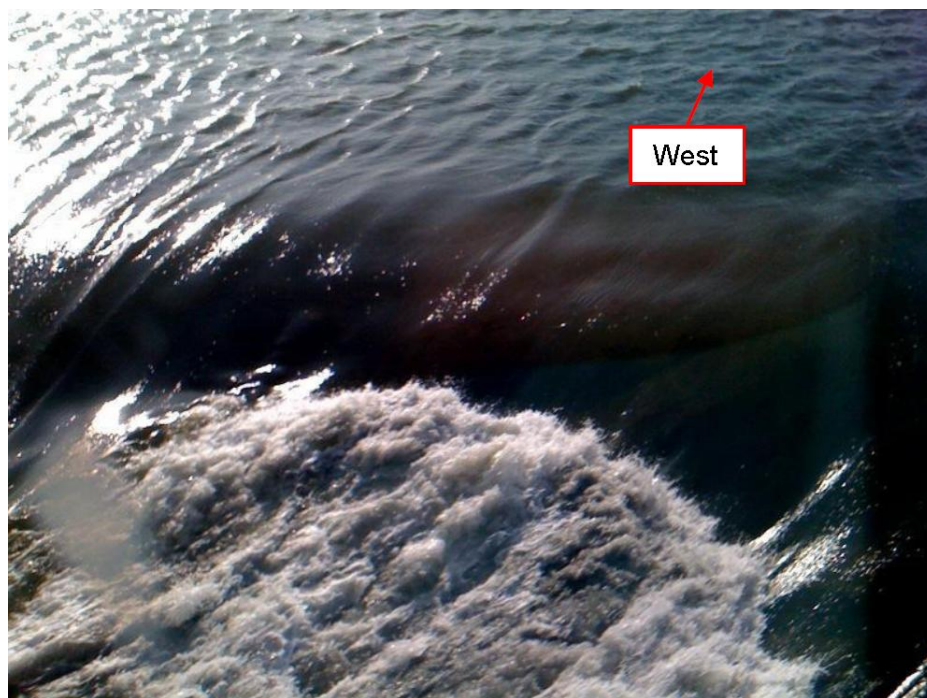
This has been verified by a photograph taken by a passenger travelling over the viaduct at 9.35 hrs on the 21st August 2009, the day of the collapse. He observed a whirlpool of approximately 3 m diameter on the western side of the viaduct. From the passenger’s position on the train, the whirlpool would have been located approximately 4 – 5 m from the viaduct. The passenger again observed and photographed this whirlpool at approximately 17.55 hrs, (see Photograph 12). This passenger’s travel over the viaduct coincided with the ebb tide flow for the day.

Photograph 12 – Vortex, photograph taken 30 minutes before the collapse

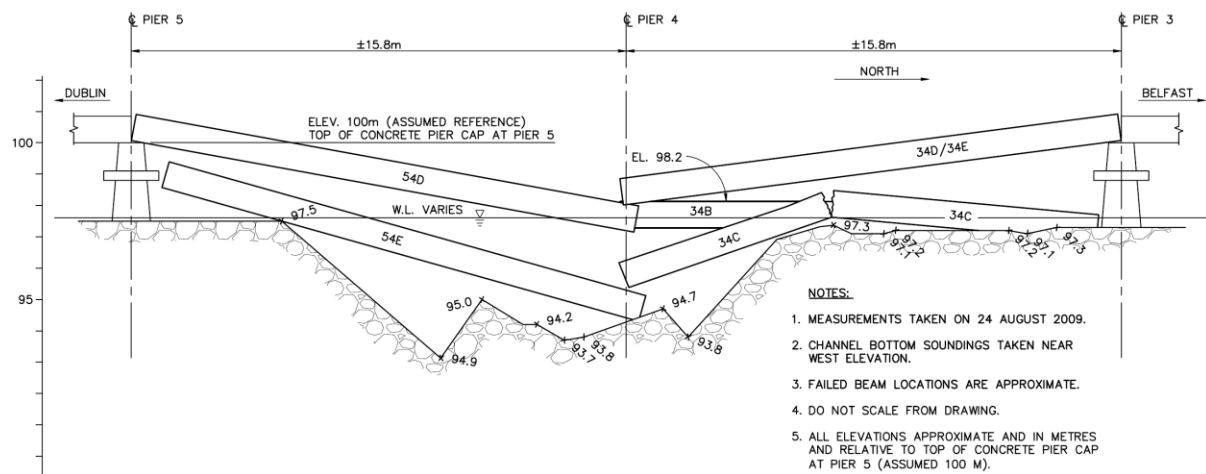
From a post accident survey (see Figure 23) an asymmetrical form can be observed. The significance of this observation is that the cause of scour is unlikely to be solely a result of '*local scour*', further reinforcing the cause of the undermining to be as a result of piping scour.

Figure 23 – Post accident survey illustrating asymmetrical scour hole

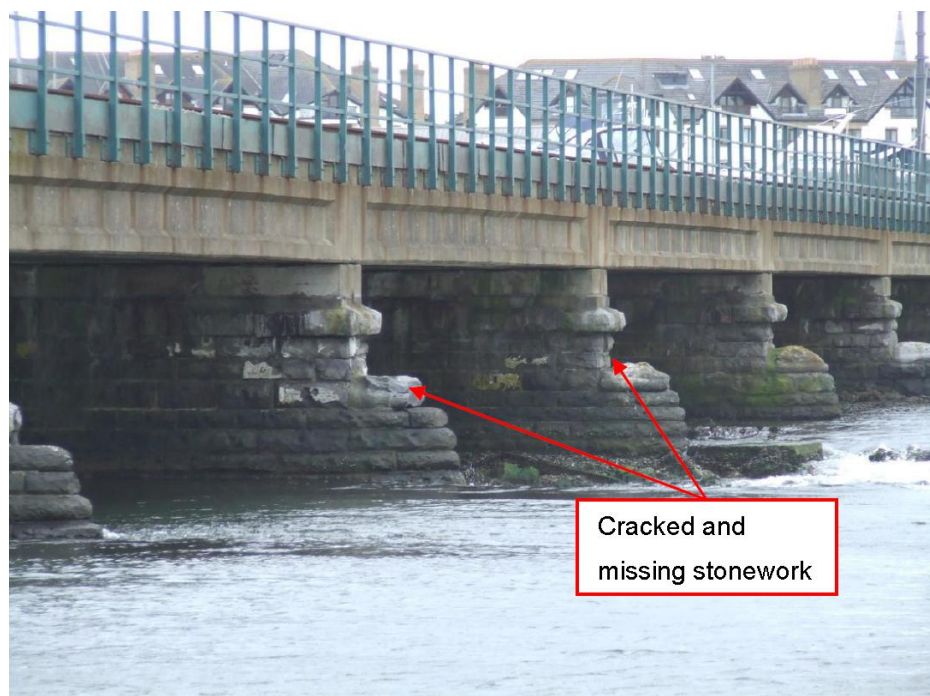
Prior to the AE carrying out an examination of Malahide Viaduct at 14.10 hrs on the 18th August 2009, the AE had not carried out an inspection of the Malahide Viaduct and was not familiar with the structure or the tidal conditions of the Broadmeadow Estuary. The AE recorded the examination with photographs and found defects in the piers' stonework, such as the piers' required repointing and found that some of the stones on a number of the piers were cracked or missing, (see Photograph 15).

Photograph 15 – Photograph taken by the AE on the 18th August 2009, showing defects to piers' stonework

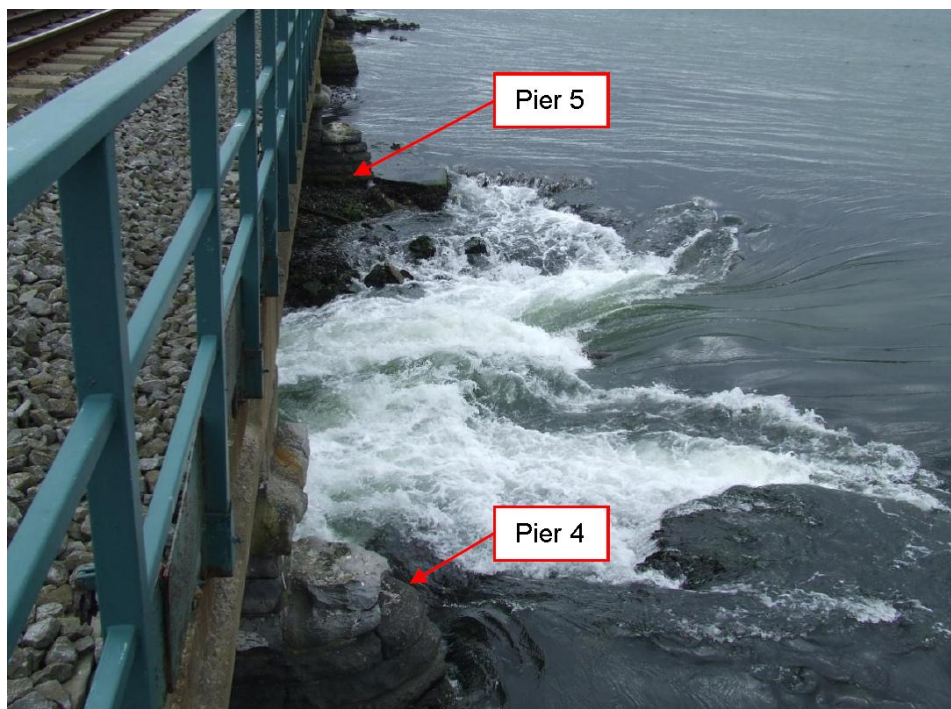
The AE also photographed (see Photograph 16) the base of the piers on the fifth span of the Malahide Viaduct (i.e. the span reported by the Malahide Sea Scouts group leader to IÉ as the span with the erosion at the base of the piers) and determined that there were no indications of erosion at the base of the piers.

Photograph 16 – Span 5 (between Pier 4 and Pier 5) of the Malahide Viaduct

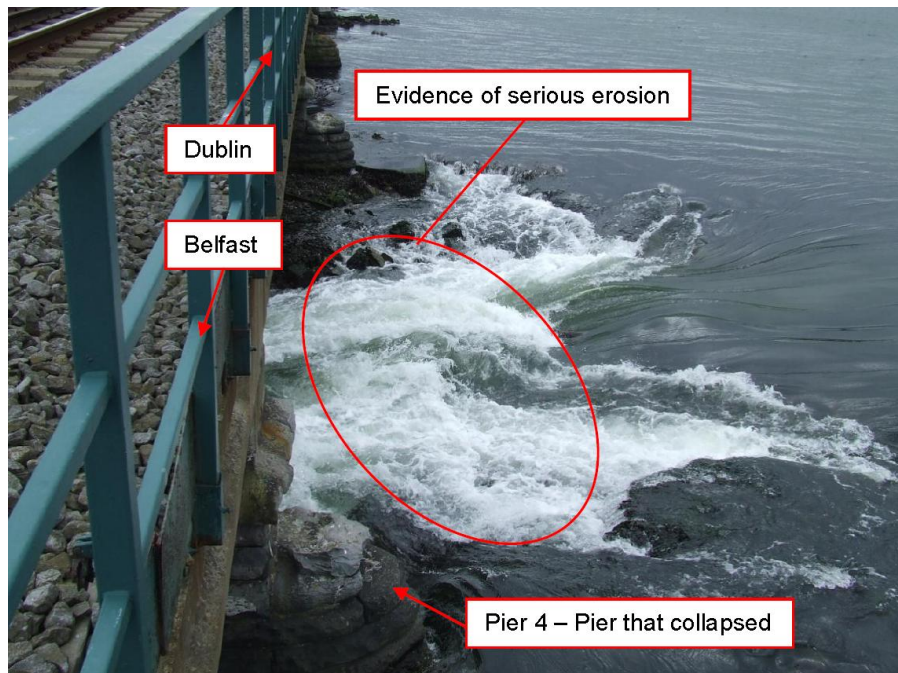
Reviewing the photograph (Photograph 18) taken by the AE, there is evidence of serious erosion, however, the AE, being unable to recall any information from the training, unable to decipher the training notes provided, and not experiencing any practical element to the training, did not conclude that there was any evidence of scouring at Malahide Viaduct. Reviewing the condition ratings, provided in the training notes, Condition Rating 4 illustrates where undercutting of the rock armour had occurred, similar to the failure mechanism of the collapse of Pier 4.

Photograph 18 – Photograph taken during inspection of Viaduct on the 18th August 2009
