ROMANIAN RAILWAY INVESTIGATING BODY

## INVESTIGATING REPORT

on the incident happened  
in the railway station Pantelimon,  
on 05 December 2009

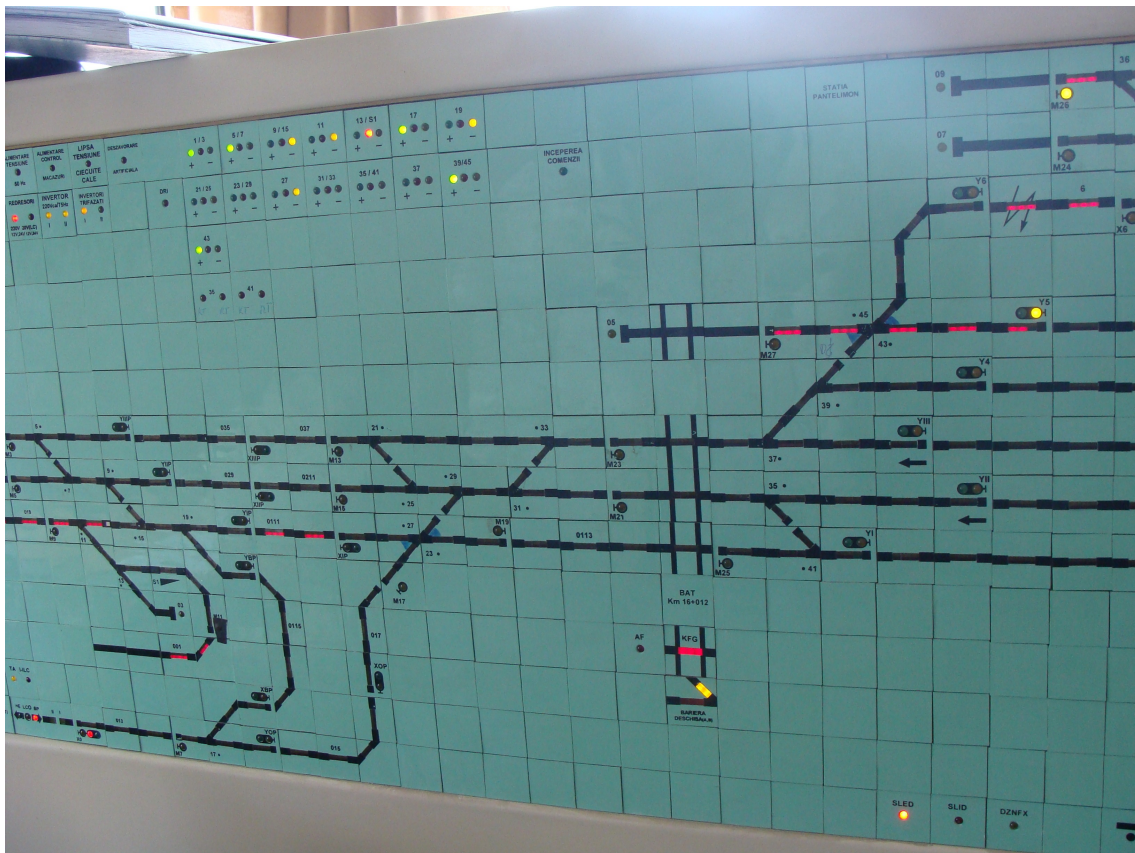
After passing the railway station Pantelimon XOP route signal, the train covers a distance of about aproximatelly 462 meters, with maximum speed of 20 km/h, after which, at 13:37, it stopped on the switch no. 37, following the engine driver's observation that the train was operated towards line 4, occupied by the passenger train no. 18207.

The place were the incident occured is located on the Branch of Bucharest Railway County, in railway station Pantelimon, in the switches area in the X end of the railway station.

## Picture 2 – The X end of the railway station CFR Pantelimon
