RAILWAY ACCIDENT AND INCIDENT INVESTIGATION DIVISION

Number: 375-7/2009/15

FINAL REPORT ON THE INVESTIGATION INTO A RAILWAY INCIDENT – THE DISPATCH ON 16 JANUARY 2009 OF PASSENGER TRAIN NO. 2630 ONTO A LOCKED RAILWAY TRACK FROM THE PRESERJE STATION TO THE BOROVNICA STATION

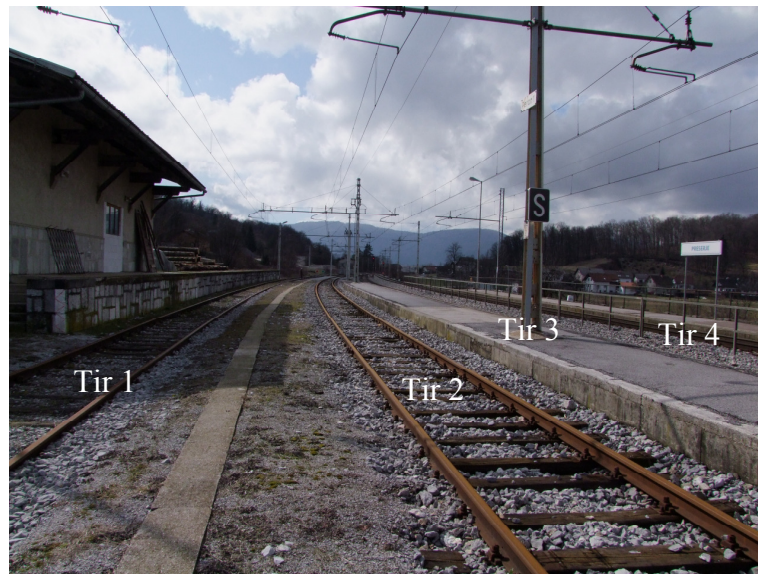
Figure 1: Preserje station tracks

Rail traffic at the Preserje station continued unimpeded along track no. 2 (two) in the Borovnica station direction and along track no. 4 in the Brezovica (and Ljubljana) direction until the departure of train no. 2630 at 08:28, when the traffic controller at the Preserje station dispatched the train onto the locked left-hand track. Track no. 3 (three) was occupied by train no. 42081, which had arrived at the station at 05:12 and was dispatched from track 3 (three) at 09:15.

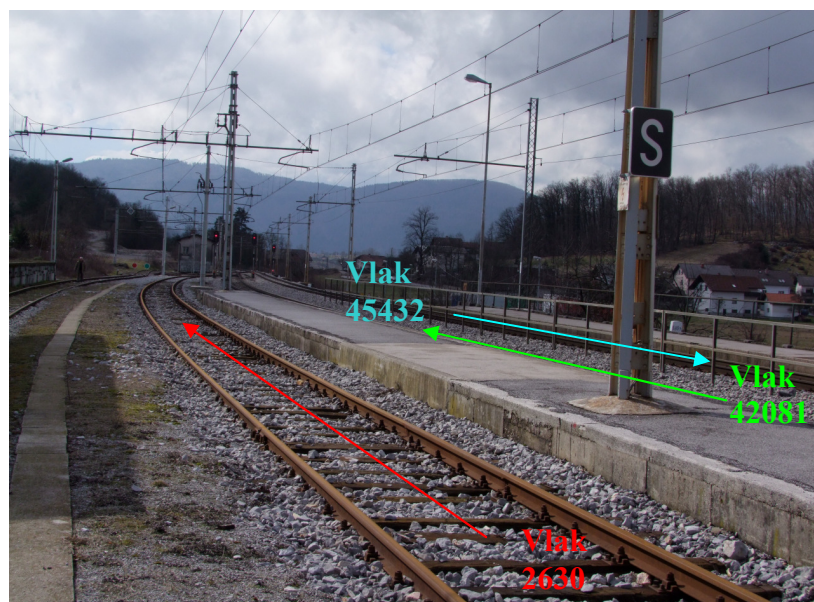
Figure 2: Tracks and direction of travel of trains

The Preserje station traffic controller stated in the minutes of the hearing of an employee – a witness under examination – that immediately following the passage of train no. 45432 along track no. 4 (four) he started protecting the exit route for train no. 2630, which at that very moment was travelling along the railway line from the direction of the Brezovica station towards the Preserje station. The traffic controller also stated that immediately following the passage of train no. 45432 (recorded in the P-13 traffic logbook at 08.21 along track no. 4 (four) of the Preserje station towards Ljubljana), he manually moved points 5 (five) and 6 (six).

This part of the traffic controller's statement is not true, because the order for the movement of points no. 6 (six) was only given at 08:28:13, which is evident from the recorded protocol of operations carried out at the interlocking. Train no. 2630 arrived at track no. 2 (two) from the Ljubljana direction at 08:26, which is evident from the analysis of the speedometer record (in the P-13 traffic logbook the time of arrival of train no. 2630 is incorrectly recorded as 08:33 and at incorrect entrance track no. 3 (three) instead of track no. 2 (two)).

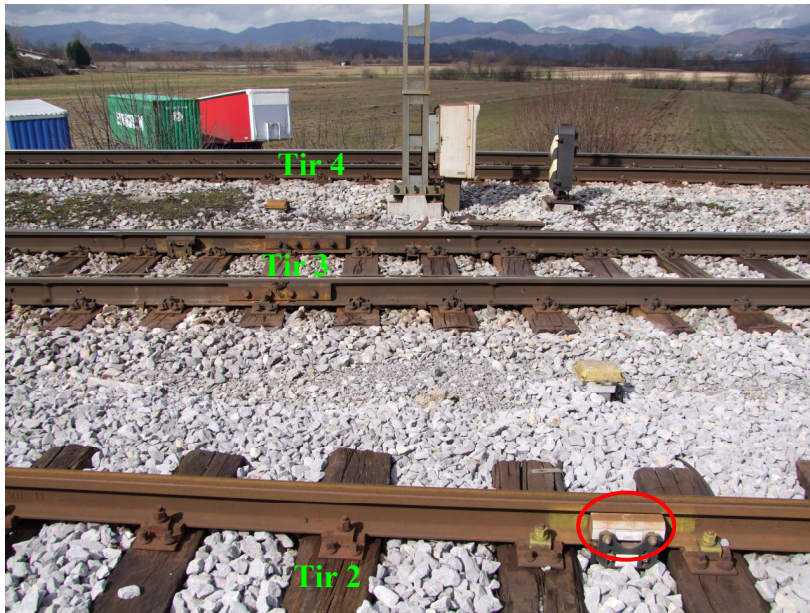
Figure 3: Axle meter, circled in red, of the ILTIS interlocking, making it impossible, when a track vehicle axle approaches, for the points to be moved to any position in the entire points area covered by the meter, in this case side "B" of the Preserje station

Taking into account the calculation of the time of passage of train no. 2630 – between pulling out after receiving the movement-allowed signal, while travelling along track no. 2 (two) until it stopped at points no. 7 (seven), which totalled 58 seconds – it can be claimed that the Preserje station traffic controller had enough time after dispatching the train to go to the Traffic Office and move points no. 6 (six) from the straight to the angled position. The traffic controller obviously ran out of time to move points no. 7 (seven), since at that moment the train had already arrived at the meter of the 5D shunt signal of points no. 5 (five), which prevented this manipulation.

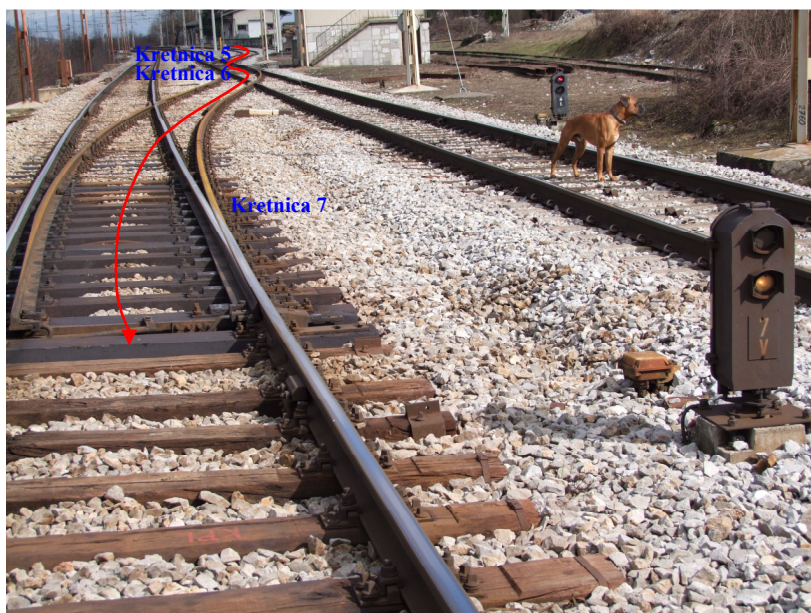
Figure 4: View of the train travelling over the controversial points area at side "B" of the Preserje station

According to calculations, the passage of train no. 2630 lasted 37 seconds, from the point it stopped at the entry to track no. 2, at km 580,650, along Platform 1 (one), to the 5D shunt signal at km 580,829 (a distance of 179 m).
